**Grand Island, Nebraska
Blight and Substandard Study - Area 18
Completed on behalf of: Middleton Electric**

PURPOSE OF THE BLIGHT AND SUBSTANDARD STUDY

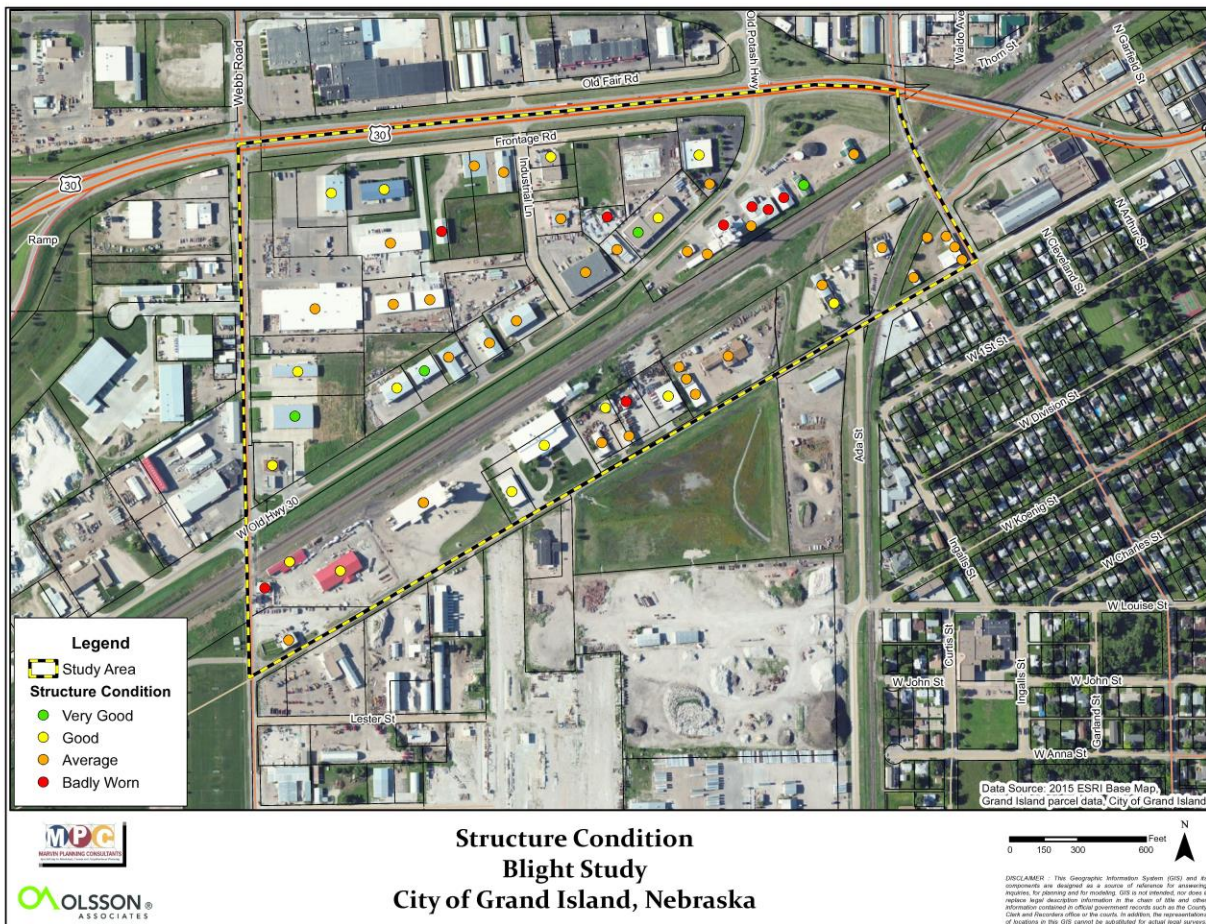
Figure 4
Structural Conditions

- 5 (7.8%) structures rated as very good
- 15 (23.4%) structures rated as good
- 32 (50.0%) structures rated as average
- 12 (18.75%) structure rated as badly worn

Based upon these data, an assumption has been made that average condition and less would constitute less than desirable conditions due to age and conditions. It is common that the older a structure gets the more maintenance and upkeep are required in order to maintain a good or higher condition. Even an average structure will show some signs of deteriorating which in turn can become a dilapidated structure in the future if it is not addressed over time.

Due to the stated conditions found in the Hall County Assessor's data, the condition of the structure is a contributing factor.

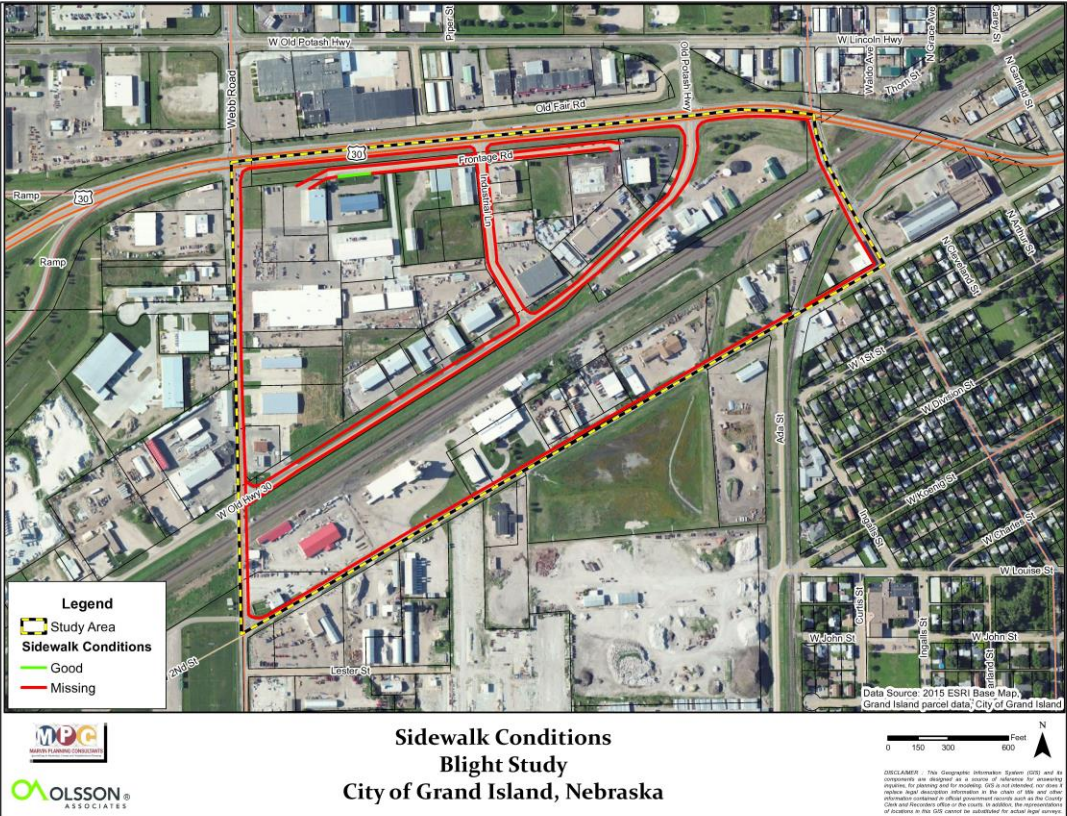
Figure 5
Sidewalk Conditions

- 180 (0.9%) lineal feet of adequate sidewalk
- 0 (0.0%) lineal feet of deteriorating sidewalk
- 19,750 (99.1%) lineal feet of no sidewalk.

There are almost no sidewalks present within the study area accessible to pedestrian traffic. Considering the uses along Webb Road, Old Highway 30, Blaine Street and 2nd Street there should be sidewalk in place. The only place sidewalk exists is in front of the car wash along the service road along US Highway 30.

In addition to the missing sidewalk indicated in Figure 5, there are other locations where sidewalk is missing, specifically along US Highways 30. These areas are included in the totals, but city and state policies are not to encourage walking and biking along major highways.

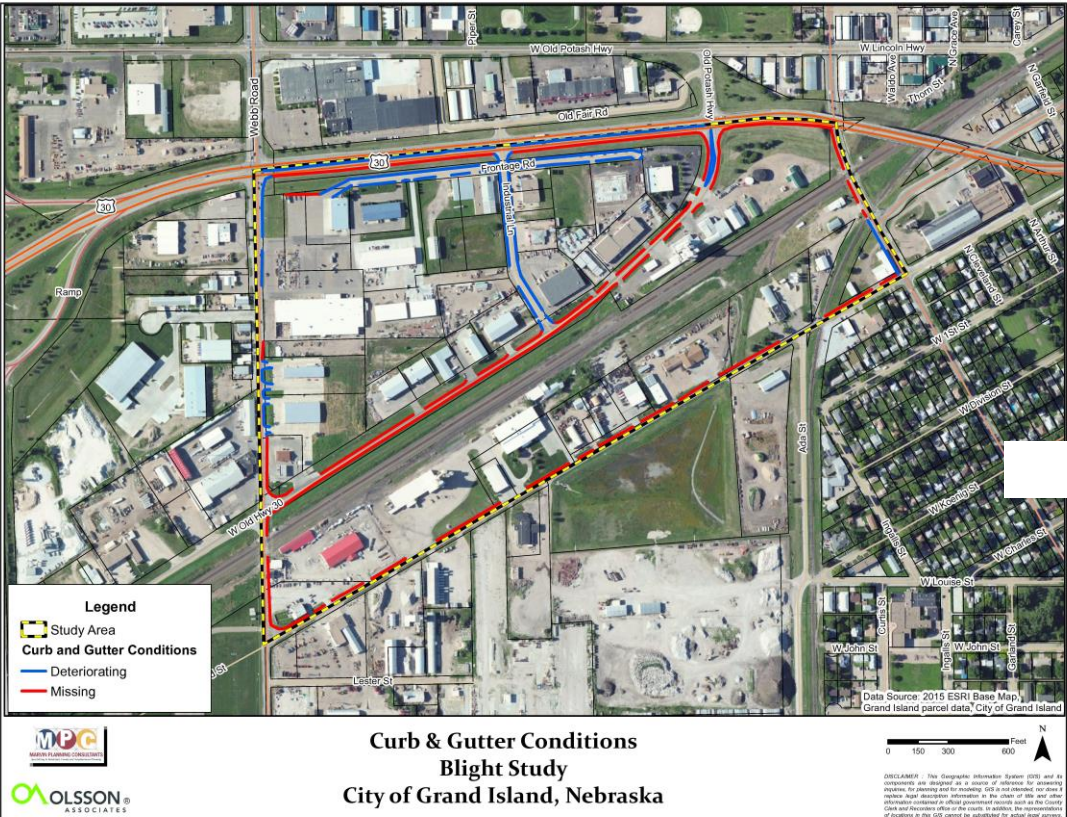
Figure 6
Curb and Gutter Conditions

- 0 (0.0%) lineal feet of adequate curb and gutter
- 8,375 (42.0%) lineal feet of deteriorating curb and gutter
- 11,575 (58.0%) lineal feet of no curb and gutter or rural section.
- There was no curb and gutter deemed to be dilapidated.

In total, 100% of the curb and gutters are in either a deteriorating state or are missing. See Figure 6 for the locations of these curb and gutter. The area is designed for surface drainage as opposed to underground stormwater piping.

Due to the large amount of deteriorating and missing curb and gutter, the curb and gutter conditions would be a direct contributing factor.

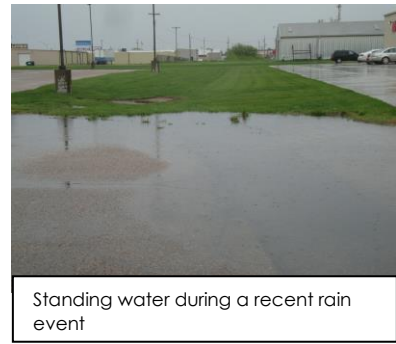
The field survey examined the entire area for potential drainage problems. One field survey was completed during and a day after a rain event. During both field visits there was standing water throughout the entire area. Water was standing in large potholes, in drainage ditches, along key drainage ways.

Standing water during a recent rain event

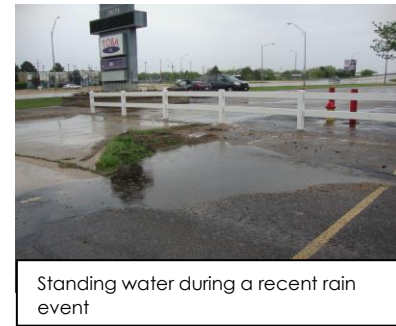
Standing water during a recent rain event

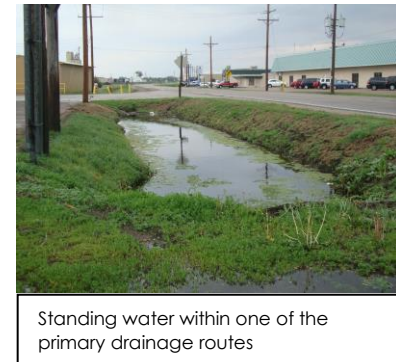
The primary way for stormwater runoff to reach the catchment is through a series of ditches along S. Webb Road, US Highway 30, 2nd Street and Old US Highway 30. This type of stormwater infrastructure typically works only when there is some topographic drop-off and the ditches remained mowed. In case of the ditches in the study area, the grass appeared to be longer than it should be to allow for water movement.

Standing water within one of the primary drainage routes

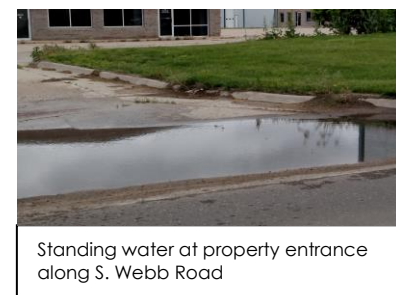
Standing water at property entrance along S. Webb Road

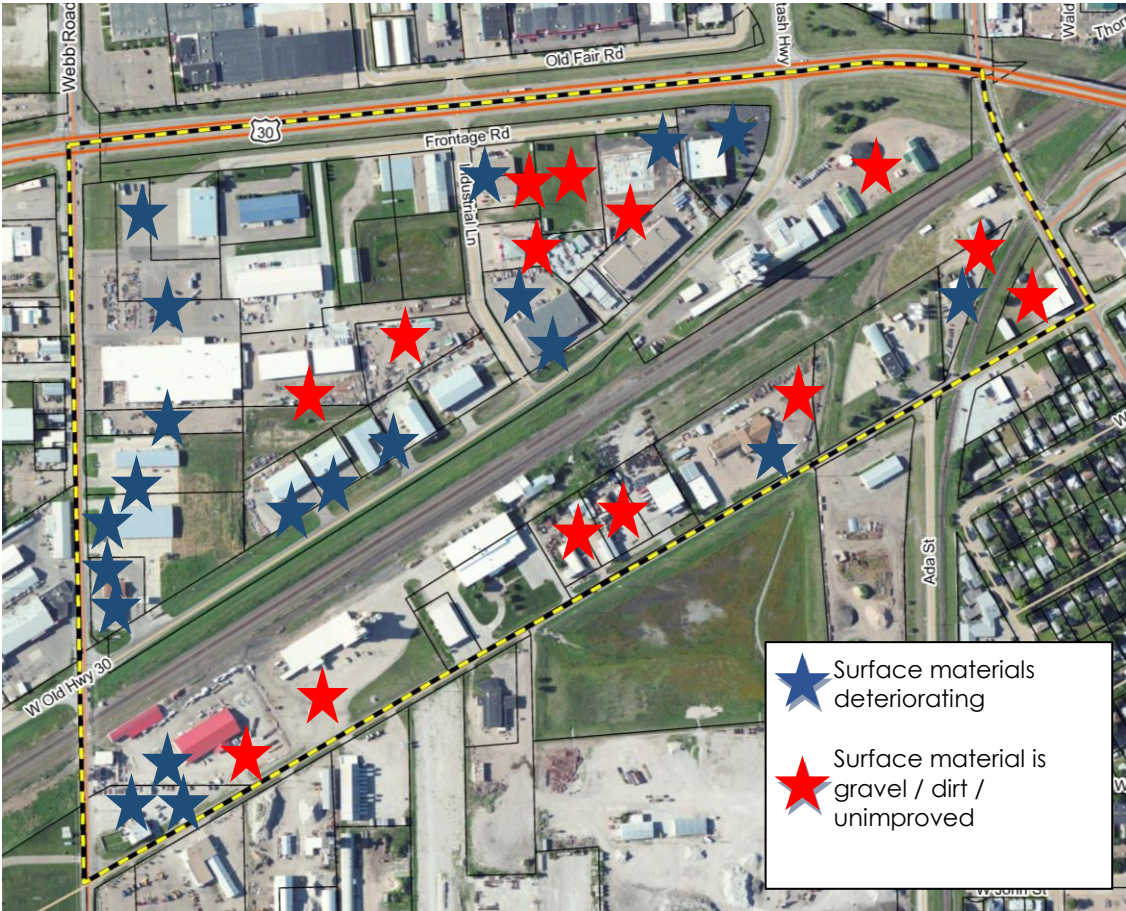
The different properties throughout the study area have less than average site improvements. A large portion of the properties have gravel/dirt drives and parking lots and in some cases they may have been concreted or asphalted in the past but it is difficult to determine due to the level of deterioration. Some properties have paved/improved parking areas and drives were found to be in a state of deterioration.

Figure 8 identifies the different properties in the study area that have deteriorating parking areas and drives, as well as those properties that have been hard surfaced and are showing signs of deteriorating and in need of repair/rehabilitation. Even though most of the land uses in this area are heavier commercial to industrial uses, the lack of hard surfacing or the deterioration of the existing hard surfacing has a major impact on the perception of the area as well as the value of the area.

Based upon the field analysis, there are sufficient elements present to meet the definition of deterioration of site and other improvements in the Study Area.

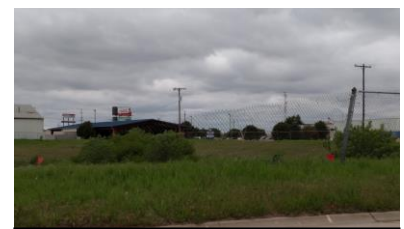
The topography found in Grand Island creates the need for unique engineering solutions to catch, store, and release stormwater. Within the center of the study there is a stormwater catchment facility. This catchment could be considered an unsafe condition contributing to the potential blighted and substandard conditions of the area. This catchment is deep and is designed to handle a massive amount of water; however, the security measures have been compromised due to a damaged fence along Industrial Lane.

Damaged fence at stormwater catchment
Source: Marvin Planning Consultants

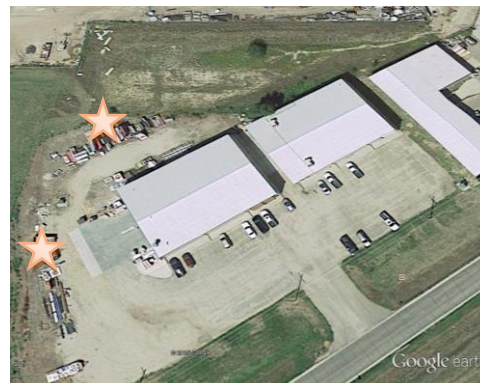
The field investigation of this study area identified two major areas where materials are stored and are not secure. One is the area to the west and north of Love Signs. Love Signs has several older signs and parts stored in an open area without any security fencing. Considering the sheet metal and other materials used for their product, these materials can be dangerous if someone were to wander into this area unauthorized.

Unsecured materials

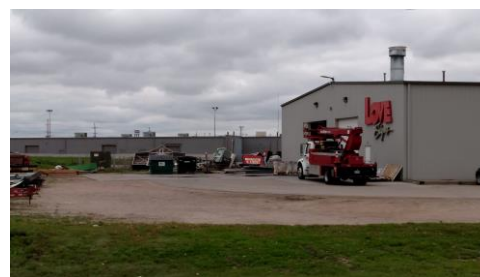
Photograph from Old US Highway 30

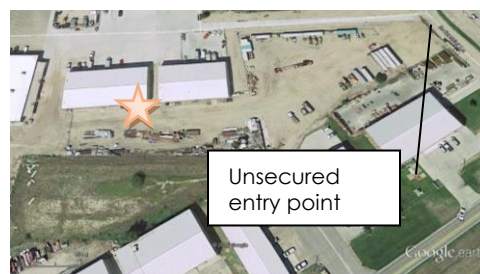
site, operated as the Storage Warehouse. The facility has a considerable amount of materials stored outside. Portions of this area are protected by fencing materials but the entry to the site along Industrial Lane is open to the public through an uncontrolled access point. This provides access to the area and could create a dangerous condition.

Second unsecured property
