BOILER INSPECTION AND REPAIR SPRING 2022 OUTAGE

C131306

Platte Generating Station

OUTAGE INSPECTION REPORT 2015

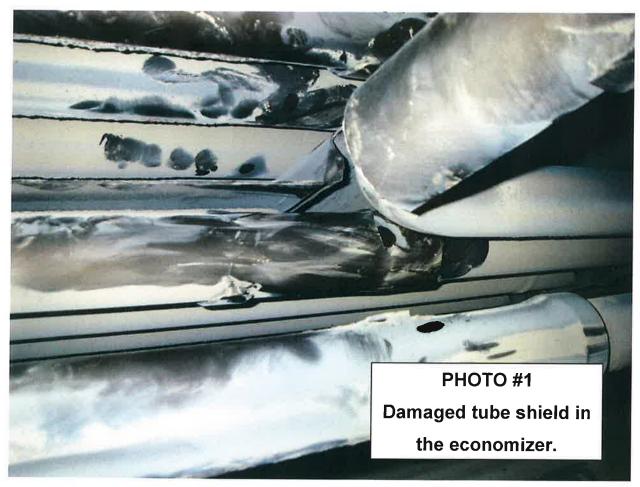
During the 2015 outage, there were damaged tube shields found along the IK-10 soot blower path. On assembly #24 at IK-10R the tube shield had been worn through, PHOTO #1. This shield was replaced during the outage by plant personnel.

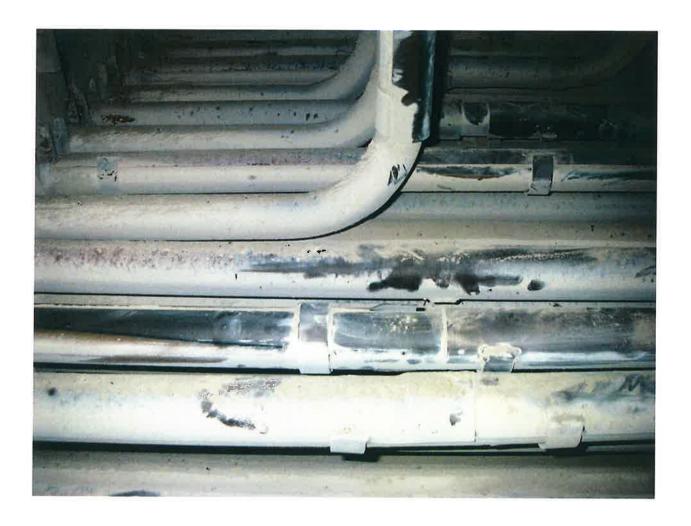
PHOTO #2

At IK-10L there was soot blower erosion on the second tube in the bottom assembly. This tube had not originally been shielded, but due to the polishing effect of the soot blower, a new tube shield was installed on this tube, PHOTO #2.

Tube needing additional shield in the economizer.

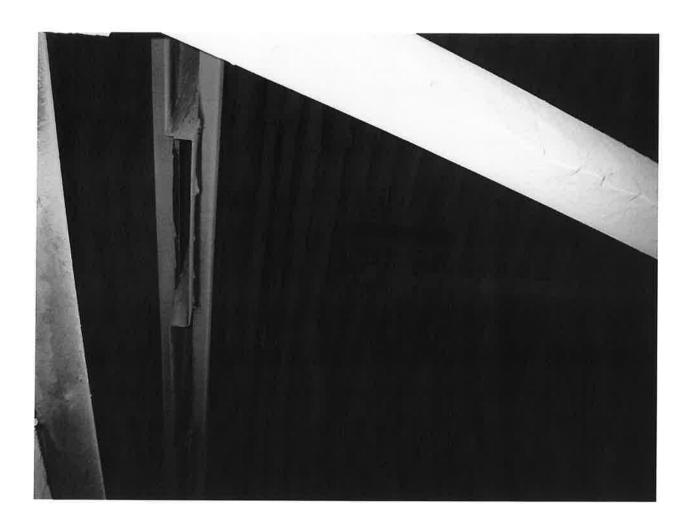
Also during the 2015 outage, the tube shields were inspected on the bottom section of the economizer, at IK-13 and IK-14. There were a few damaged tube shields that were replaced in this area during the last outage in 2014. No further tube shield damage was found during this outage. PHOTO #3 shows the tube shields on the bottom of the economizer.

PHOTO #3
Under side of economizer assembly.

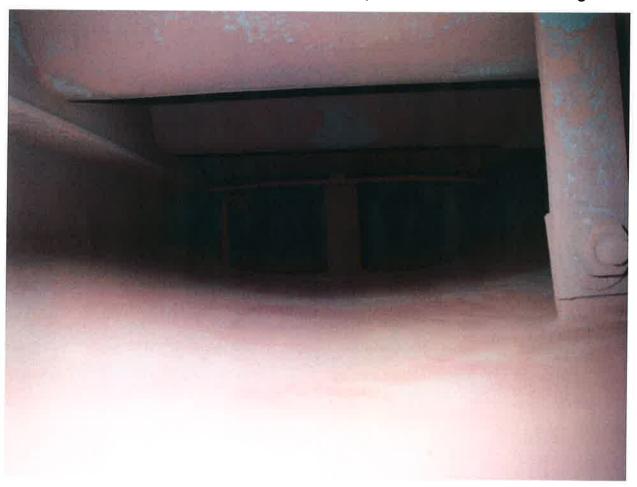
The steam drum was opened in the spring 2015 outage. Special attention was given to the welds at each of the drum penetrations. Heavy walled pressure vessels are susceptible to cracks at penetrations from thermal cycling. Welded penetrations are also susceptible to weld under cutting due to chemical attack or corrosion. No signs of crack indications, or weld under cutting were found. PHOTO #4 shows the left side downcomer penetration and vortex inhibitor, a common place for weld undercutting.

PHOTO #4
Steam drum down
comer penetration.

Perform periodic inspections in the steam drum of the penetration welds for signs of stress corrosion and crack indications.

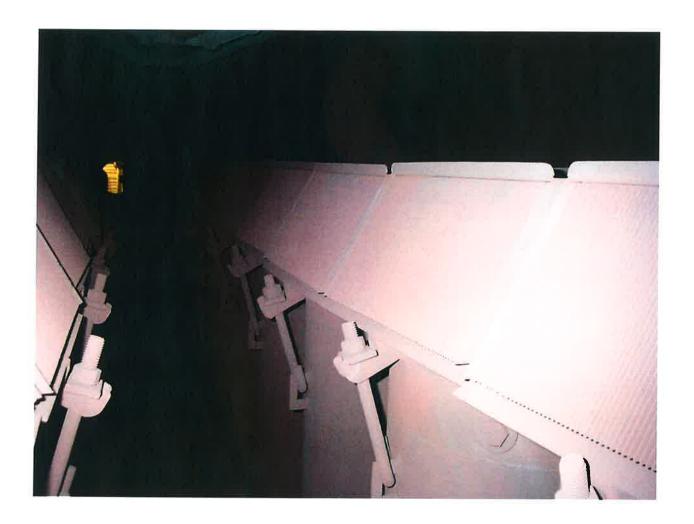
The internal hardware in the drum was found in good condition, PHOTO #5 below. The drum internals were checked for loose nuts on the hold down bolts on the separator cans. No maintenance or repairs were needed during the outage.

PHOTO #5
Steam drum internal
hardware.

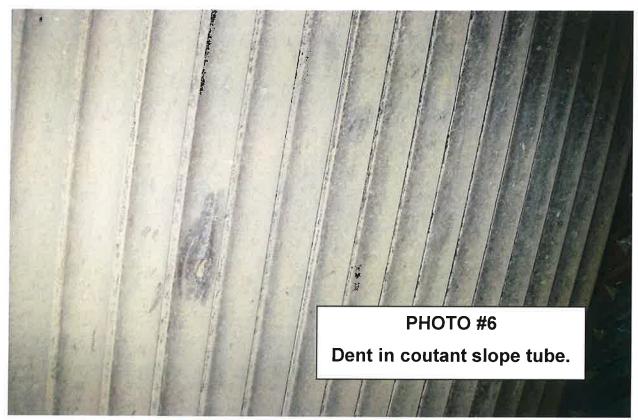
The water wall tubes of the front and rear coutant slopes were also inspected during the outage. The coutant slopes were checked for gouges and dents. If a tube does not have a sharp gouge, or is not dented past half its inner diameter, it does not need to be sectioned out. There were several dents in the coutant slope tubes, but no repairs were needed. PHOTO #6 shows a typical dent found on the slope tubes.

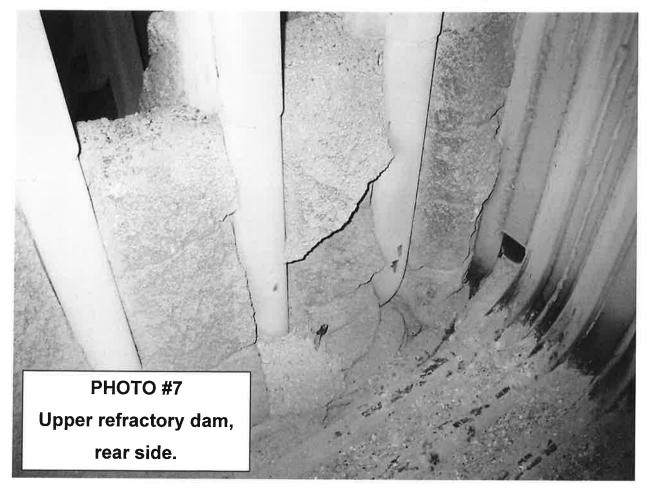
The refractory dam at the top of the water wall section, the water wall screen tubes, was replaced during a previous outage. This refractory dam is still in good condition. The front side of this refractory is in good condition, but there are areas on the rear side that have portions where the refractory has broken away. This is found on both the right and left ends of the refractory. PHOTO #7 shows one of these areas where the refractory has broken off and the water wall screen tubes are visible.

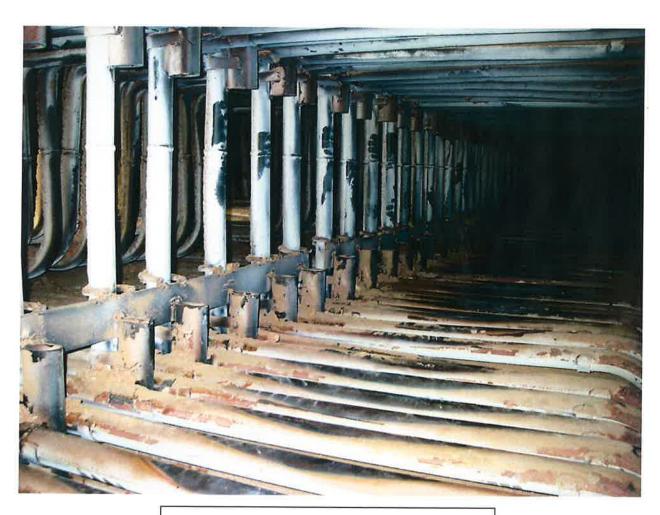
The horizontal superheat tubes were inspected for erosion damage and any tube bowing that could affect gas flow through the backpass. The main problem in the horizontal superheat assemblies has been the erosion damage that has been caused by the retractable soot blowers at IK-8 and IK-12. PHOTO #8 shows the sootblower lane at IK-8. There were no tube shield issues and no new signs of erosion.

Horizontal Superheat tubes
between the two banks of tubes.

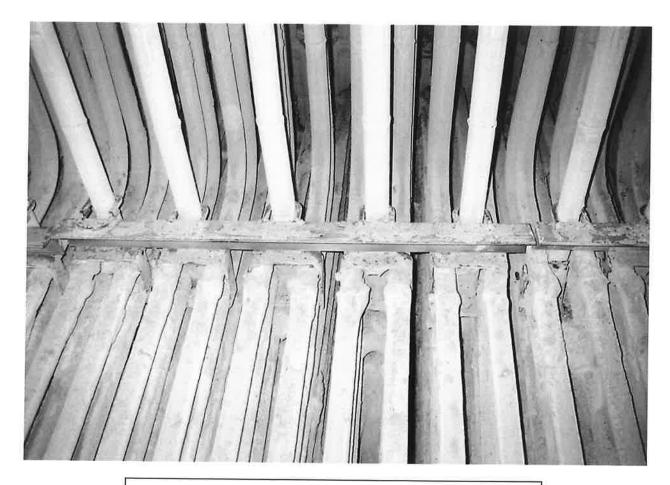
PHOTO #9

On the top bank of the horizontal superheat assemblies, there were areas of ash pluggage, as shown in PHOTO #9. This ash is a combination of ash build up from the flow through the backpass and the debris that has been removed from the finishing superheat assemblies. The alignment bars were also replaced with new stainless bars during the 2014 outage.

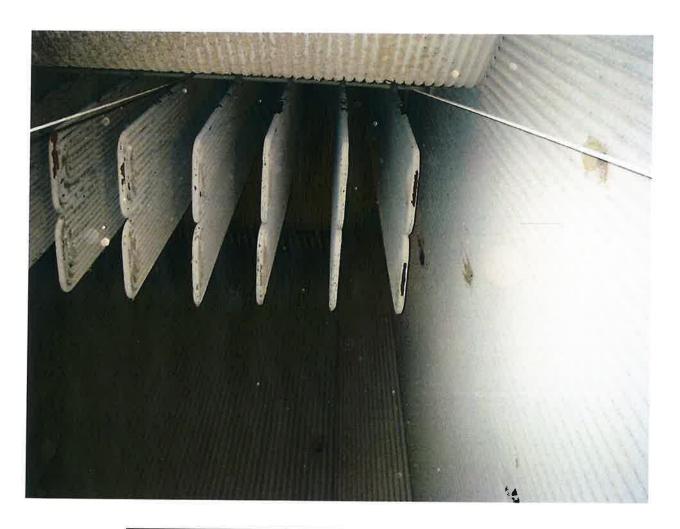
The superheat pendant platen assemblies were not accessible during the 2015 outage. PHOTO #10 shows the superheat pendant platens, as viewed from the sky climber. The pendant platens are normally inspected during major outages, when access is available. There have been no reported issues or repairs with these tube assemblies.

PHOTO #10
Superheater pendant assemblies on the east side of the furnace.

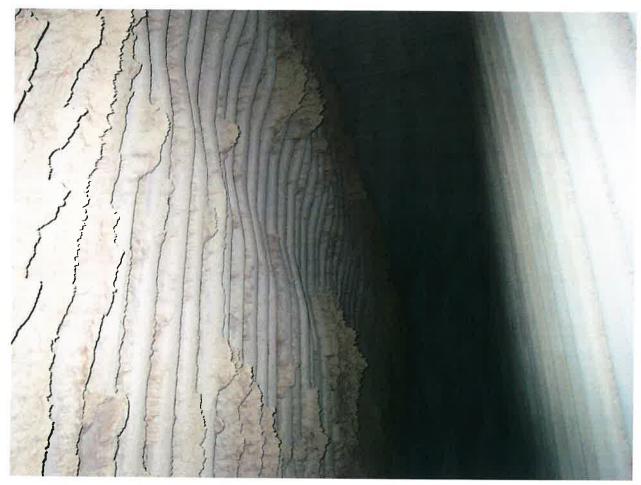
The finishing superheat assemblies were inspected during this outage for tube misalignment, ash fouling, and soot blower erosion. The main problem in these tube assemblies in the past was the amount of ash pluggage. These assemblies typically have pluggage in the upper section of the tubes, but this was cleared in the major outage last year. PHOTO #11 shows the current ash build up on these tube assemblies, which is a normal amount of build up for this boiler.

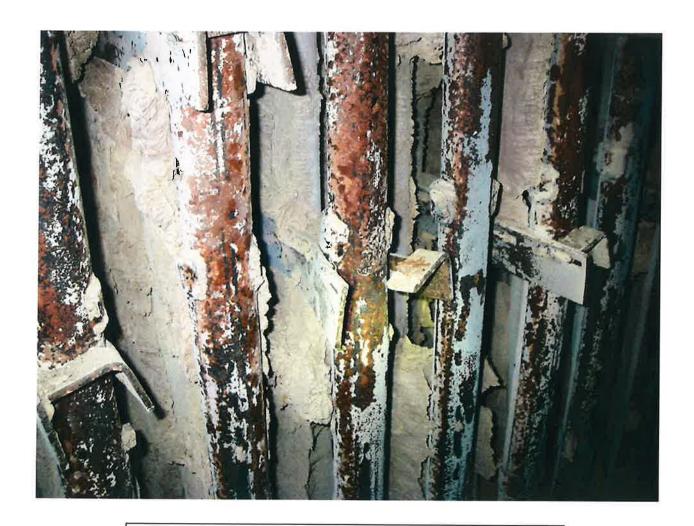
The other problem noted on the finishing superheater assemblies is the alignment bands. Several of these bands have broken due to overheating, PHOTO #12. These bands keep the individual tubes of the assembly in alignment. This is not a serious issue, but these bands may need to be addressed in a future outage. There are various types of alignment components that are commercially available as replacements or upgrades.

PHOTO #12
Finishing superheater with broken alignment bands.

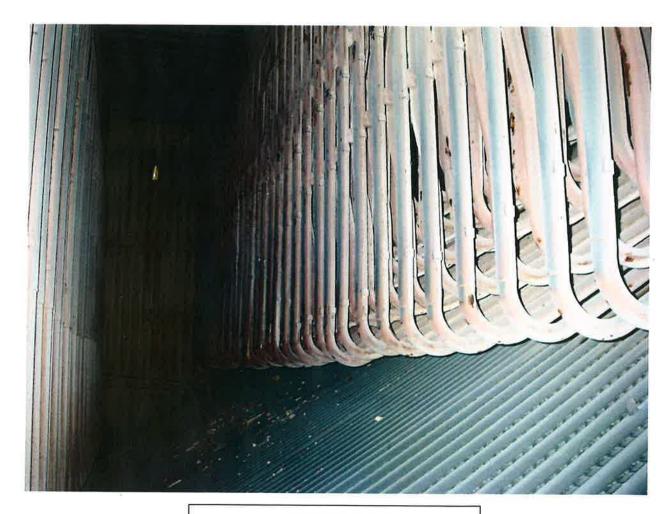
The reheat assemblies were inspected from scaffolding between the front and rear assemblies. Close access in normally made available during routine outages. There were no repair issues seen during this outage. PHOTO #13 shows this tube. It was to be repaired during the outage.

PHOTO #13
Reheat assemblies.

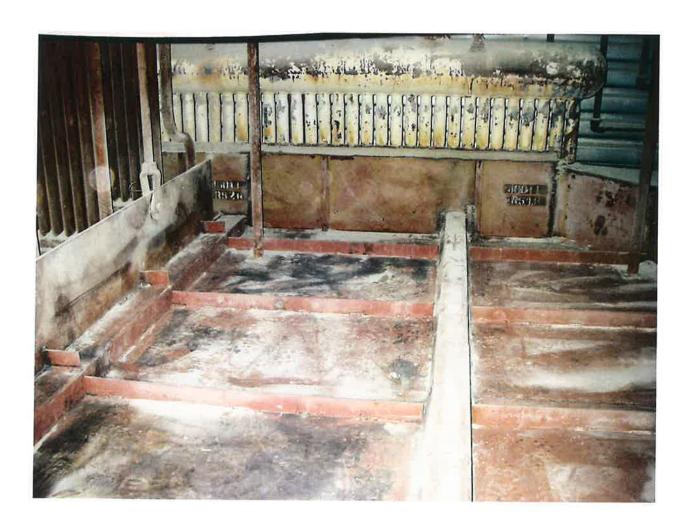
The penthouse enclosure was found to be in good condition. The penthouse enclosure has remained consistently clean over the past few years. PHOTO #14 shows the flooring of the penthouse.

PHOTO #14
Penthouse floor casing.

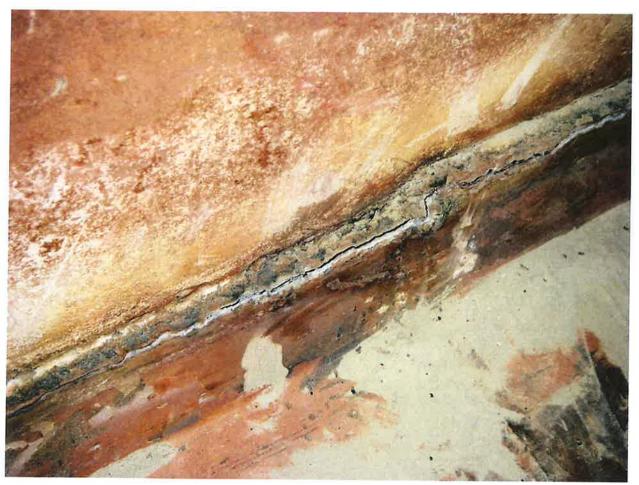
The main issues were the number of casing leaks and cracks that are allowing flyash into the penthouse. These leaks are small and are not allowing enough flyash into the penthouse to be considered a serious problem. PHOTO #15 shows one of the many casing cracks found in the penthouse.

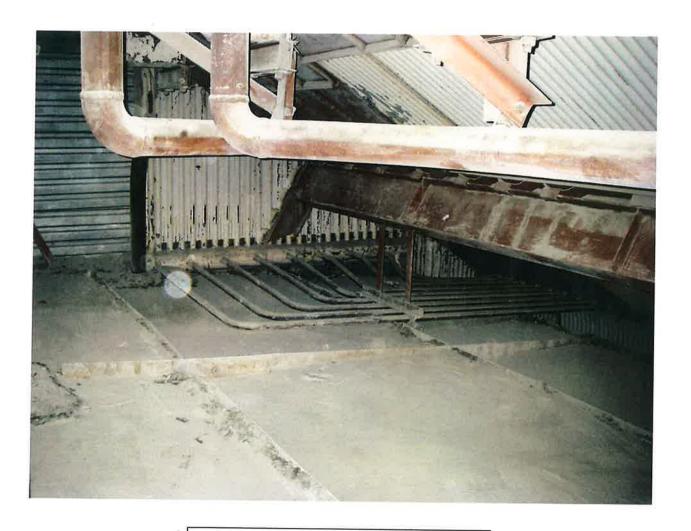
The nose arch dead air space was inspected during the outage for casing leaks, ash accumulations, and any other repair items. During the outage no fly ash accumulations were found. PHOTO #16 shows the current condition of the upper nose arch area.

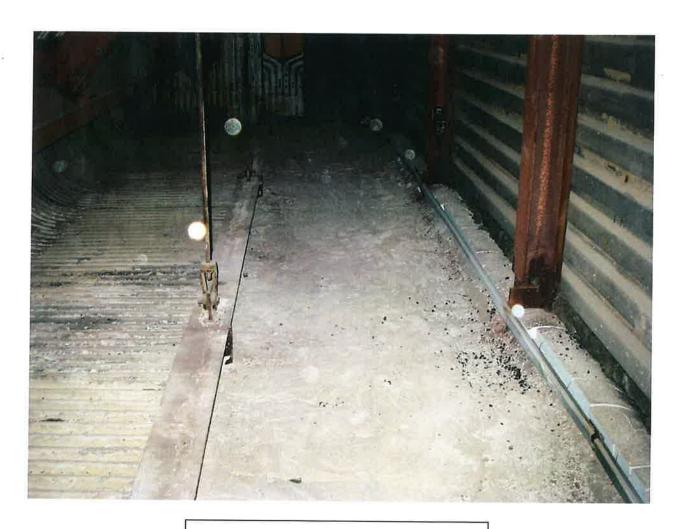
The lower dead air spaces were inspected and found in good overall condition, with no casing leaks, no ash accumulations, and no insulation damage. There were some small casing leaks found in the lower dead air spaces. These casing leaks were not serious and since they seal against the lower furnace area there is very little chance of ash ingress. The front dead air space is shown in PHOTO #17.

PHOTO #17
Lower dead air space.

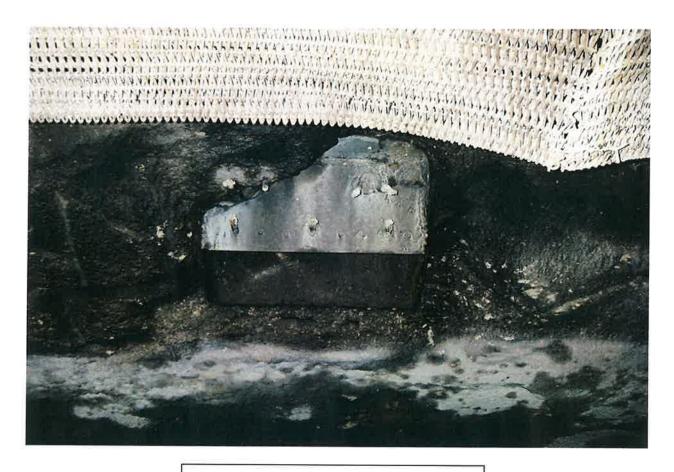
The refractory on the inside lining of the bottom ash hoppers is in fair condition, with signs of damaged refractory. The penetrations into the hopper are in fair condition. PHOTO #18 shows one of the vacuum breaker chutes in the bottom ash hopper along with damaged refractory.

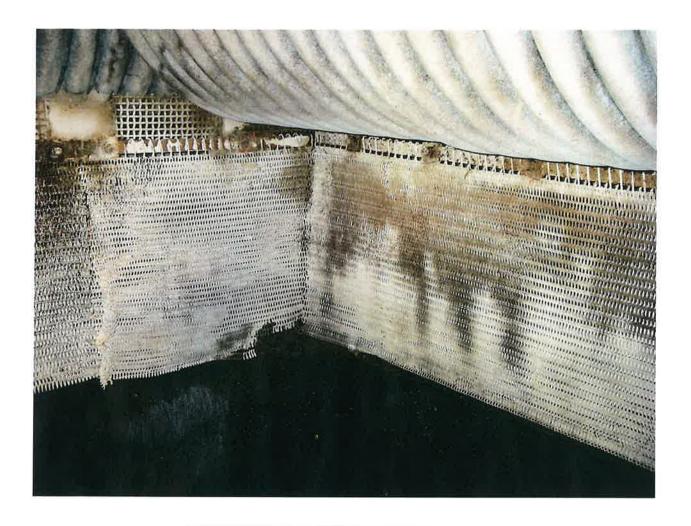
The drip screens were replaced back in 1999 with flexible screens instead of the original rigid screens. There were a few sections of screens that had holes in them and have been replaced since then. PHOTO #19 shows the current condition of the screens in the right front corner.

PHOTO #19
Bottom ash drip screens.

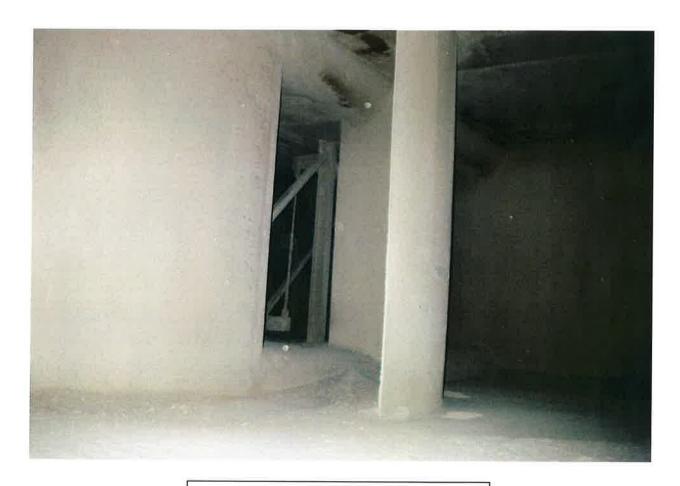
The secondary air ducts were inspected for ash accumulation, casing leaks, and other items that might require repair. These ducts were found to be in good condition. There was some ash build up found in these ducts, see PHOTO #20, but it is not as severe as many other such ducts in coal fired units. The secondary air ducts connect the air preheater to the windboxes. No repair items were found during these inspections.

PHOTO #20
Secondary air ductwork,
between the air preheater and
the left side windbox.

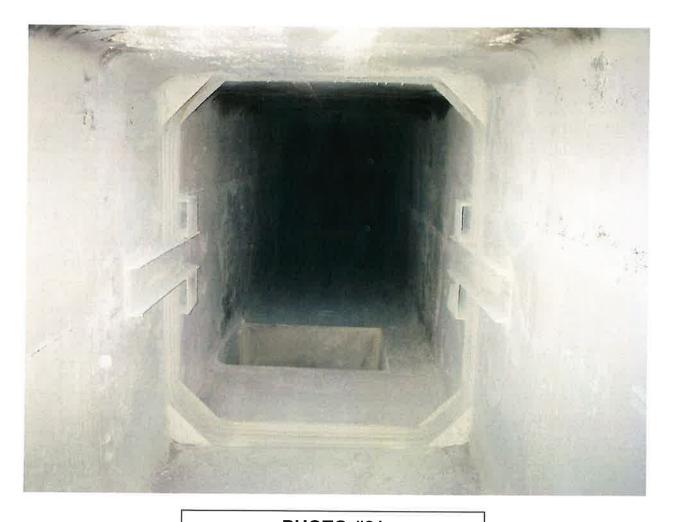
PHOTO #21

The mill hot air ducts were inspected during this outage for ash accumulation in the expansion joints, casing leaks, and other items that could require repair. These ducts were found to be in good condition, PHOTO #21. There was some ash build up in the expansion joints in these ducts. The mill hot air ducts supply hot air from the windboxes to each of the coal mills.

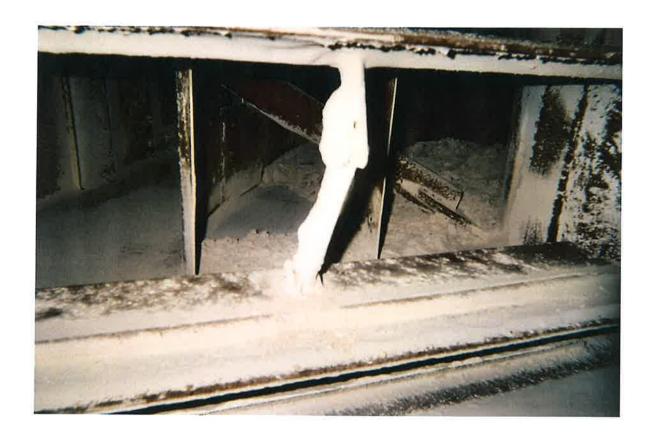
The windbox ducts were inspected during the outage for ash accumulations, casing leaks, and any signs of structural damage. The windbox ducts were found in good condition. Windbox box dampers were stroked and all dampers worked properly. PHOTO #22 shows one of the damper assemblies.

PHOTO #22
Windbox dampers.

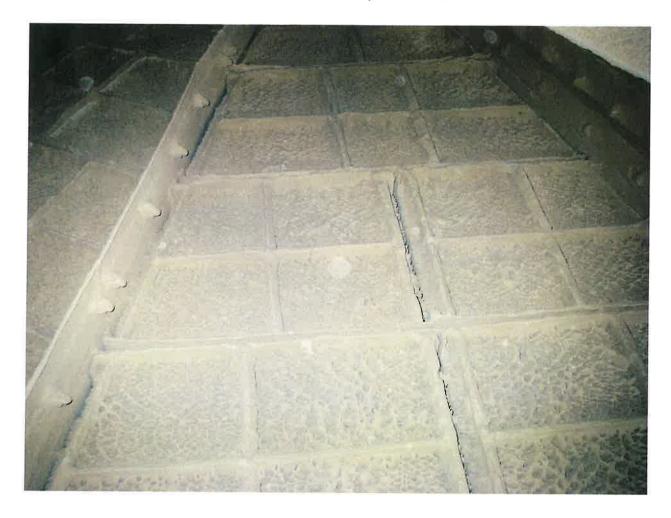
The air preheater was found in good condition. The radial and circumferential seals were all in place with no damage to the seals. There was a coating of ash on the top side of the air preheater. PHOTO #23 shows this view on the hot side of the air preheater.

PHOTO #23
Slightly hardened ash build up on the top side of the air preheater.

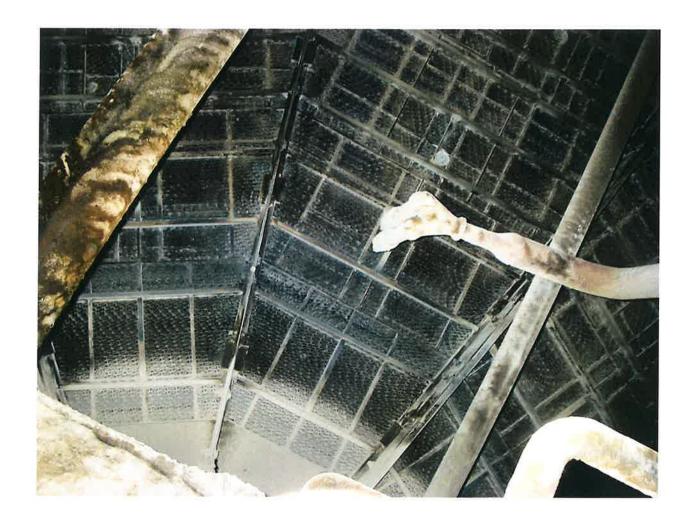
The cold end baskets were also checked during the outage. The cold end baskets were found in fairly good condition. There is some cold end corrosion damage on the outer most baskets, PHOTO #24. This damage is typical and is not considered severe.

PHOTO #24
Cold end basket elements in the air preheater.

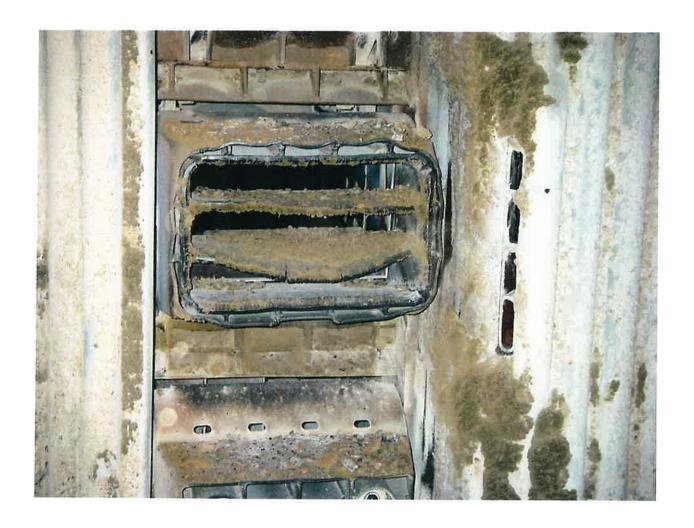
PHOTO #27
Warped splitter plate in coal
nozzle A, corner 1.

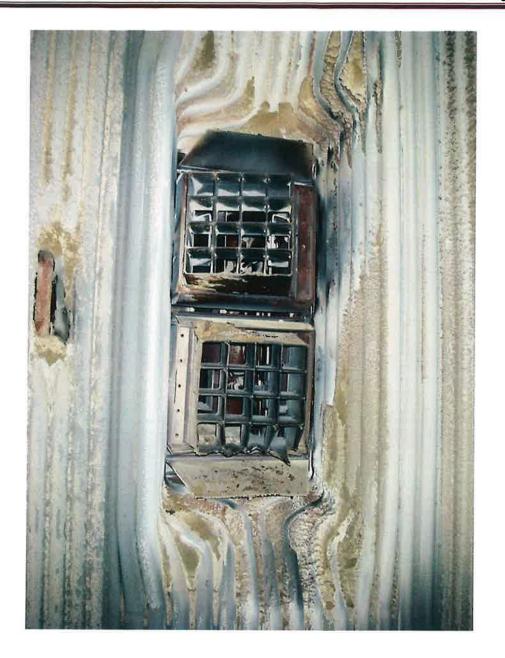
PHOTO #28

Corner 2, separated over fire air nozzles.

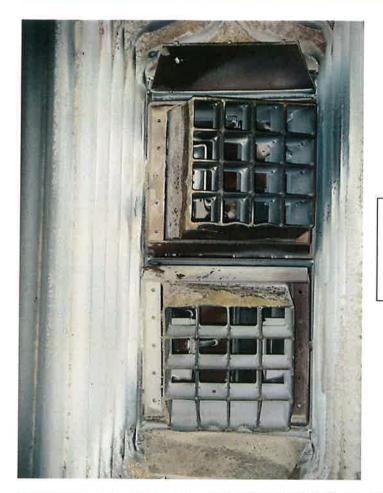
PHOTO #31

Corner 3, separated over fire air nozzles.

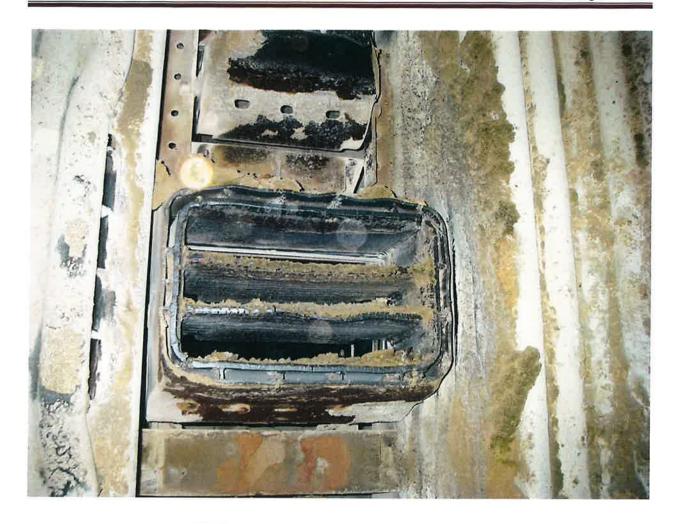
PHOTO #33
Warped and cracked splitter
plate in coal nozzle A, corner 3.

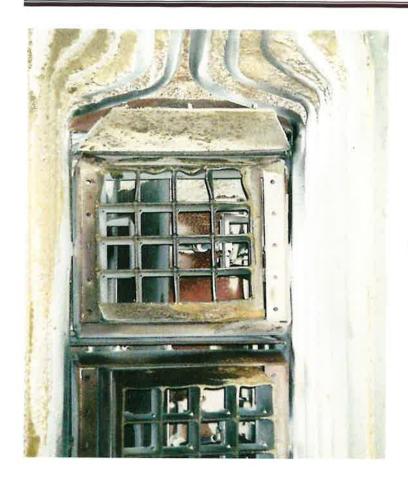
PHOTO #34
Corner 4, separated over fire air nozzles.

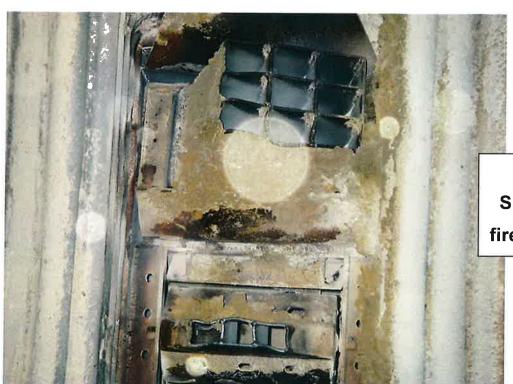
PHOTO #35
Slag build up on over fire air nozzle, corner 3.

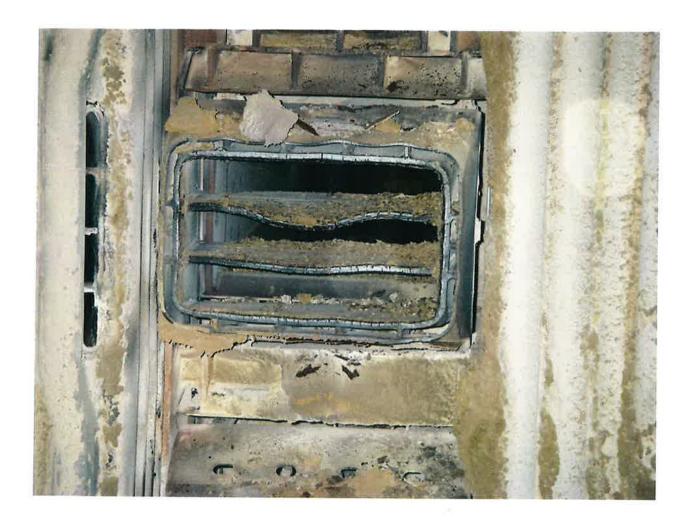
PHOTO #36
Warped and cracked splitter plate in coal nozzle A, corner 4.

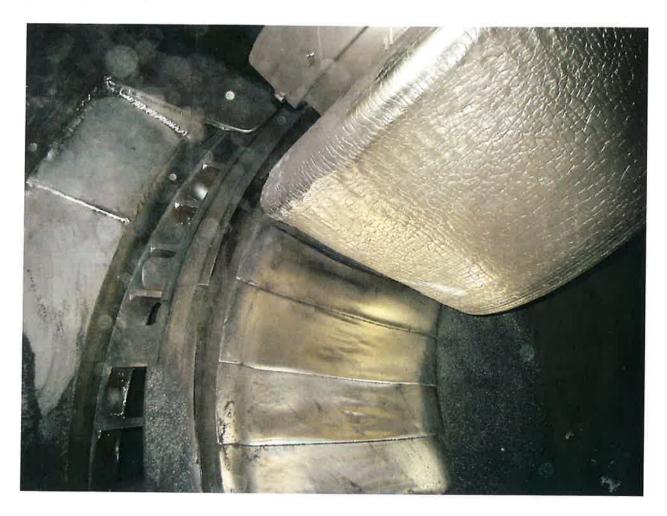
PHOTO #37

Pulverizer A normally has the least amount of running time of the four pulverizers on this unit and was found in fair condition with minimal wear. The overlaid rolls were found in good condition, PHOTO #37. Standard bull ring segments are in good condition and could be overlaid at the next grinding roll replacement.

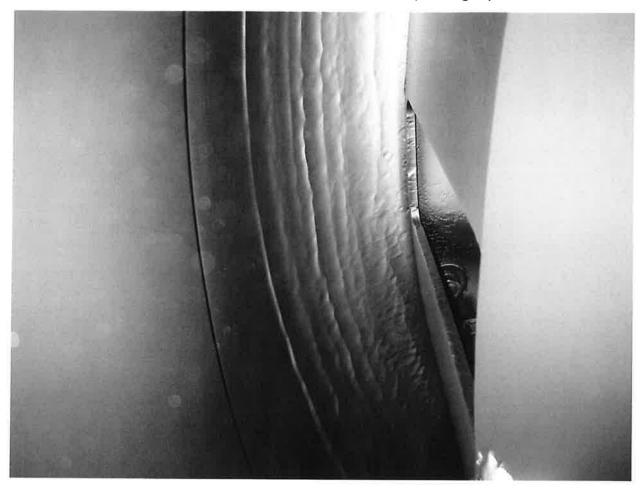
The classifier cone and classifier blades were all intact, but the classifier cone is showing signs of erosion wear. PHOTO #38 shows the erosion on the nuts at the top edge of the classifier cone and on the mill top. These nuts and their stud bolts should be covered with a pipe cap welded into place to protect these items that hold the cone in place. The erosion on the original pulverizer top can also been seen in this photograph.

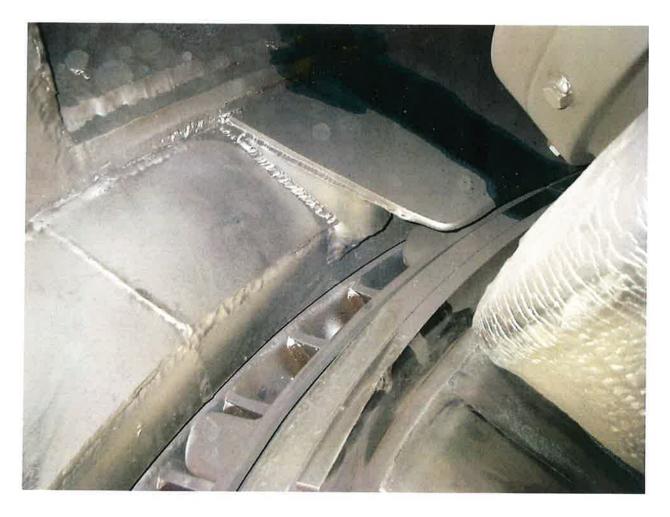
The vane wheel gap on mill A was found to be a bit too wide. PHOTO #39 shows the vane wheel and the air gap between the vane wheel and the stationary liner. When the air gap is too large (greater than ½") this can allow air to bypass the vane wheel and disrupt the air flow around the edge of the grinding bowl. This can allow coal to spill into the under bowl section, which then will come out of the pyrite chute.

PHOTO #39
Pulverizer - A, vane wheel air gap.

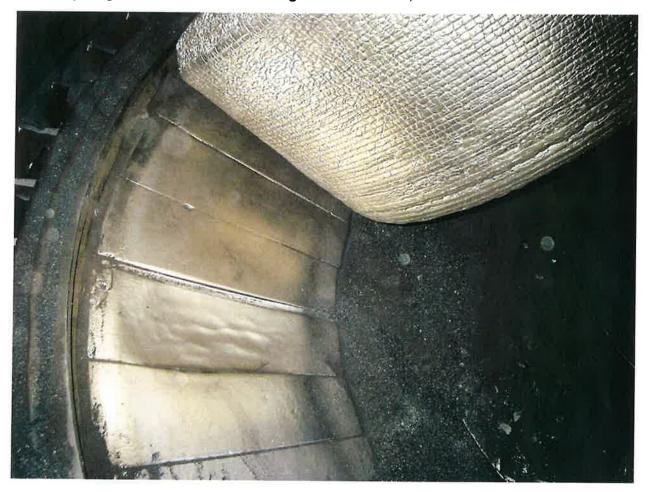
PHOTO #40

Pulverizer B was found in good condition. This pulverizer has a new style top and classifier assembly. This new style top and classifier have a new internal classifier cone with turning vanes. This cone is hung from large tabs mounted to the pulverizer side wall. The overlaid grinding rolls and bull ring segments were found in good condition, PHOTO #40.

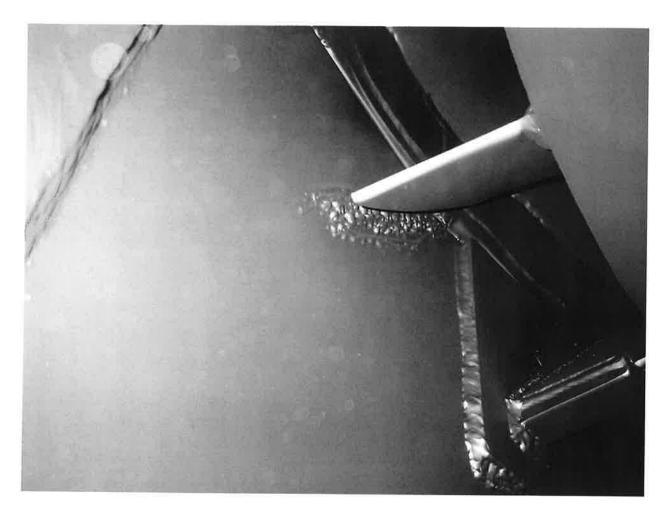
The stationary vanes on the classifier cone are showing signs of erosion wear and the pulverizer side wall behind these vanes has been worn down and filled in with weld media, PHOTO #41. These areas will need to be monitored and additional padwelding will most likely be required in future outages. The adjustable classifier vanes were found in good condition with little wear.

PHOTO #41
Pulverizer - B, stationary vanes and erosion wear on pulverizer side wall.

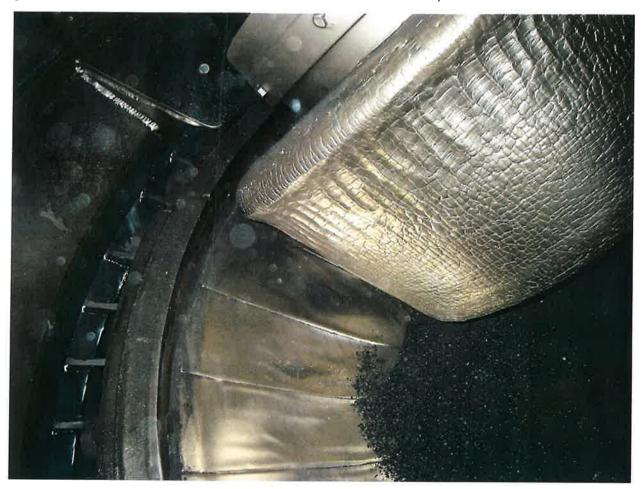
PHOTO #42

Pulverizer C was found in good condition. This pulverizer was the first pulverizer at this site to be retrofitted with the new style top and classifier assembly. The overlaid grinding rolls and bull ring segments were found in good condition, with minor amounts of erosion wear, PHOTO #42.

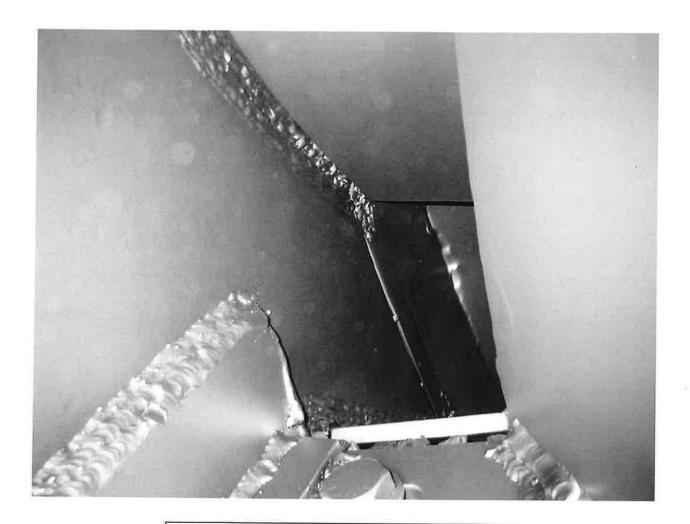
PHOTO #43

The stationary vanes on the classifier cone have heavy erosion wear and the pulverizer side wall behind these vanes has been worn down and filled in, PHOTO #43. This wear is the most severe in Pulverizer - C. These areas will need to be monitored and additional padwelding will most likely be required in future outages. The adjustable classifier vanes were found in good condition with little wear.

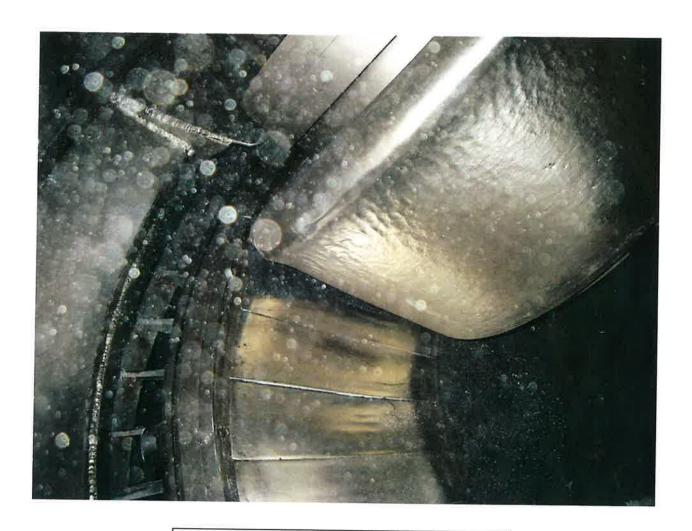
PHOTO #44

Pulverizer D has the most recent top and classifier assembly change out. This new style top and classifier have a new internal classifier cone with turning vanes. The grinding rolls and bull ring segments were found in good condition, PHOTO #44.

Pulverizer - D, moderate wear on the grinding roll with minimal wear on the grinding segments. The vane wheel air gap (distance between the vertical edge of the skirt and the outer edge of the vane wheel) is too large in this pulverizer. An additional vertical strip was added in the past to the body liner skirt to close this gap, PHOTO #45. This additional piece is not working properly and since it does not extend under the kicker plate (ramp plate under the grinding roll) the amount of air bypassing the vane wheel is most likely quite high and this may be affecting how smoothly the pulverizer is grinding the coal. It is recommended that the body liner skirt or the entire vane wheel kit be replaced in this pulverizer, as it will most likely improve the rough grinding condition that has been occurring in this pulverizer.

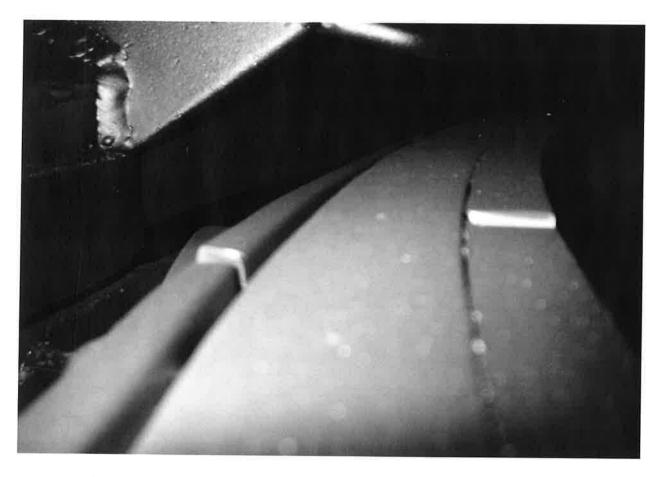
PHOTO #45
Pulverizer - D, vane wheel air gap.

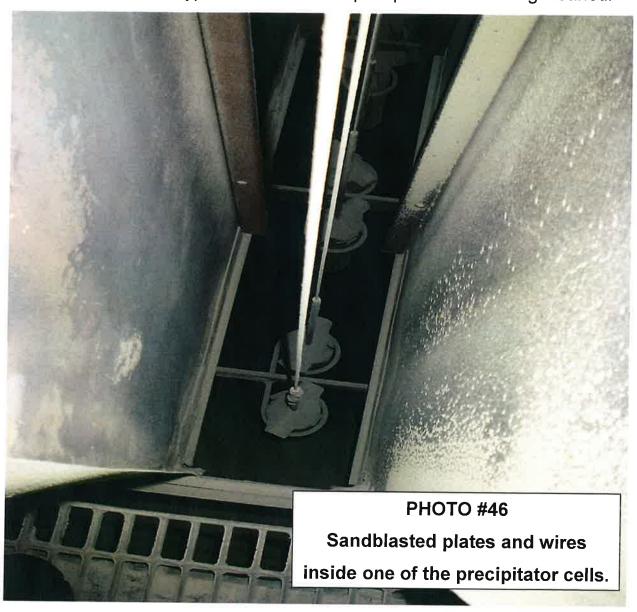
The precipitator internals were inspected during this outage. They were checked after the sandblasting for internal wear and any signs of mechanical distress. Overall, the precipitator cleaning appeared to be thorough with all wires and weights in place, and all plates in fairly good condition. No repairs were required inside the precipitator box. PHOTO #46 below, shows a typical section of the precipitator after being cleaned.
