MASONIC TEMPLE BUILDING—GRAND ISLAND, NEBRASKA
Life Safety Study

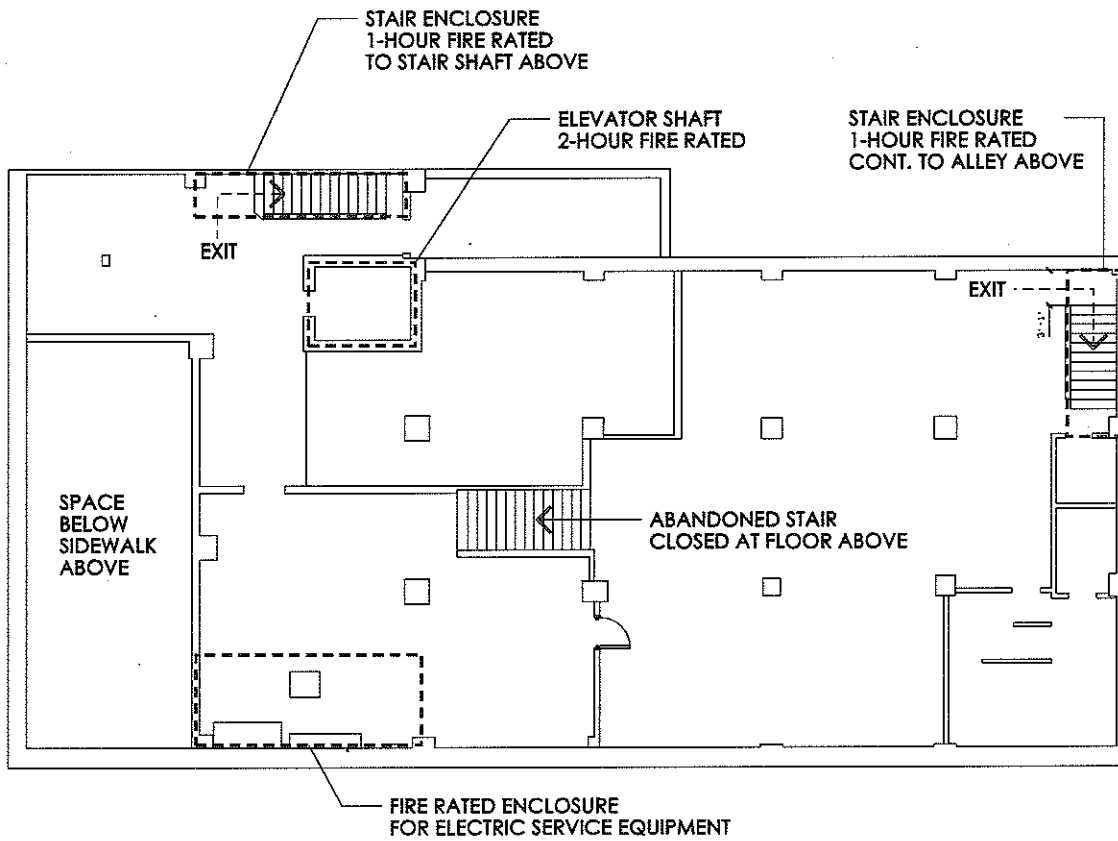
Basement Plan

The basement also requires a second means of egress. There are 2 existing stairs from the basement—one that connects to the main stair system at the NW and one at the east that only extends to first floor. This stair as currently constructed does not provide a continuous egress path to an exterior exit door, but this could be easily done.

S-1 OCCUPANCY - STORAGE

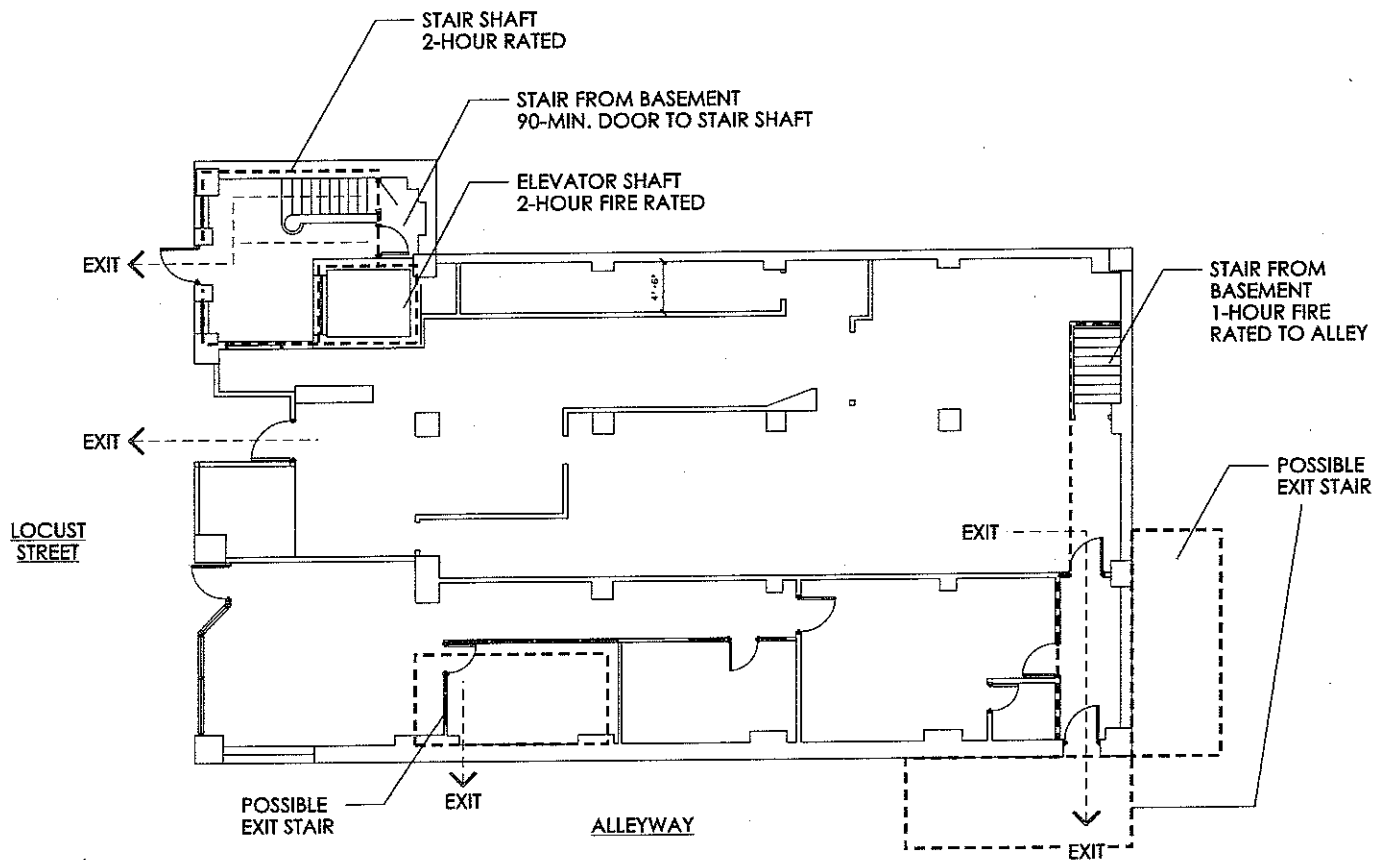
First Floor Plan

M - OCCUPANCY - RETAIL

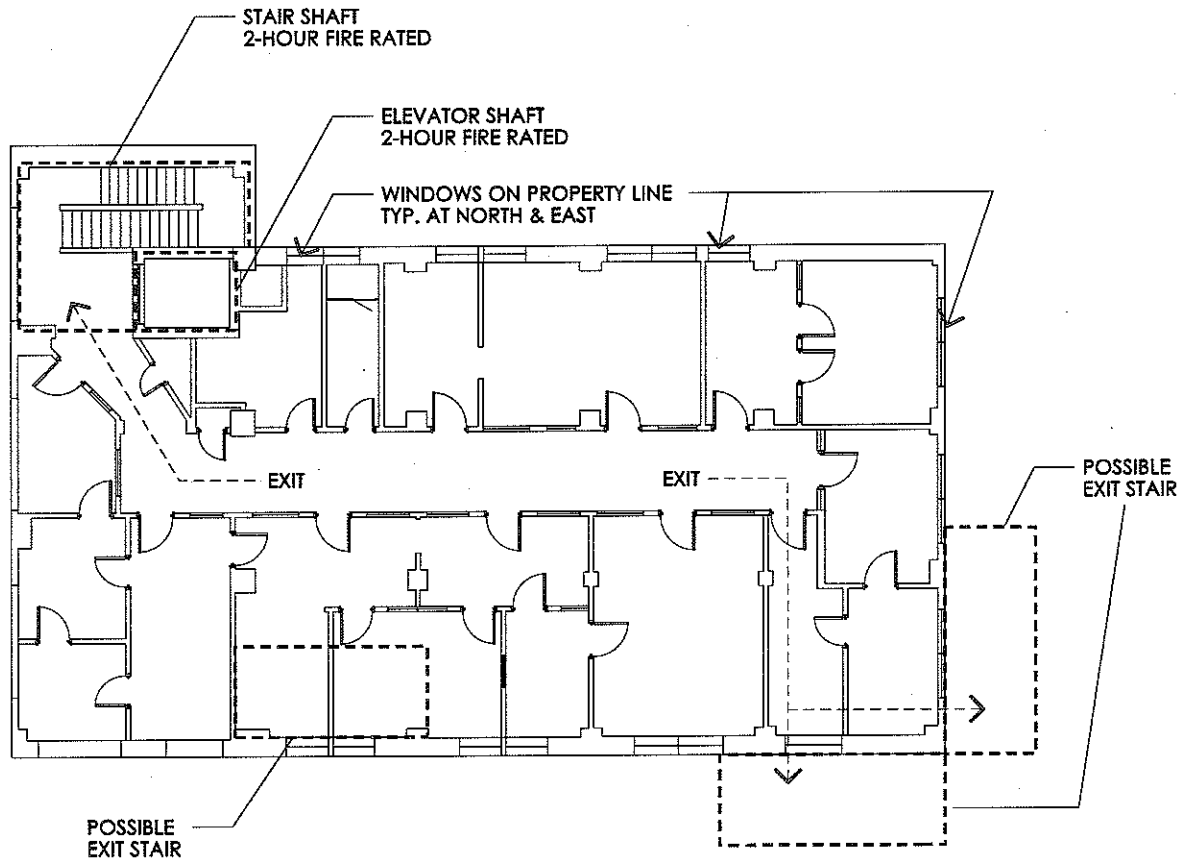
Second Floor Plan

B - OCCUPANCY - OFFICES

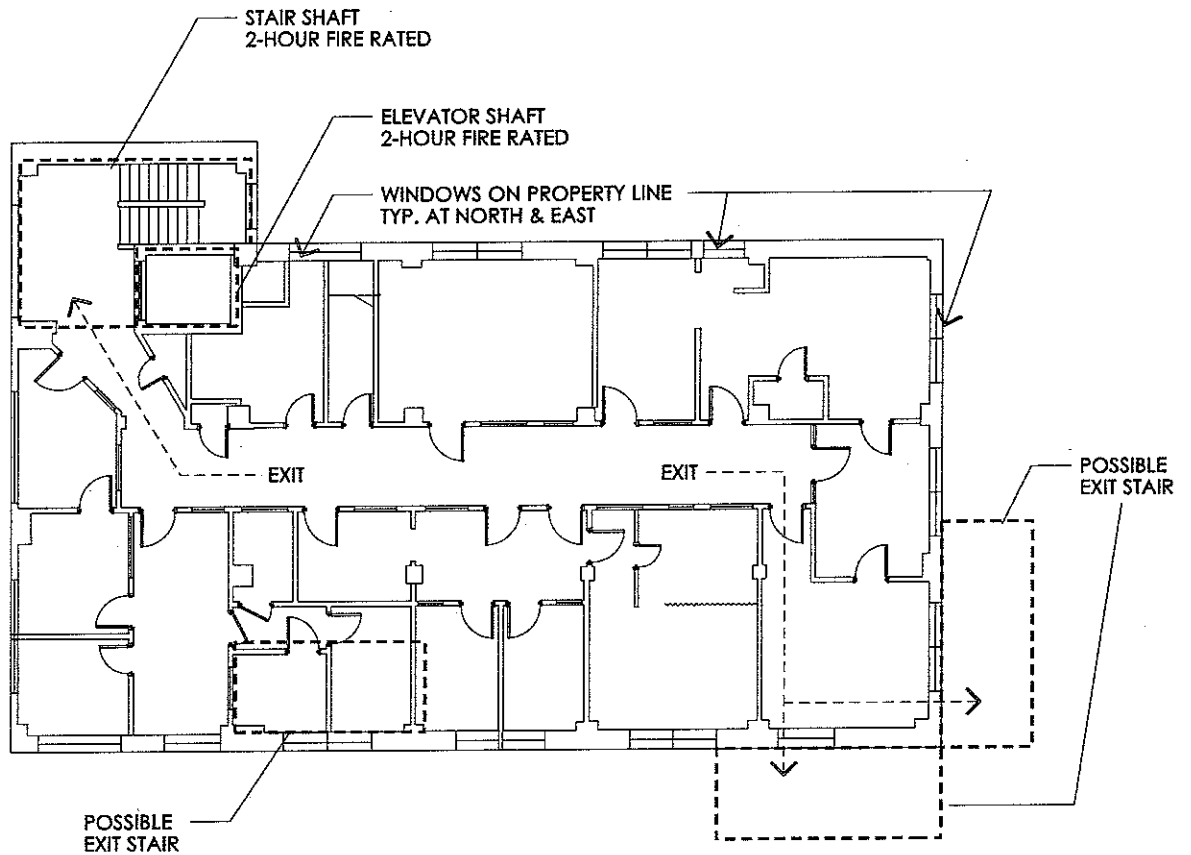
Third Floor Plan

R-2 OCCUPANCY - APARTMENTS

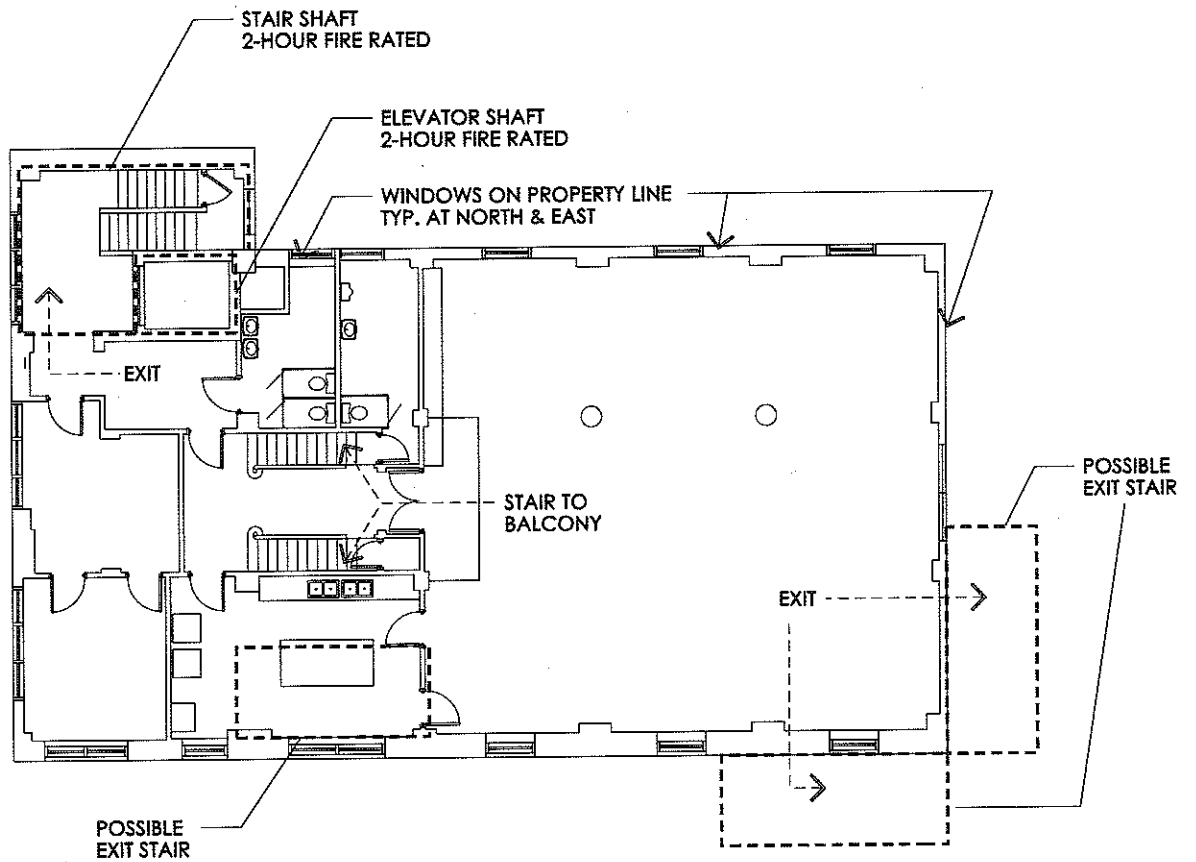
Fourth Floor Plan

A-2/A-3 OCCUPANCY - MEETING ROOM

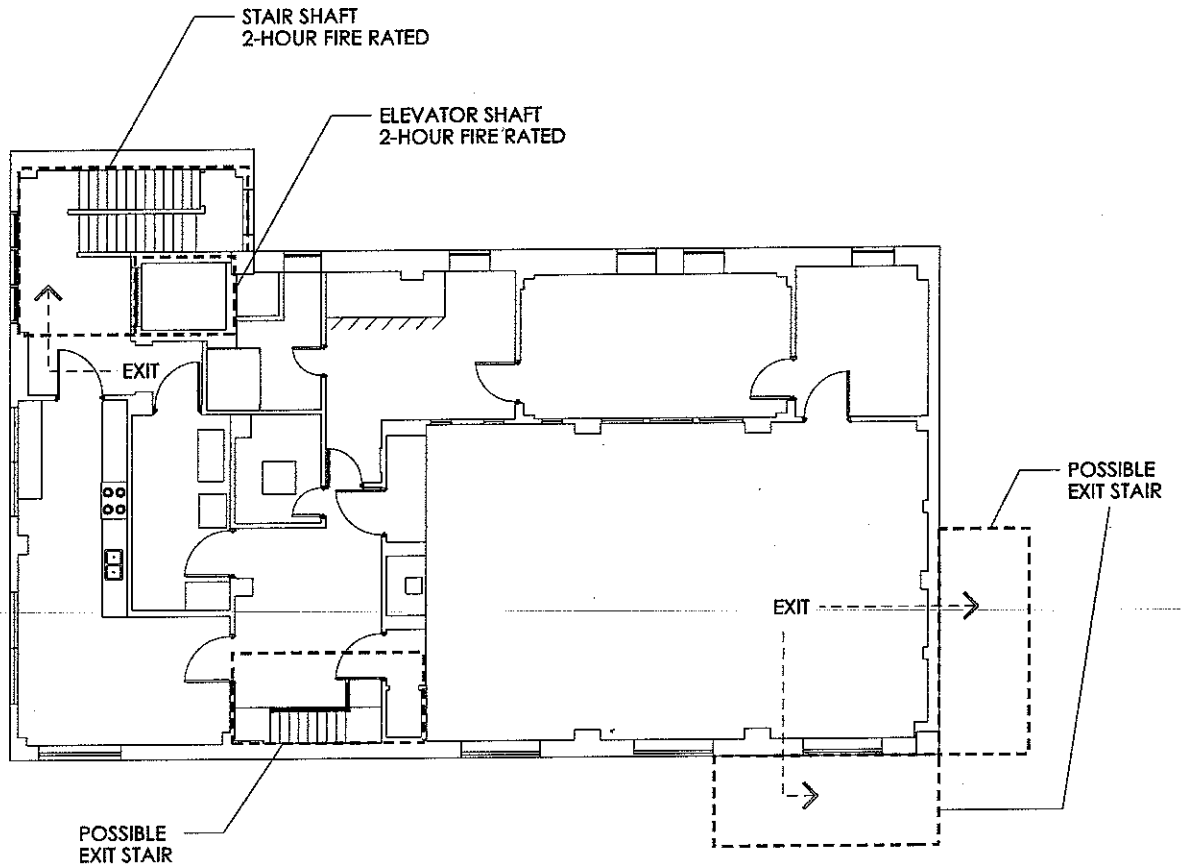
Fifth Floor Plan

R-2 OCCUPANCY - APARTMENT

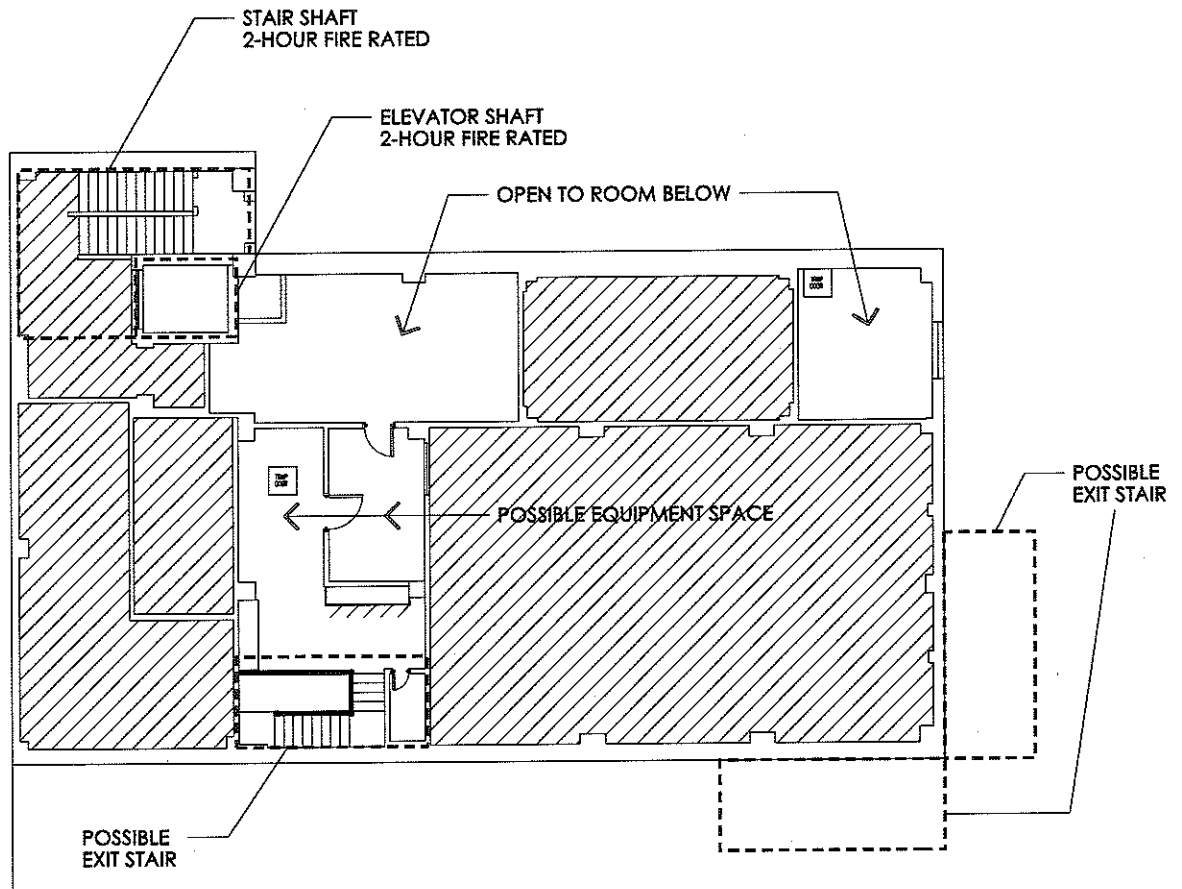
Fifth Floor Mezzanine Plan

There is also a small between the floor space at fifth level that again does not meet the exact code definition for a mezzanine. If this area is for non-habitable uses, such as for HVAC equipment, this is probably not a major issue and no additional separation will be required.

PART OF R-2 OCCUPANCY (BELOW)

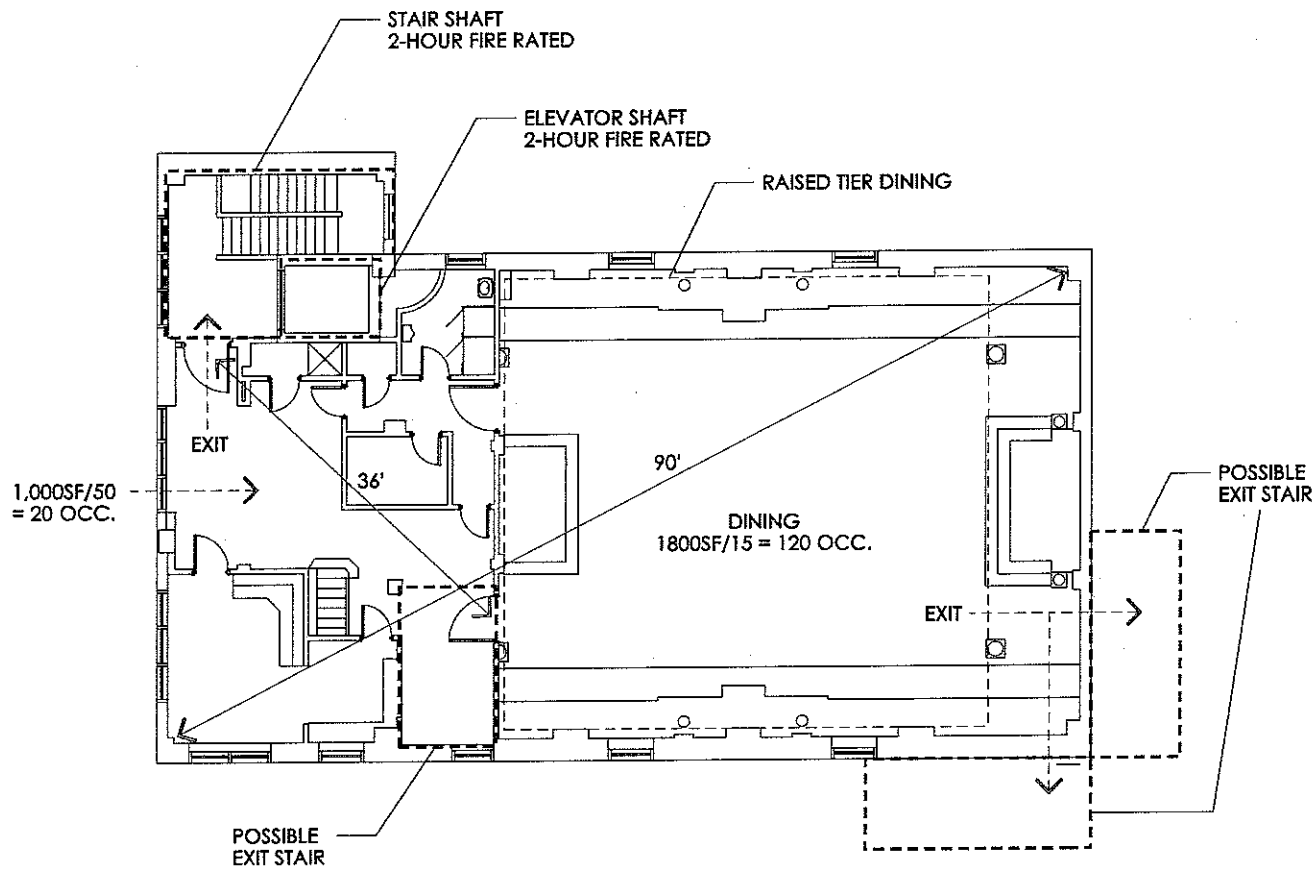
Sixth Floor Plan

The existing 6th and 7th floors served originally as the main Masonic Temple meeting room and consist of a 2-story space with seating areas at the 7th level overlooking the room. The west part of 7th floor is also generally open to the 6th floor. The IBC and LSC have provisions for mezzanines, but the 6th and 7th floor condition in total does not meet the exact code definition for a mezzanine. Therefore, 7th floor must be considered as a floor for code purposes. The IBC and LSC generally restrict openings between floors as there typically is the need to keep smoke and fire from spreading through a building and this deficiency will need to be addressed. However, IBC and LSC recognize balconies/galleries as part of an assembly space, so that closure is not required at these locations. The needed floor closures can likely be achieved by self-closing doors—with magnetic release holders if it is desired to have these doors stand open.

A-3 OCCUPANCY - DINNER THEATER

140 OCCUPANTS (TABLES)

280 OCCUPANTS (CHAIRS ONLY)

Resolve the miscellaneous openings between floors—specifically at 6th and 7th levels—and the associated exit issues on these floors. These issues start to get into those where the existing conditions need to be analyzed as to how life safety can be improved without necessarily meeting the full list of code requirements that may be involved. This would include the need for all new work to meet the existing code requirements, and using other means—such as providing the second exit stair and adding a fire sprinkler system—to increase life safety to the extent other non-conforming conditions can be allowed to remain in place.

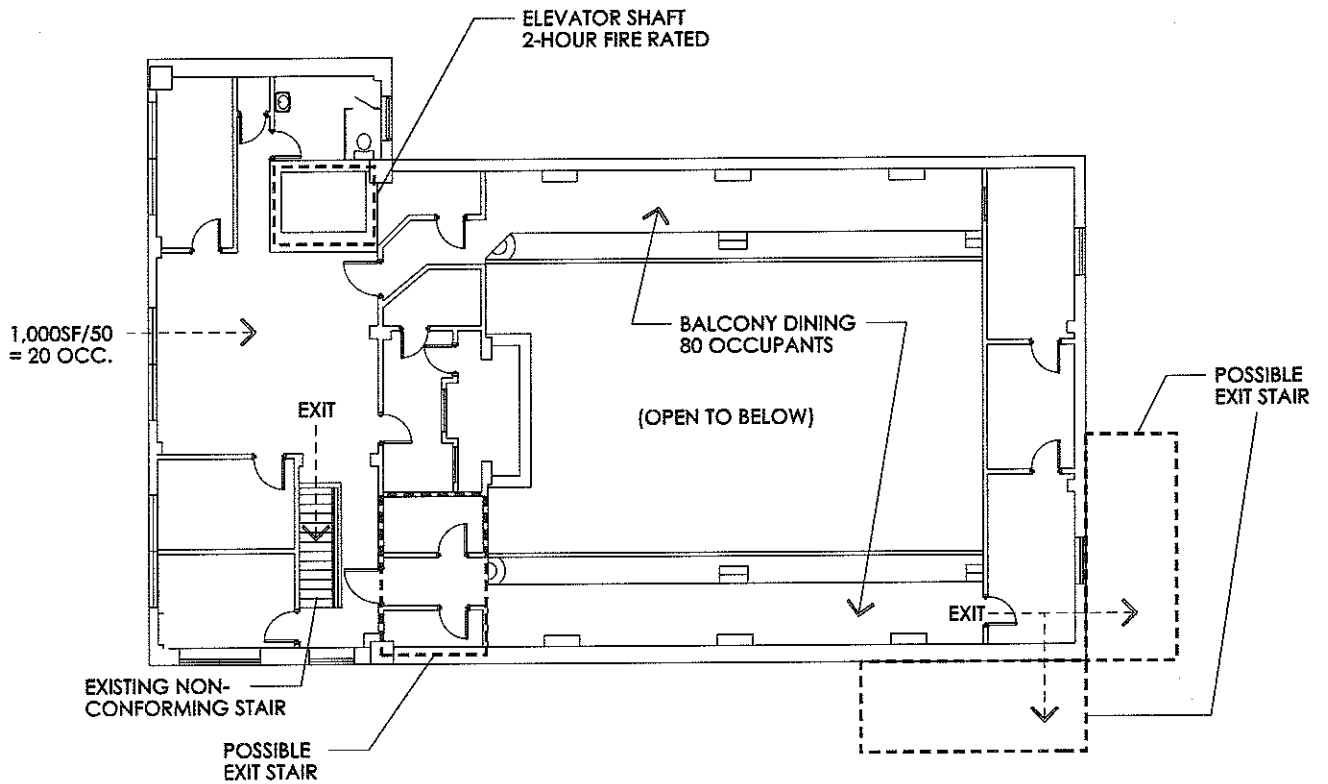
Seventh Floor Plan

The separate stair from 6th to 7th floors is also too narrow, is not fully enclosed, does not provide a continuous access path to an exit stair system, and has rise and tread dimensions that do not meet code—including the LSC code for existing stairs.

A-3 OCCUPANCY - UPPER DINNER THEATER

100 OCCUPANTS
