**Grand Island, Nebraska
Blight and Substandard Study - Area 28
Prepared for: Woodsonia Acquisitions, LLC**

PURPOSE OF THE BLIGHT AND SUBSTANDARD STUDY

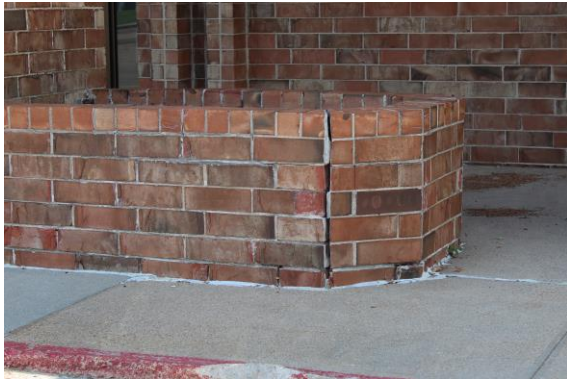
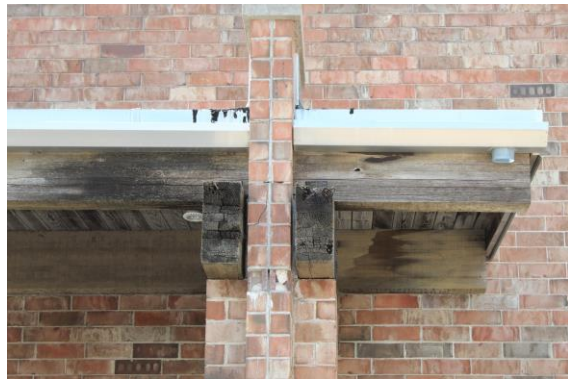
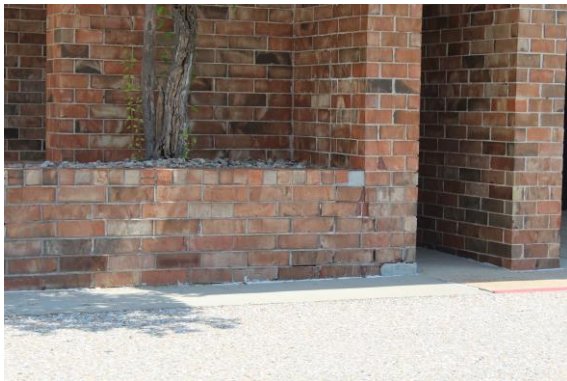
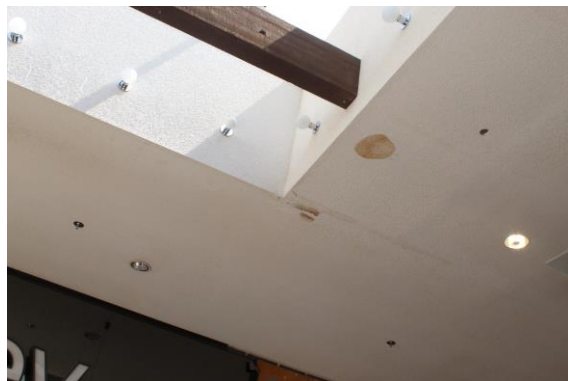
The exterior portion of the mall is showing considerable wear, likely due to deferred maintenance. In the photos on the previous page, there are examples of where masonry and wood construction has been compromised and is in danger of falling from the building onto the ground. Based upon a visual ground inspection, it appears like there is considerable water penetration in the brick-and-mortar system. Said photos also show water penetration inside one of the structures. An assumption was made, based upon the data, that an average condition or less would constitute less than desirable conditions due to age and condition of the structure/building. It is common for older structures to get more maintenance and upkeep to maintain a good or higher condition. Even an average structure shows some signs of deteriorating which in turn can become a dilapidated structure in the future if not maintained. Overall, 80.0% of the structures in this study area are an average condition or worse.

- Several locations around the primary mall are indicating moisture damage to the brick façade. There is clear moisture damage inside of the mall as well.

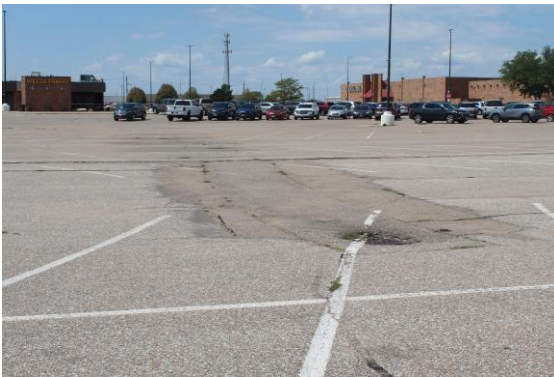
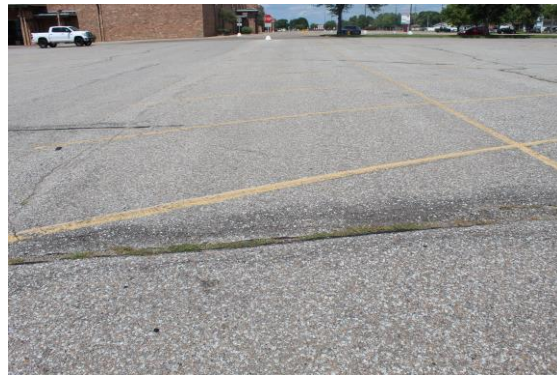
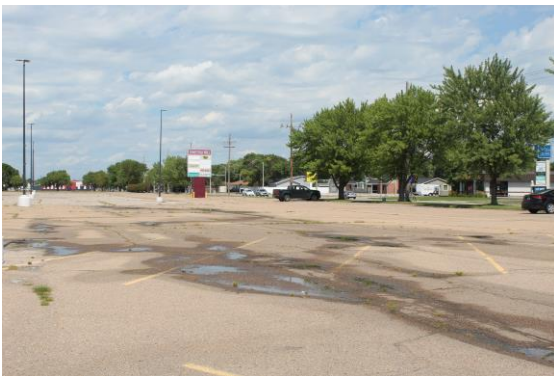
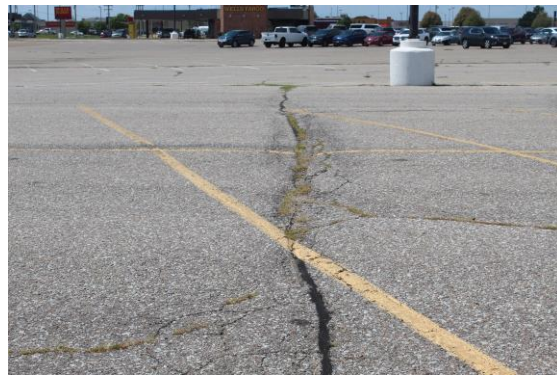
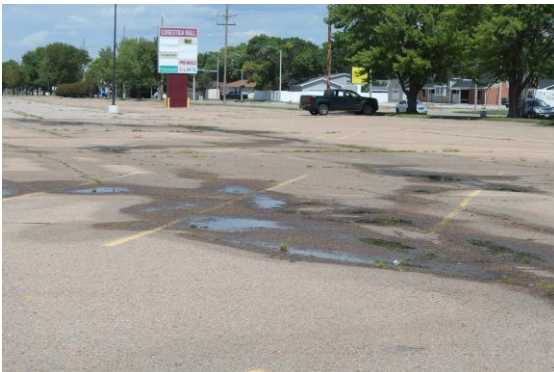
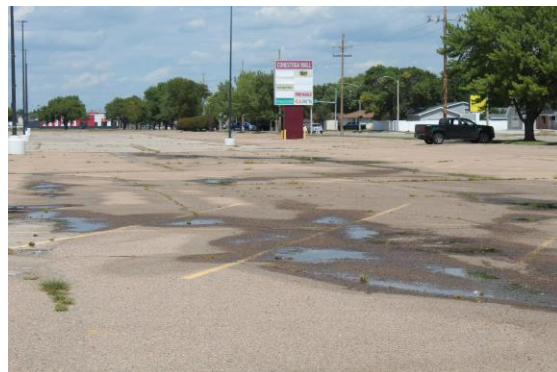
The site improvements include the areas determined to be common areas for public ingress and egress to the study area as well as the area designed to move vehicular traffic through the site. Also, this includes the actual surface parking areas. The condition of the site improvements varies greatly. The Study Area contains a major deteriorated condition; the parking areas throughout the area, as well as the demarcated driving areas. The parking areas throughout the entire Study Area are in a serious state of deterioration. They are not yet in a dilapidated condition. The parking surface and driving areas contain major surface cracking, small break-ups and spawling. These conditions have been likely caused by several circumstances over the years, including:

- Lack of maintenance
- Sub-soil conditions
- Heavier than expected traffic
- Freeze/thaw cycles

Preventing a number of these items are possible through proper design, enforcement, and maintenance, with maintenance being a key. Photos below indicate examples of different deteriorated conditions within the parking and driving areas across the entire site. Due to a large amount of broken pavement in the Study Area, the parking areas are considered to be deteriorated or in a state of deteriorating; therefore, they are a direct contributing factor to the conditions of blight.

- **Deterioration of site or other improvements**
 - The majority of the asphalt parking areas around the primary mall is in a deteriorating state and appears to have forgone updating for a considerable time.

- There are several places where the parking surfaces are in a worse than deteriorated state based upon the photographs in the report.
- **Diversity of Ownership**

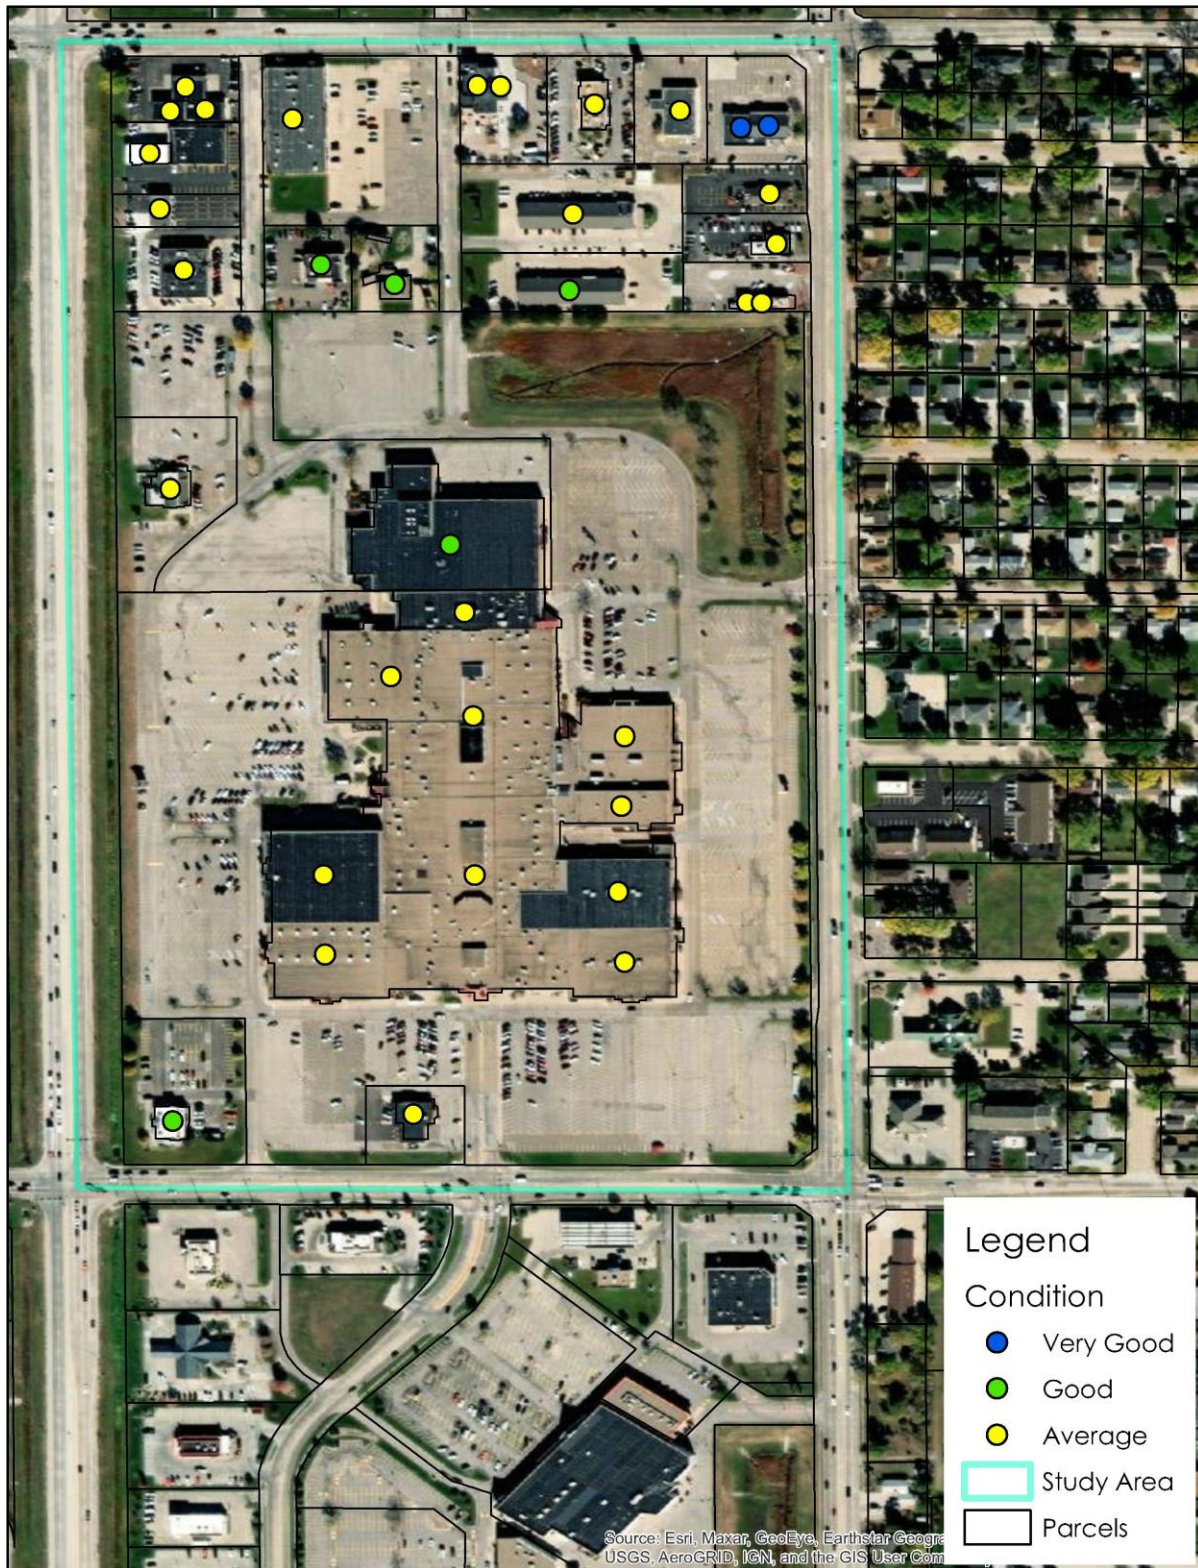
Figure 3
Structural Conditions

Existing structural conditions of buildings in the study area were determined using the Hall County Assessor's database. Structures rated out as either Very Good, Good, Fair, Average, or badly worn. Based upon the data provided to the planning team, the following is the breakdown for structures in the study area:

- 2 (5.7%) structures rated as very good
- 5 (14.3%) structures rated as good
- 0 (0.0%) structure rated as fair
- 28 (80.0%) structures rated as average
- 0 (0.0%) structures rated as badly worn

Due to the stated conditions found in the Hall County Assessor's data, the condition of the structures is a contributing factor.

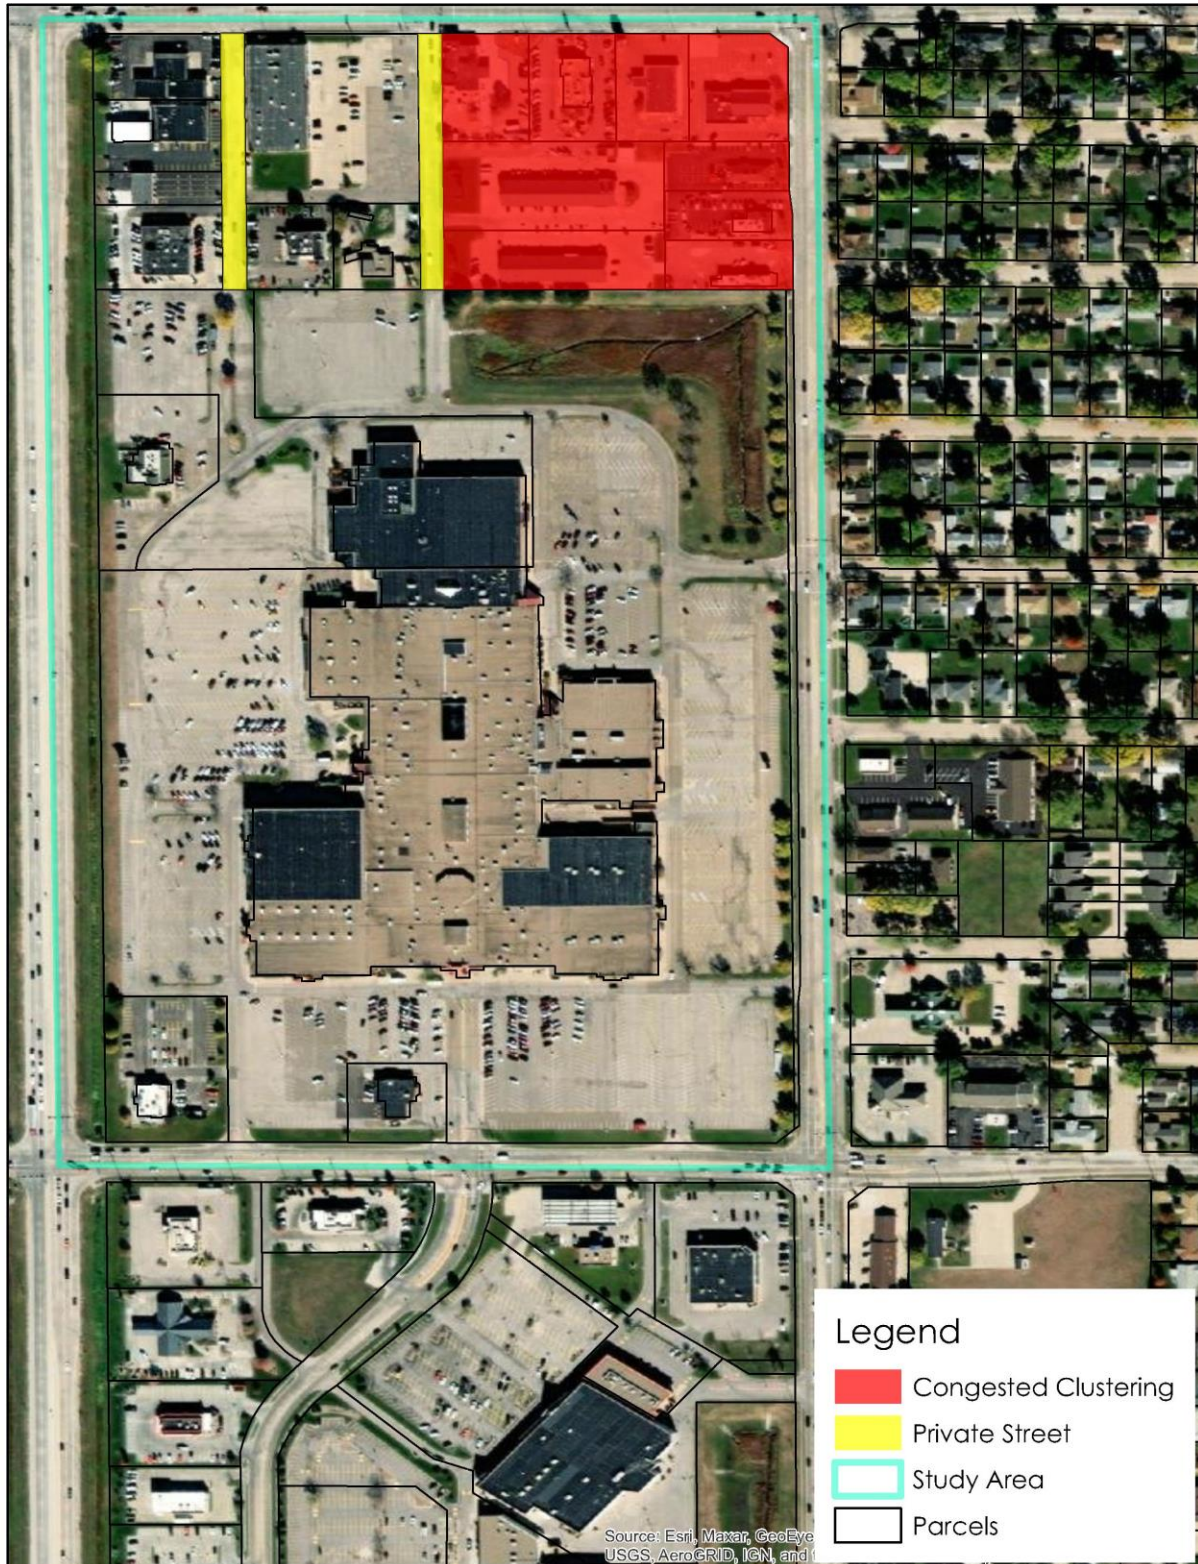
Figure 5
Improper Platting

See Figure 5 for specific locations of the discussed items above. Based upon the analysis, sufficient ownership issues present to make Improper Subdivision or Obsolete Platting a contributing factor for Blighting.

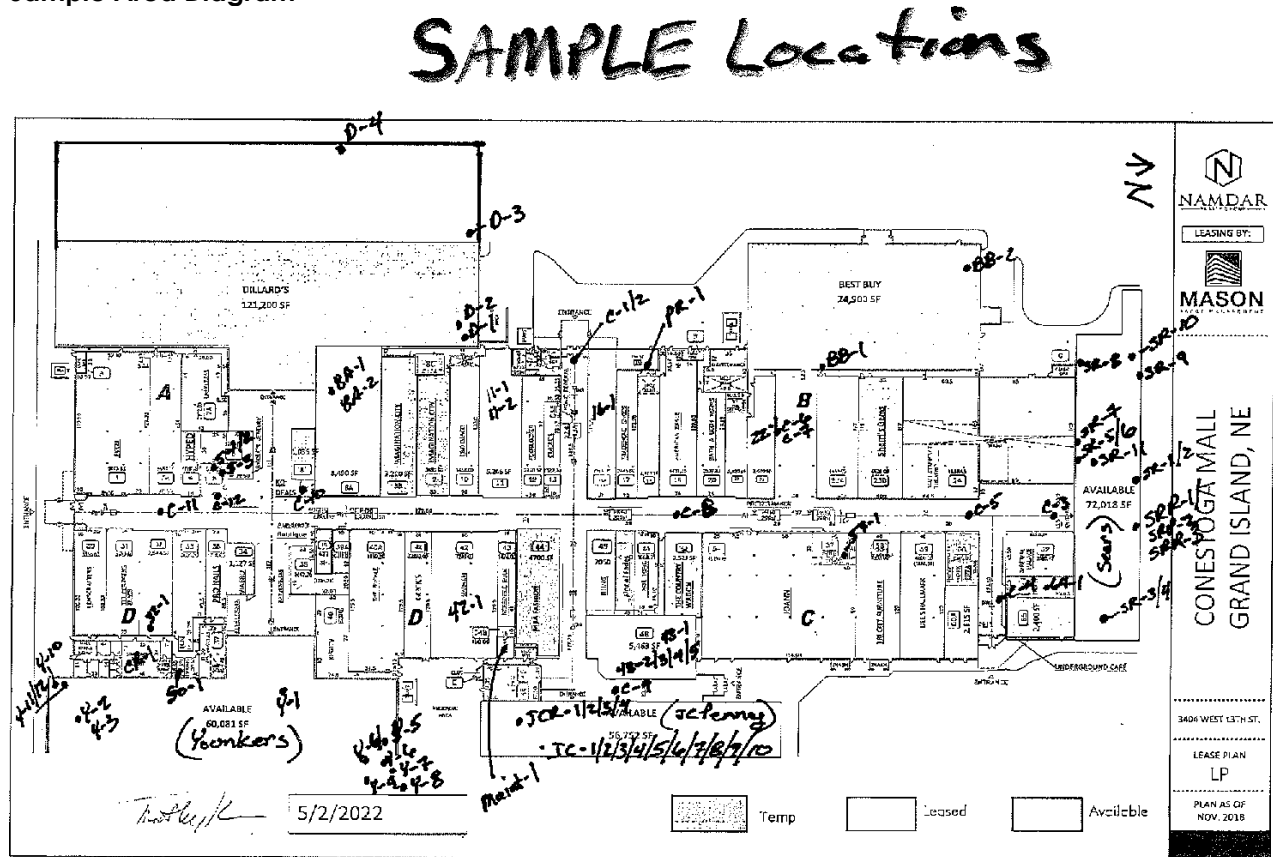
Figure 7
Sample Area Diagram

Woodsonia commissioned an asbestos analysis of the Conestoga Mall portion of the study area. The study was completed by Heartland Testing and Consulting LLC in August 2022. The following areas for the mall were reviewed and/or sampled. Inspection of the following occupied spaces were not completed due to no access: Units 3A, 4, 7A, 9, 23B, 33, 34, 38 & 40. Inspection of sub-flooring in the occupied tenant spaces of the facility were limited due to current sales area floor coverings. Additional review of the occupied spaces sales are sub-floors should be completed when the spaces are available for destructive review. Below is a summary of the spaces with limited review: 8, 9, 10, 12, 13, 17, 19, 20, 23A, 24, 30, 31, 36, 37, 39A, 40A, 41, 42, 44, 49, 50, 52, 54, 58, 59, 60, 62, Best Buy and Dillard's.

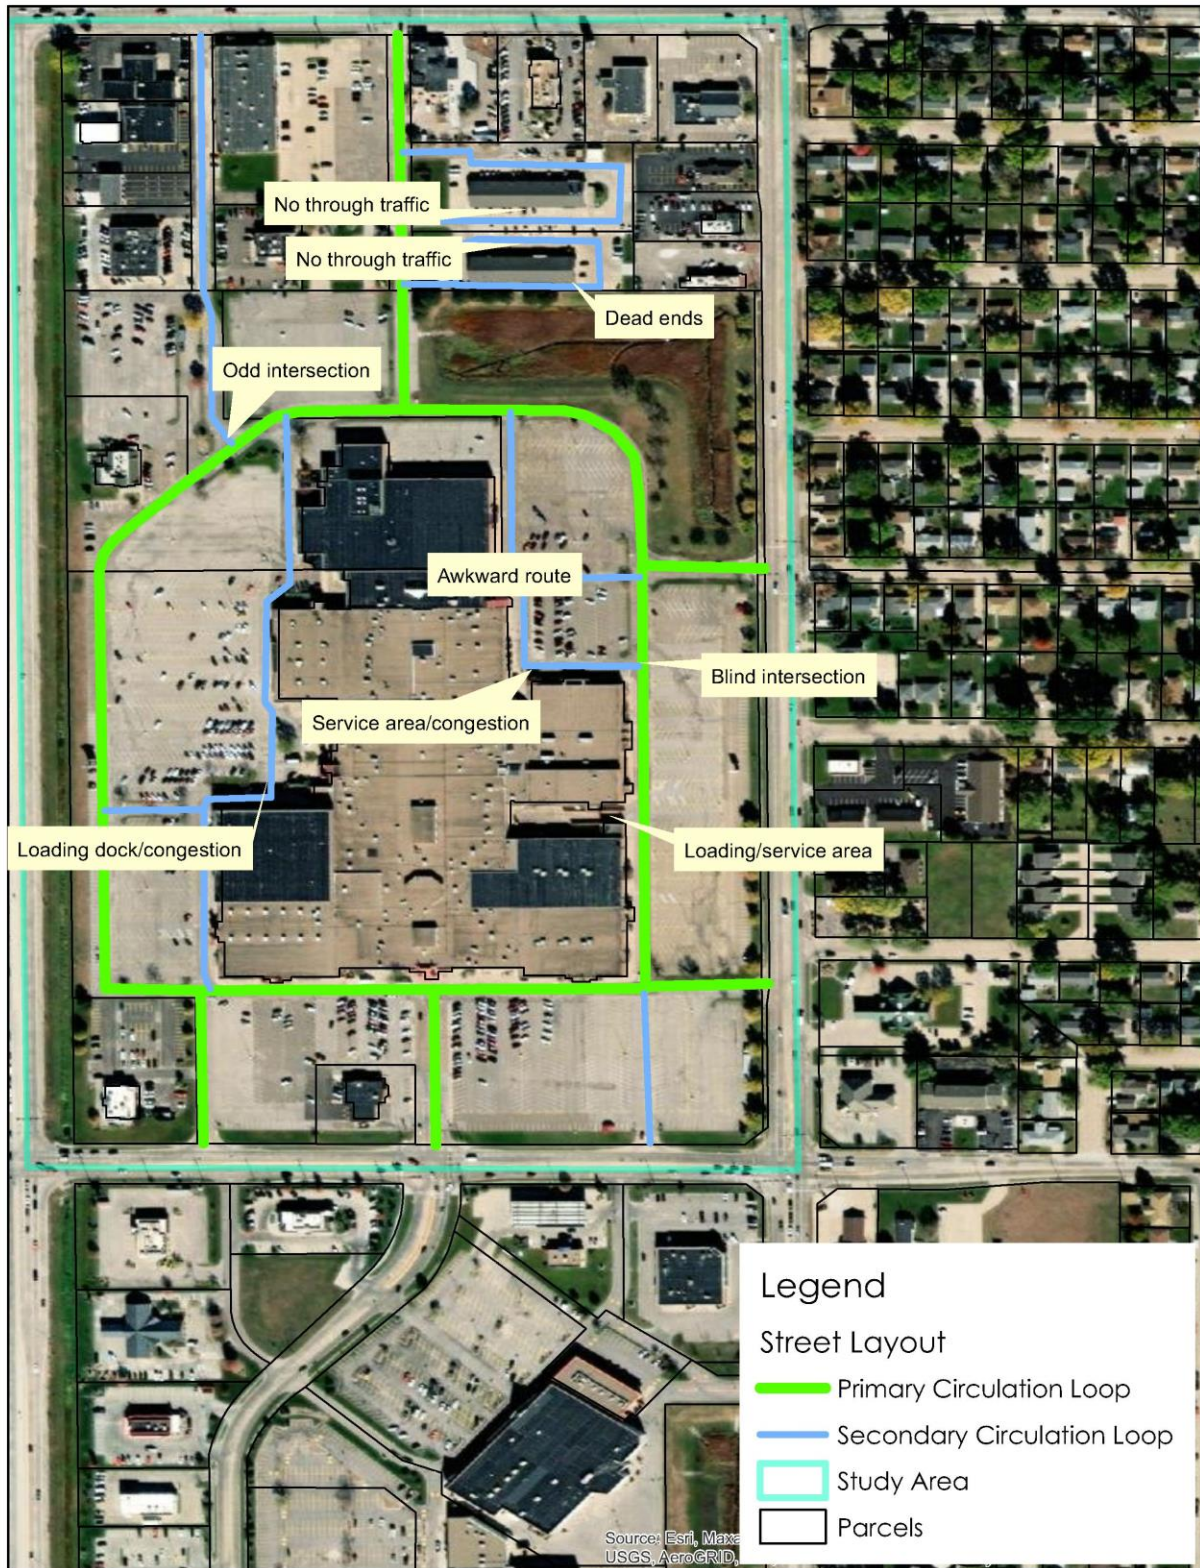
Figure 8
Defective Street Layout

Under normal blight evaluation, this criteria would apply to public streets. However, in the case of this study area, it applies to the internal traffic circulation of the mall property and the adjoining strip centers to the north. Figure 8 indicates the primary and secondary circulation loops. The Figure also indicates potential concerns with the layouts on the site. There are enough circulation concerns on-site to make Defective/Inadequate Street Layouts a contributing factor to declaring the area as Blighted.

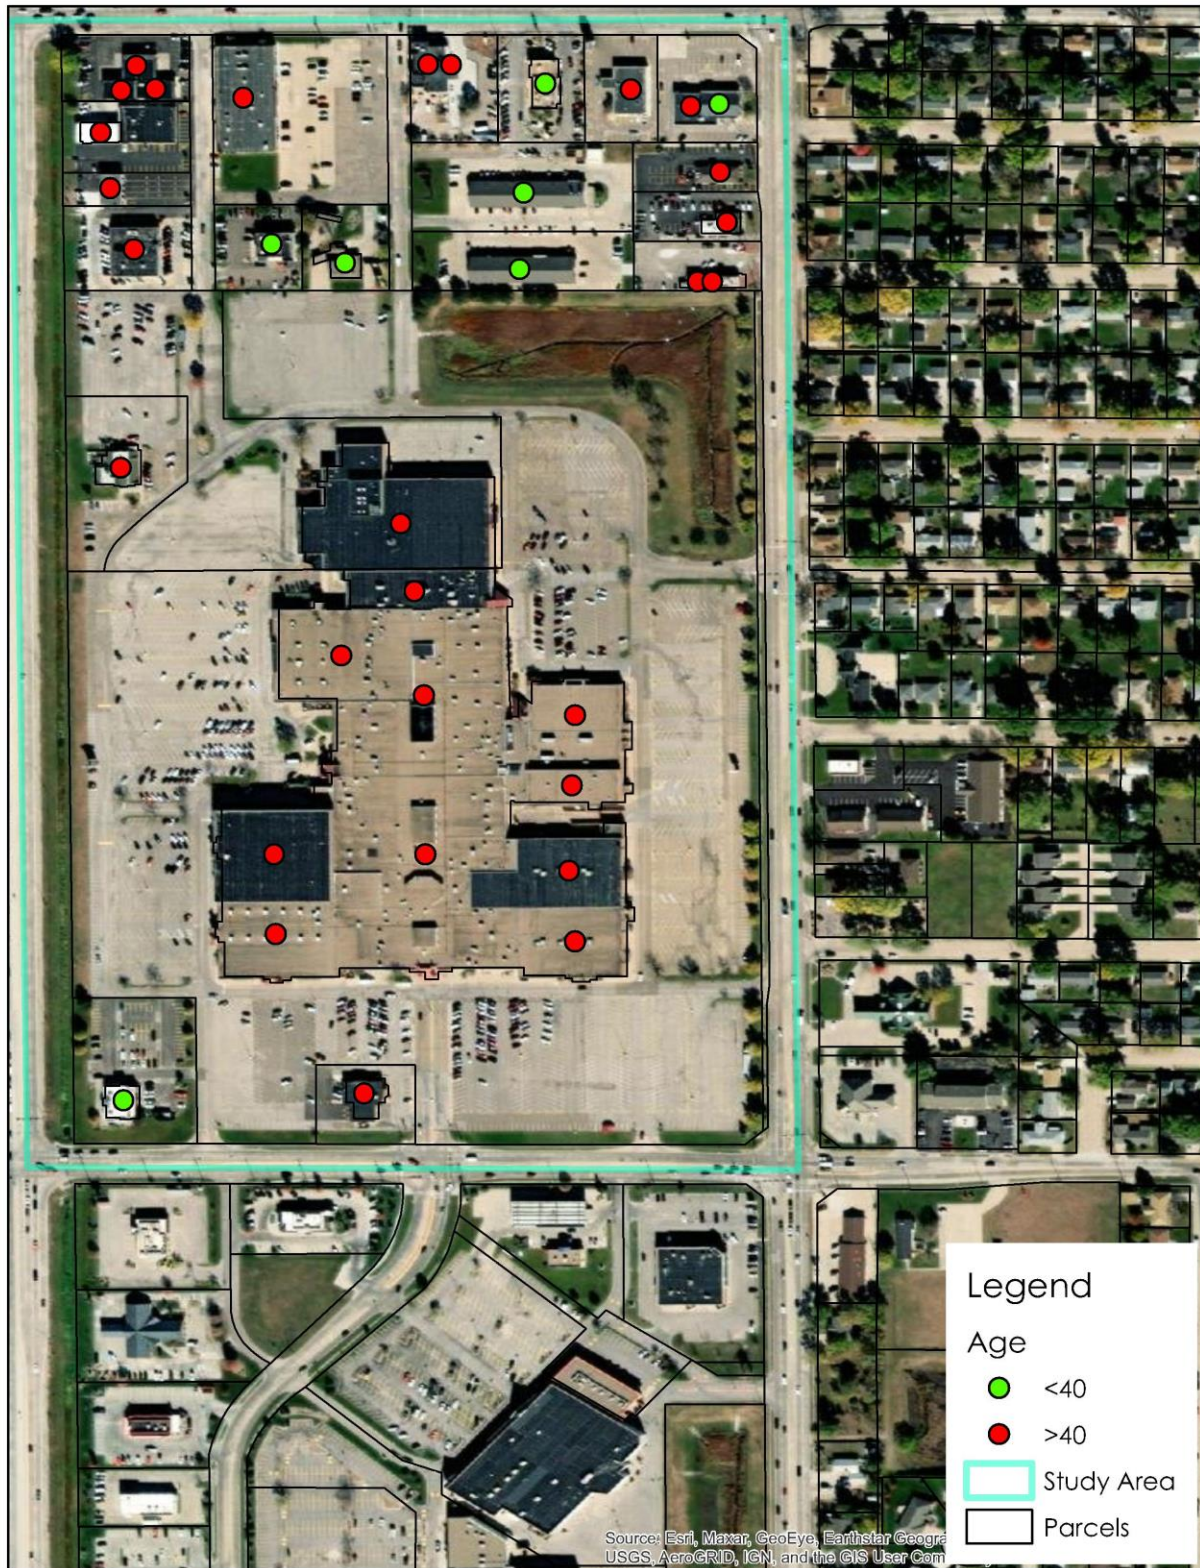
Figure 9
Structure Age

The final means to examine the age of structures is the actual number of structures within the 40 years or more or less than 40 years categories. Overall, there are 35 structures within the study area, based upon the Hall County Assessor's data (Hall County Assessor divides the primary mall structure into 11 separate units, thus 35 total). After researching the structural age on the Hall County Assessor's and Treasurer's websites, the following breakdown was determined:

- 28 (80.0%) unit was determined to be 40 years of age or older
- 7 (20.0%) unit was determined to be less than 40 years of age

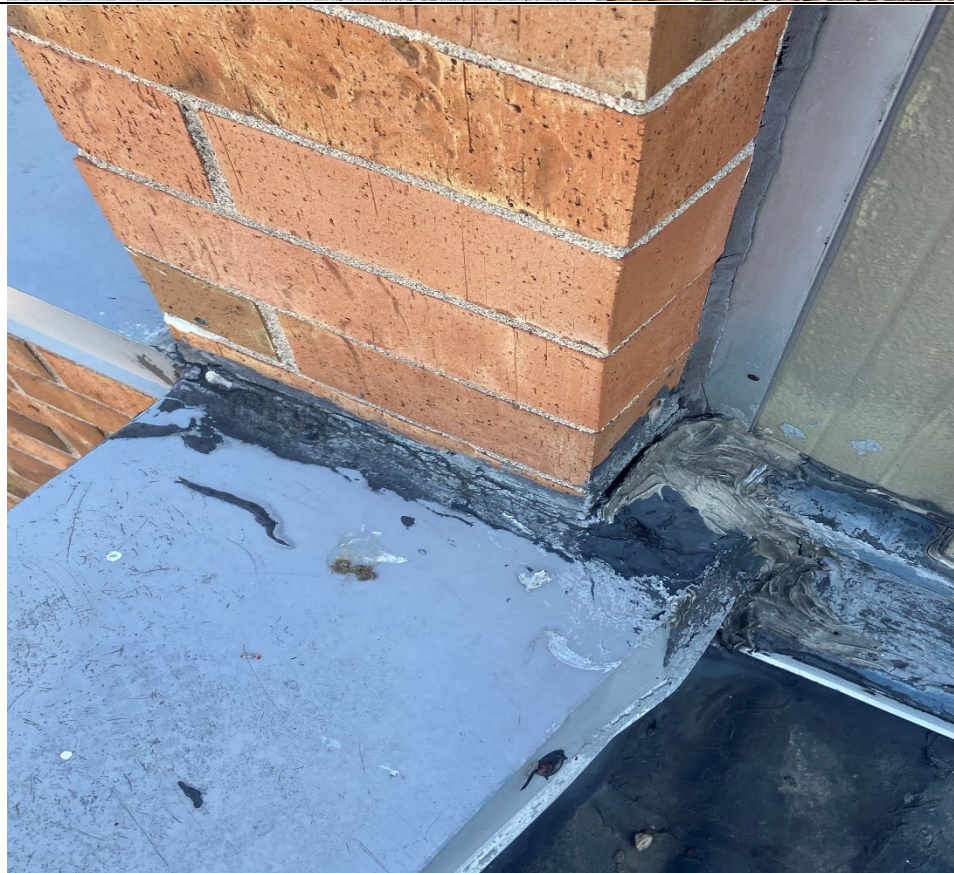
Photo 12:

**View of
Sample SRR-2,
material
appears to be a
patch material.**

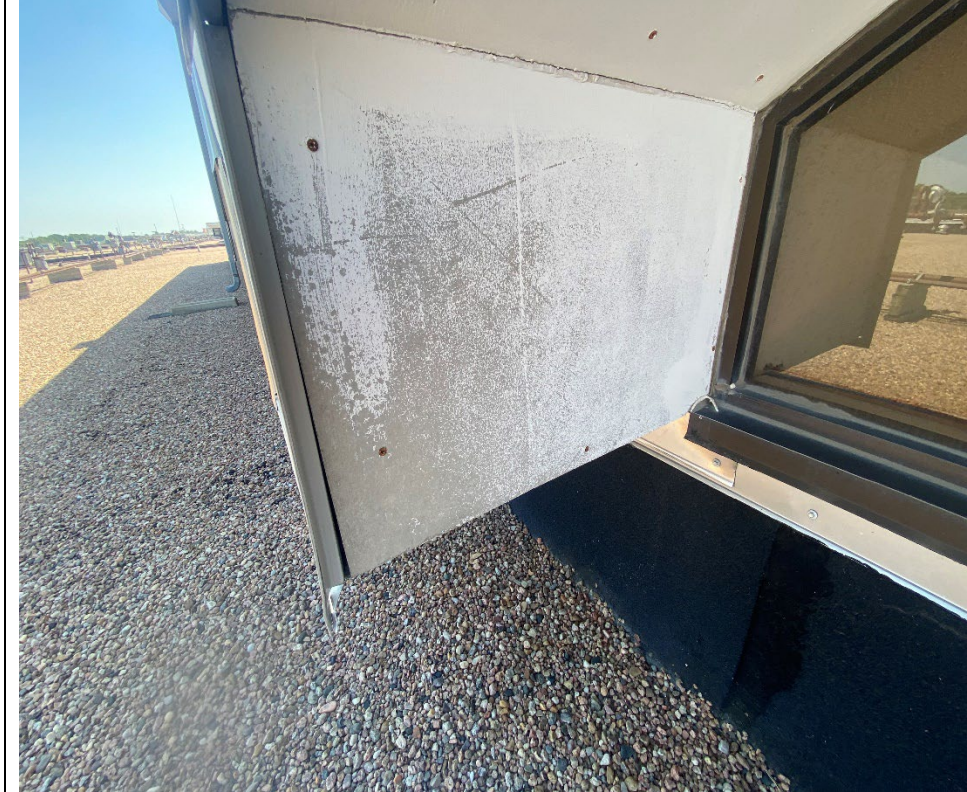
Photo 14:

**View of
Assumed
transite soffit.**
