PURPOSE OF THE BLIGHT AND SUBSTANDARD STUDY

The purpose of completing this Blight and Substandard study is to examine existing conditions within a specific part of Hall County. This study has been commissioned by the Central Nebraska Growth Foundation to analyze the possibility of declaring the area as blighted and substandard.

This specific study includes the entire Cornhusker Army Ammunition Plant site, approximately 20 square miles; less the areas previously declared blighted and substandard on the O'Neill (Area 20) and GI EDC site and the Platte River Industrial Site (Area 22).

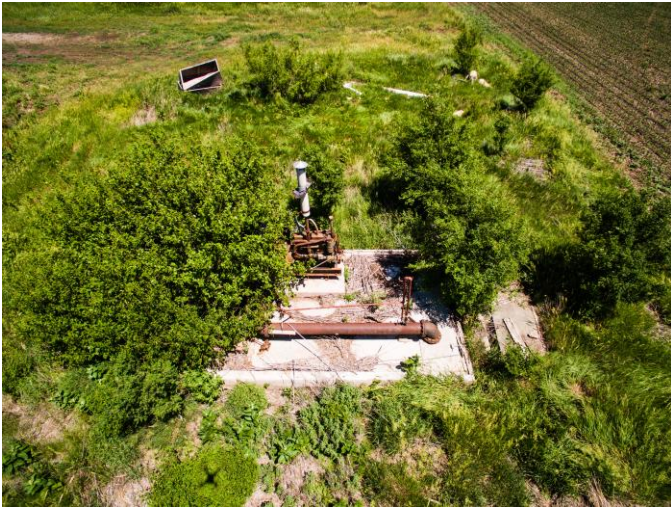
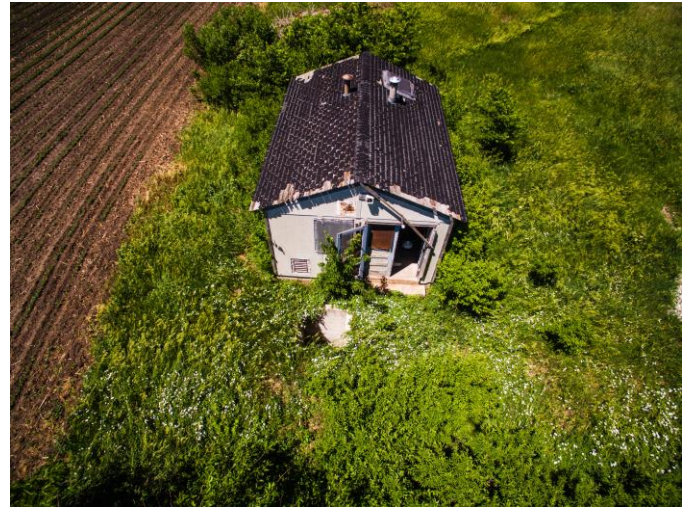
Deterioration of Structures – Old Sewage Treatment Plant circa 1970

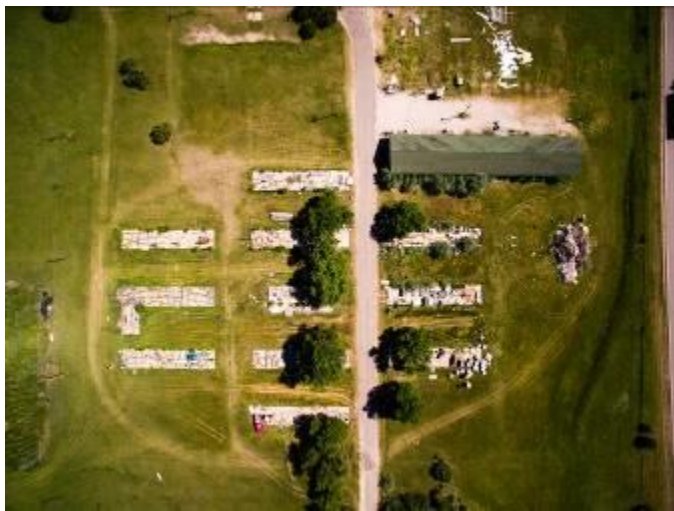
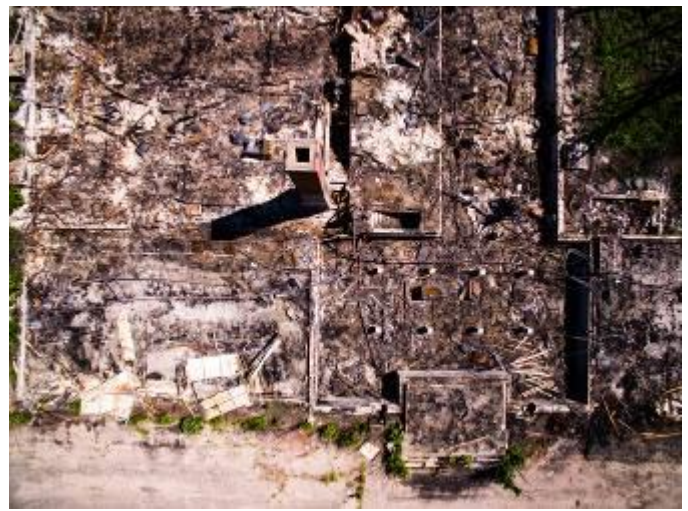
Deterioration of Structures – Old Administrative Area (left), burned down Base Fire Station (right)

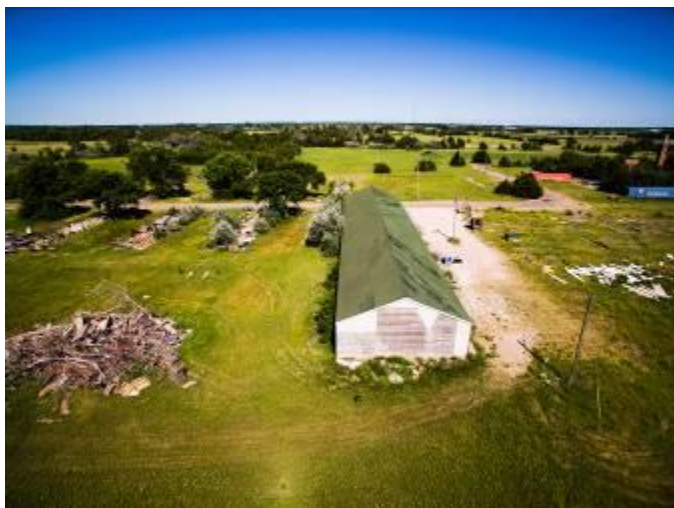
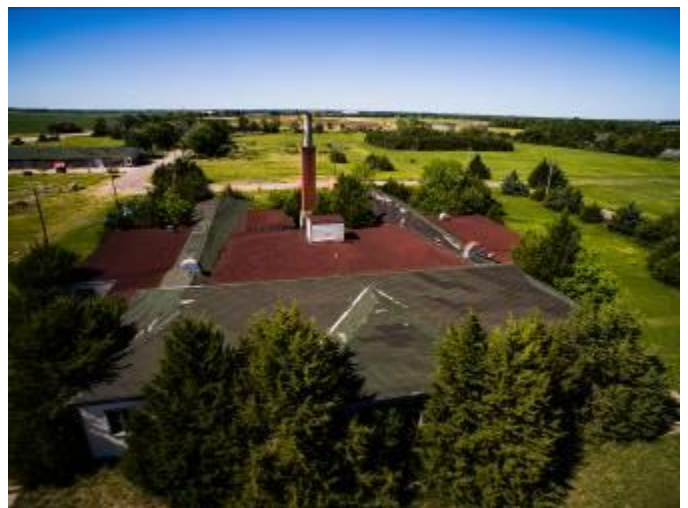
Deterioration of Structures – Old Administrative Area

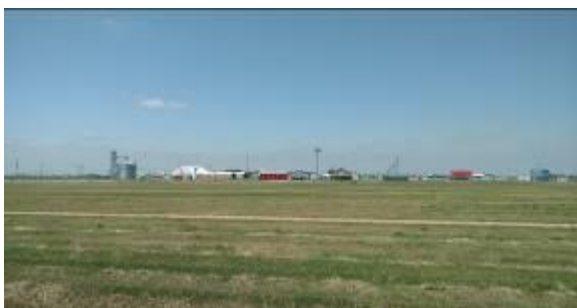
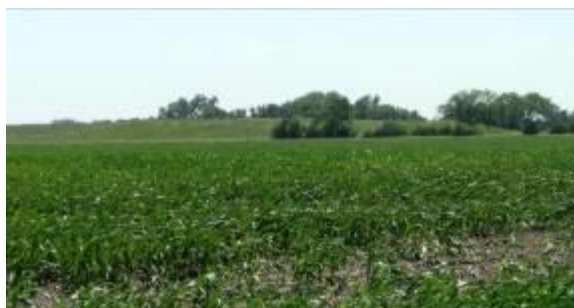
Figure 5.B
Topographic Map of Study Area

The area shown in Figure 5.A indicates contours as low as 1890 feet on the east side and 1905 on the far west edge of the area. The cross slope of this entire four-mile area is less than 1% slope (0.07%). However, there is a creek flowing through this four-mile area which likely draws some of the drainage on the west edge. Also, this very slight slope is across four sections of land. Therefore, the slopes within each section are likely considerably less than the 0.07%.

Example of the Existing Topography within the Study Area

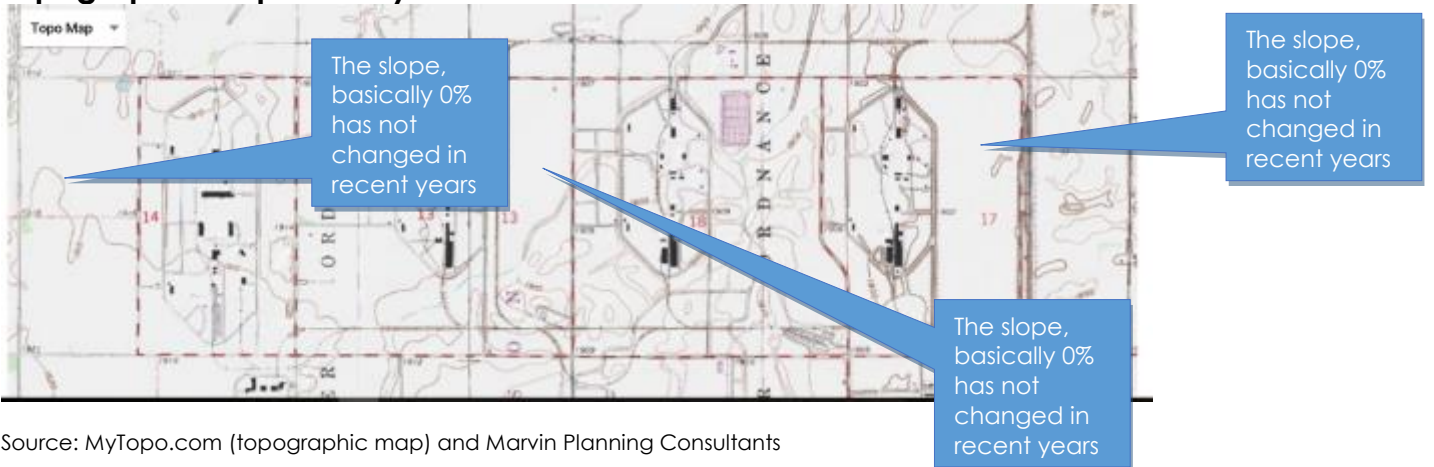
Figure 5.C
Topographic Map of Study Area

The area shown in Figures 5.C is a bit more difficult to quantify since some of the old bomb line sites have been regraded since the removal of the structures. Specifically, there is new construction occurring in Section 13 (old bomb line 3 at present) (However, this area is not part of this study). However, after driving around these sections, as well as flying some of these sections with a drone, it is safe to presume similar slopes are within this area.

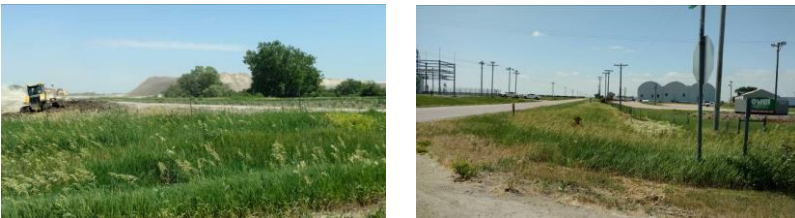
Figure 5.D
Topographic Map of Study Area

Example of the Existing Roadside Ditches

In addition to the flatness of the study area, the entire study area is designed to drain using “rural section” ditches along all of the county roads in the area, See Figure 6. The flatness of the study area, seen in Figure 5.A through 5.E would indicate the drainage ditches will also have a minimal amount of slope to sufficiently drain the area. Also, a lot of these ditches have not recently been mowed or cleaned which will slow drainage and encourage ponding of water.

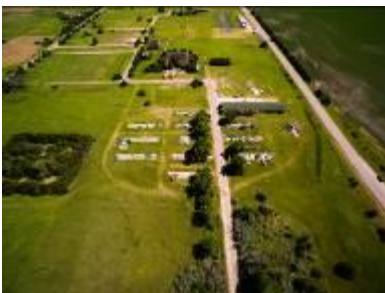
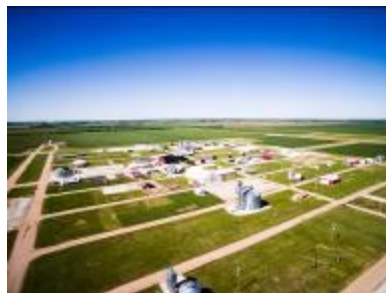
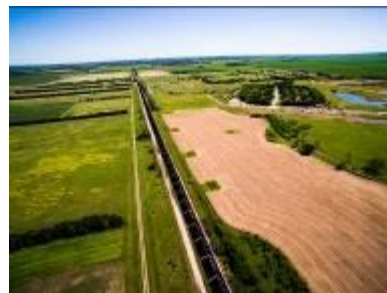
Figure 6
Drainage Conditions

The area shown in Figures 5.E indicates contours as low as 1905 feet on the east side and 1930 on the far west edge of the area. Again, the cross slope of the four-mile area is less than 1% slope (0.12%). Also, this very slight slope is across four sections of land, examination of each section indicates they are all nearly flat with minimal slope anywhere within a section.

Example of the Existing Topography within the Study Area

Another drainage system employed in this study area is a pair of drainage ditches running north and south with one located on the east side of the area and one on the west side, see Figure 6. These ditches were constructed during the early years of the Army Reservation and may be in need of cleaning and scouring.

All of the conditions discussed above will create the potential for standing water within this study area. Standing water from poor drainage can be a catalyst for health issues like West Nile and other mosquito-borne diseases due to the potential mosquito breeding during the summer months.

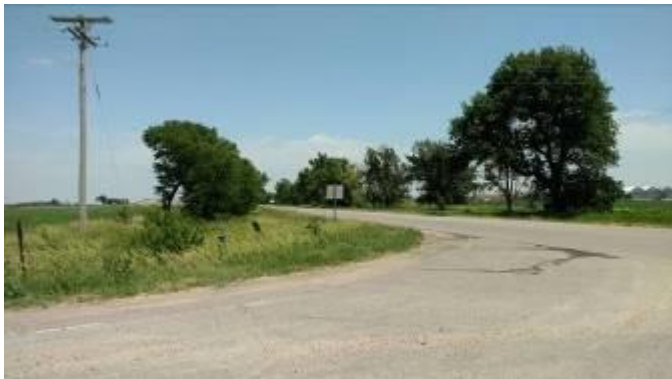
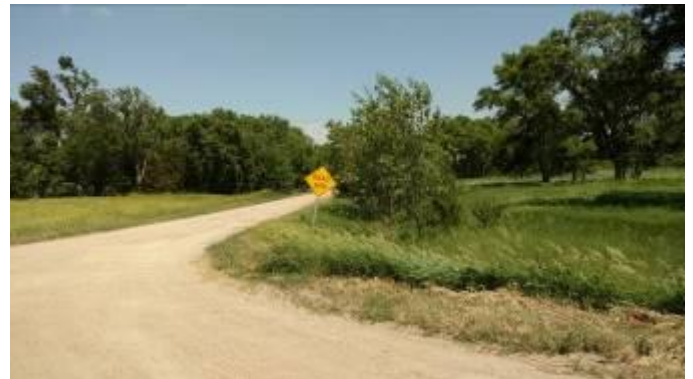
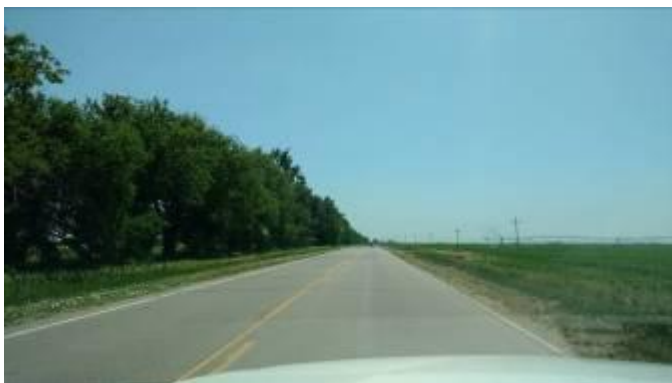
Example of the Existing County Roads within the Study Area

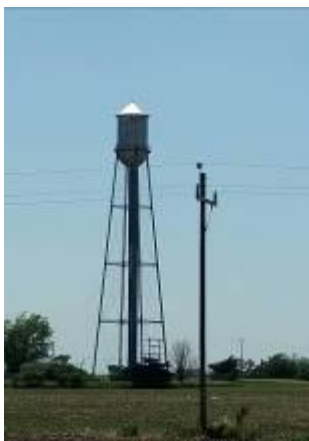
Old Water Tower located on a previously declared property (O'Neill Study)

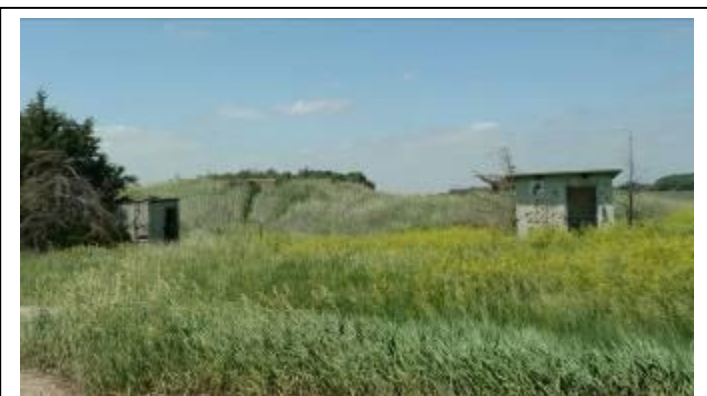
Abandoned Sewage Treatment Plant

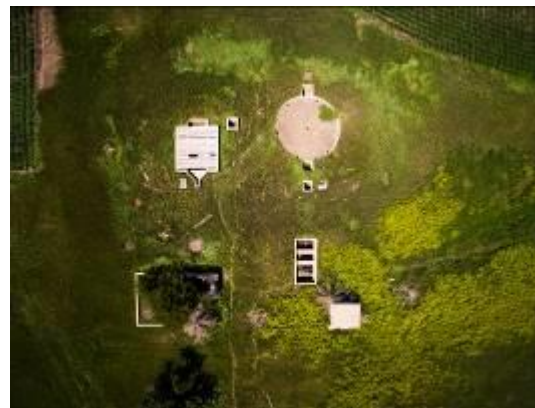
Abandoned Sewage Treatment Plant – Aerial View

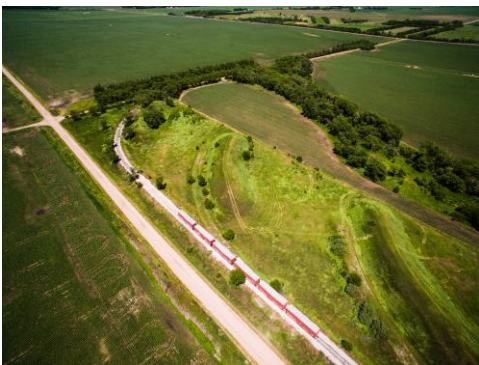
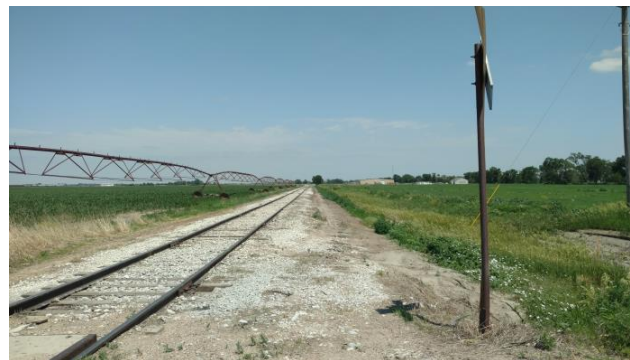
- The entire Study Area is within an EPA Superfund Site
- The contamination plume is a major condition factor arresting sound growth in the Grand Island area.
- The condition of the railroad track is a deterrent for any business needing rail service
- The numerous landfill/construction and debris sites within the Study Area create unknowns and extreme costs for future clean-up
- Large berms along 70th near Capital Avenue
- The existing water system and sanitary sewer systems are not capable of use; except for, specific prescribe uses as defined by the numerous reports for this site
- Drainage capacity of the area is minimal regarding the ability to handle large amounts of runoff during large storm events.

Example of Conditions Arresting Growth

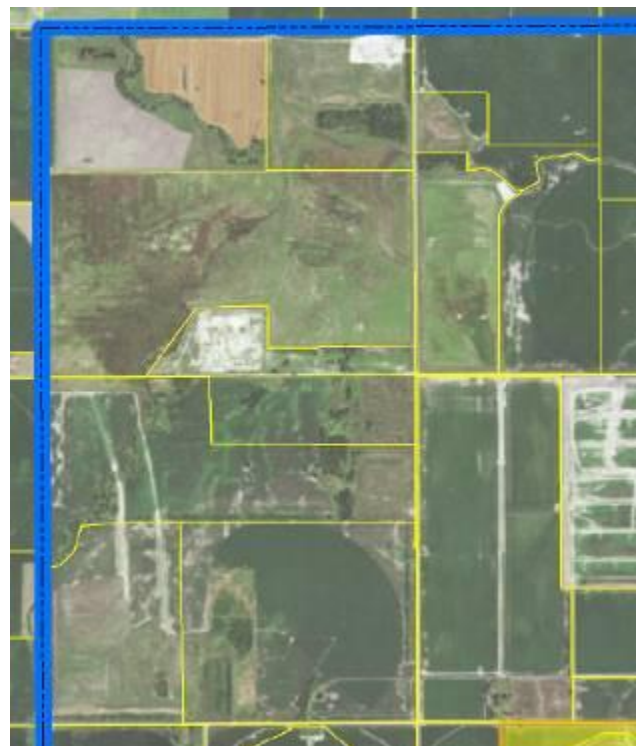
Figure 12
Lot/Parcel Layout

A large reason for this was likely due to what could be split off and sold at a specific time. Examining Figure 11, it is obvious the sale of the parcels, and the shape of the land did not have a specific plan or rationale. The previous section, Diversity of Ownership, identified 26 different landowners; however, there are 89 parcels owned by those landowners.

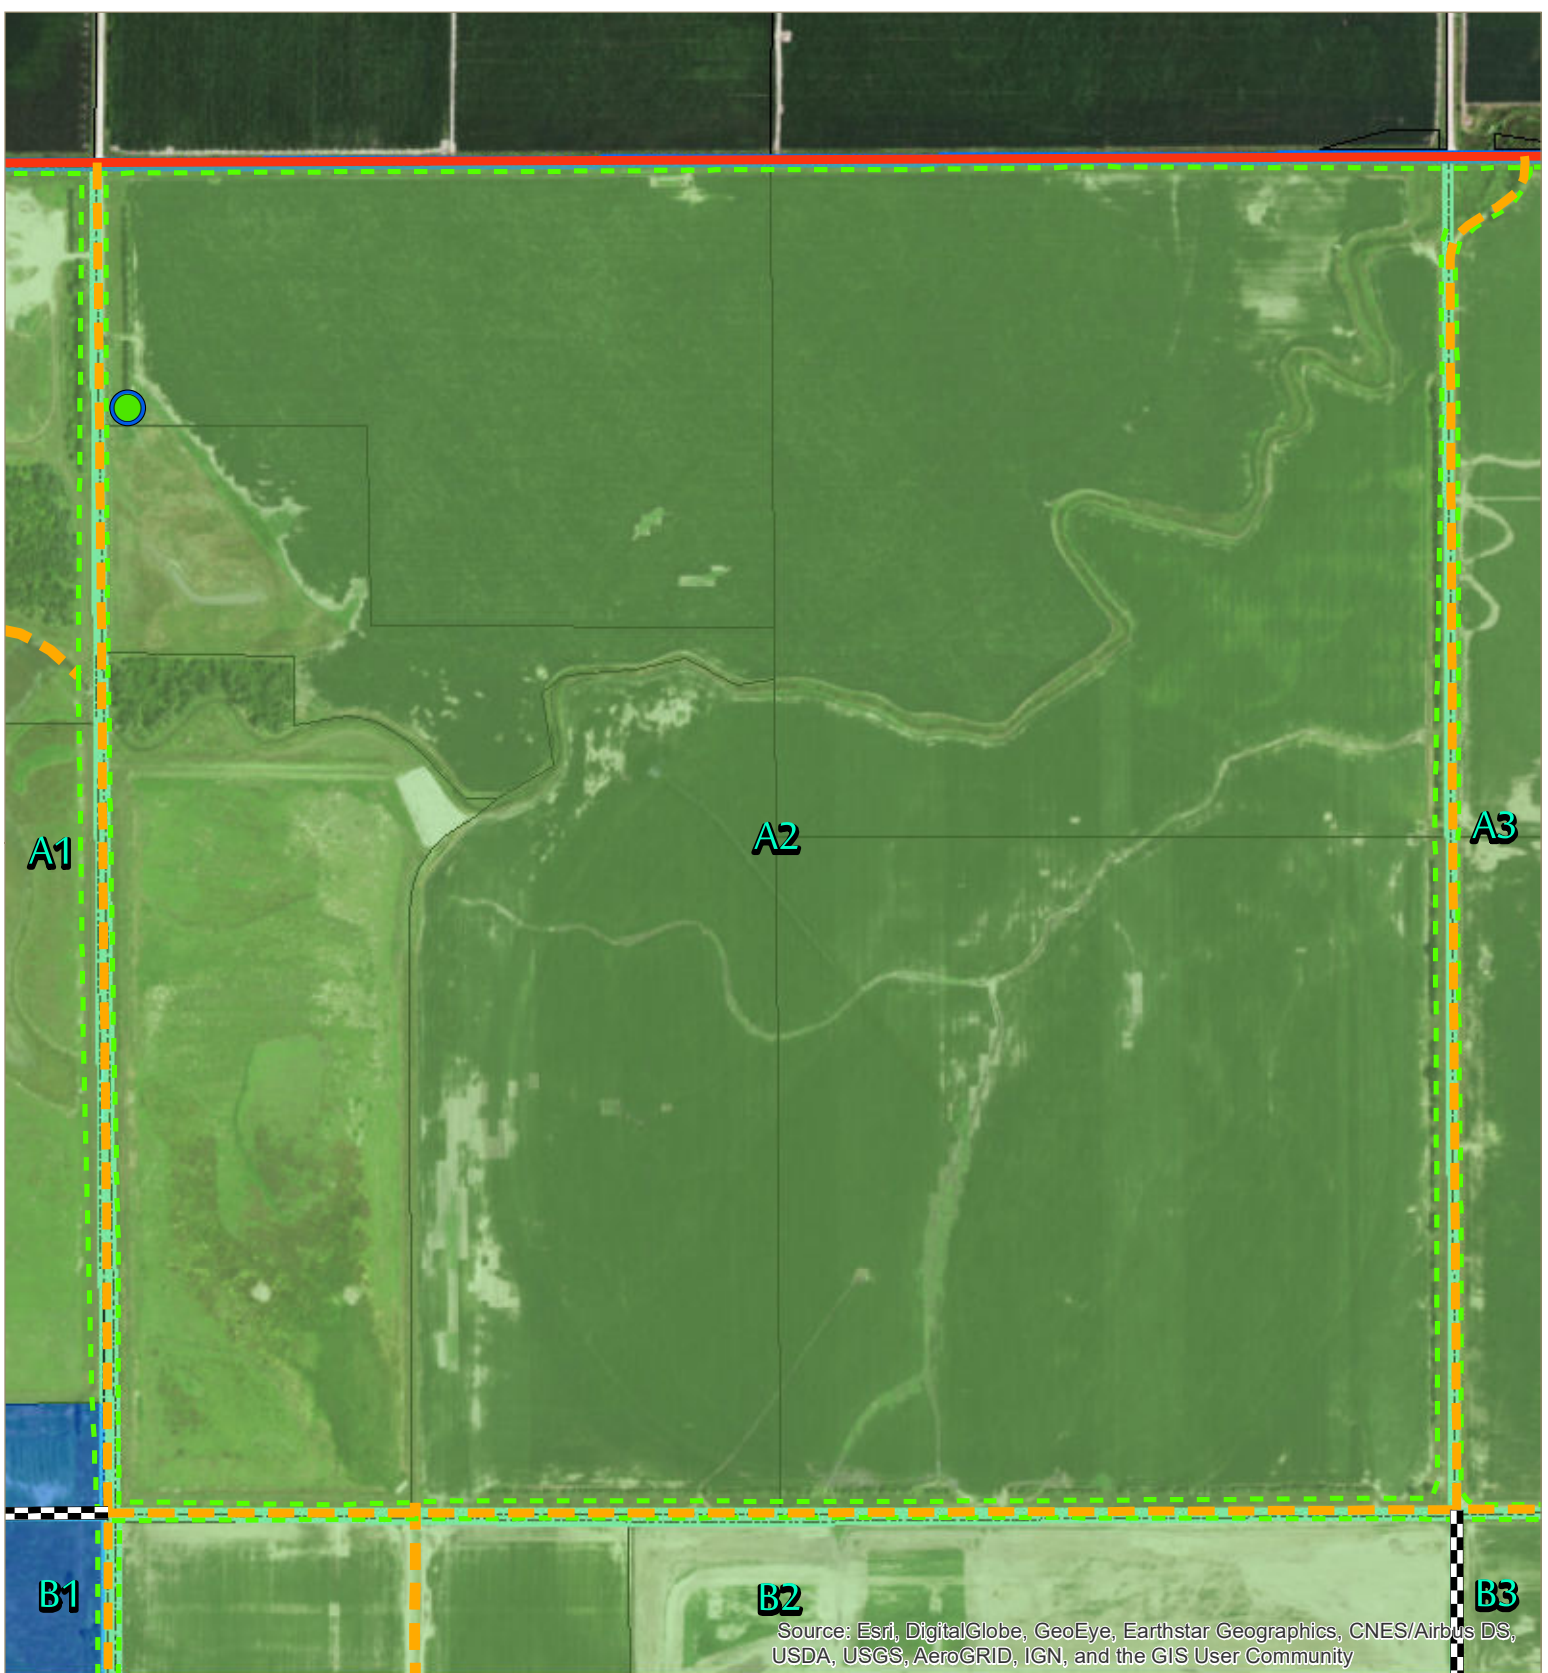
CAAP - SECTION A2

<ul style="list-style-type: none"> Previously Studied Areas CAAP Blight Study Limits CAAP Index Mapping Sections Hall County Parcels 	<ul style="list-style-type: none"> Less Than 40 Years Old - 44 Structures 40+ Years Old - 158 Structures Good - 46 Structures Deteriorated-Dilapidated - 156 Structures 	<p>Existing Land Use</p> <ul style="list-style-type: none"> Agricultural Commercial Industrial Parks & Rec Public 	<p>Road Conditions</p> <ul style="list-style-type: none"> Good (Paved) - 37,111 Linear Feet Fair (Paved) - 34,565 Linear Feet Gravel Road - 164,648 Linear Feet Closed - 23,459 Linear Feet 	<p>Drainage Features</p> <ul style="list-style-type: none"> Drainage Ditch Rural Sections Ditches 	<p>DATA SOURCES: BASE DATA PROVIDED BY HALL COUNTY AERIAL IMAGERY PROVIDED BY ESRI</p>
--	---	---	---	---	--

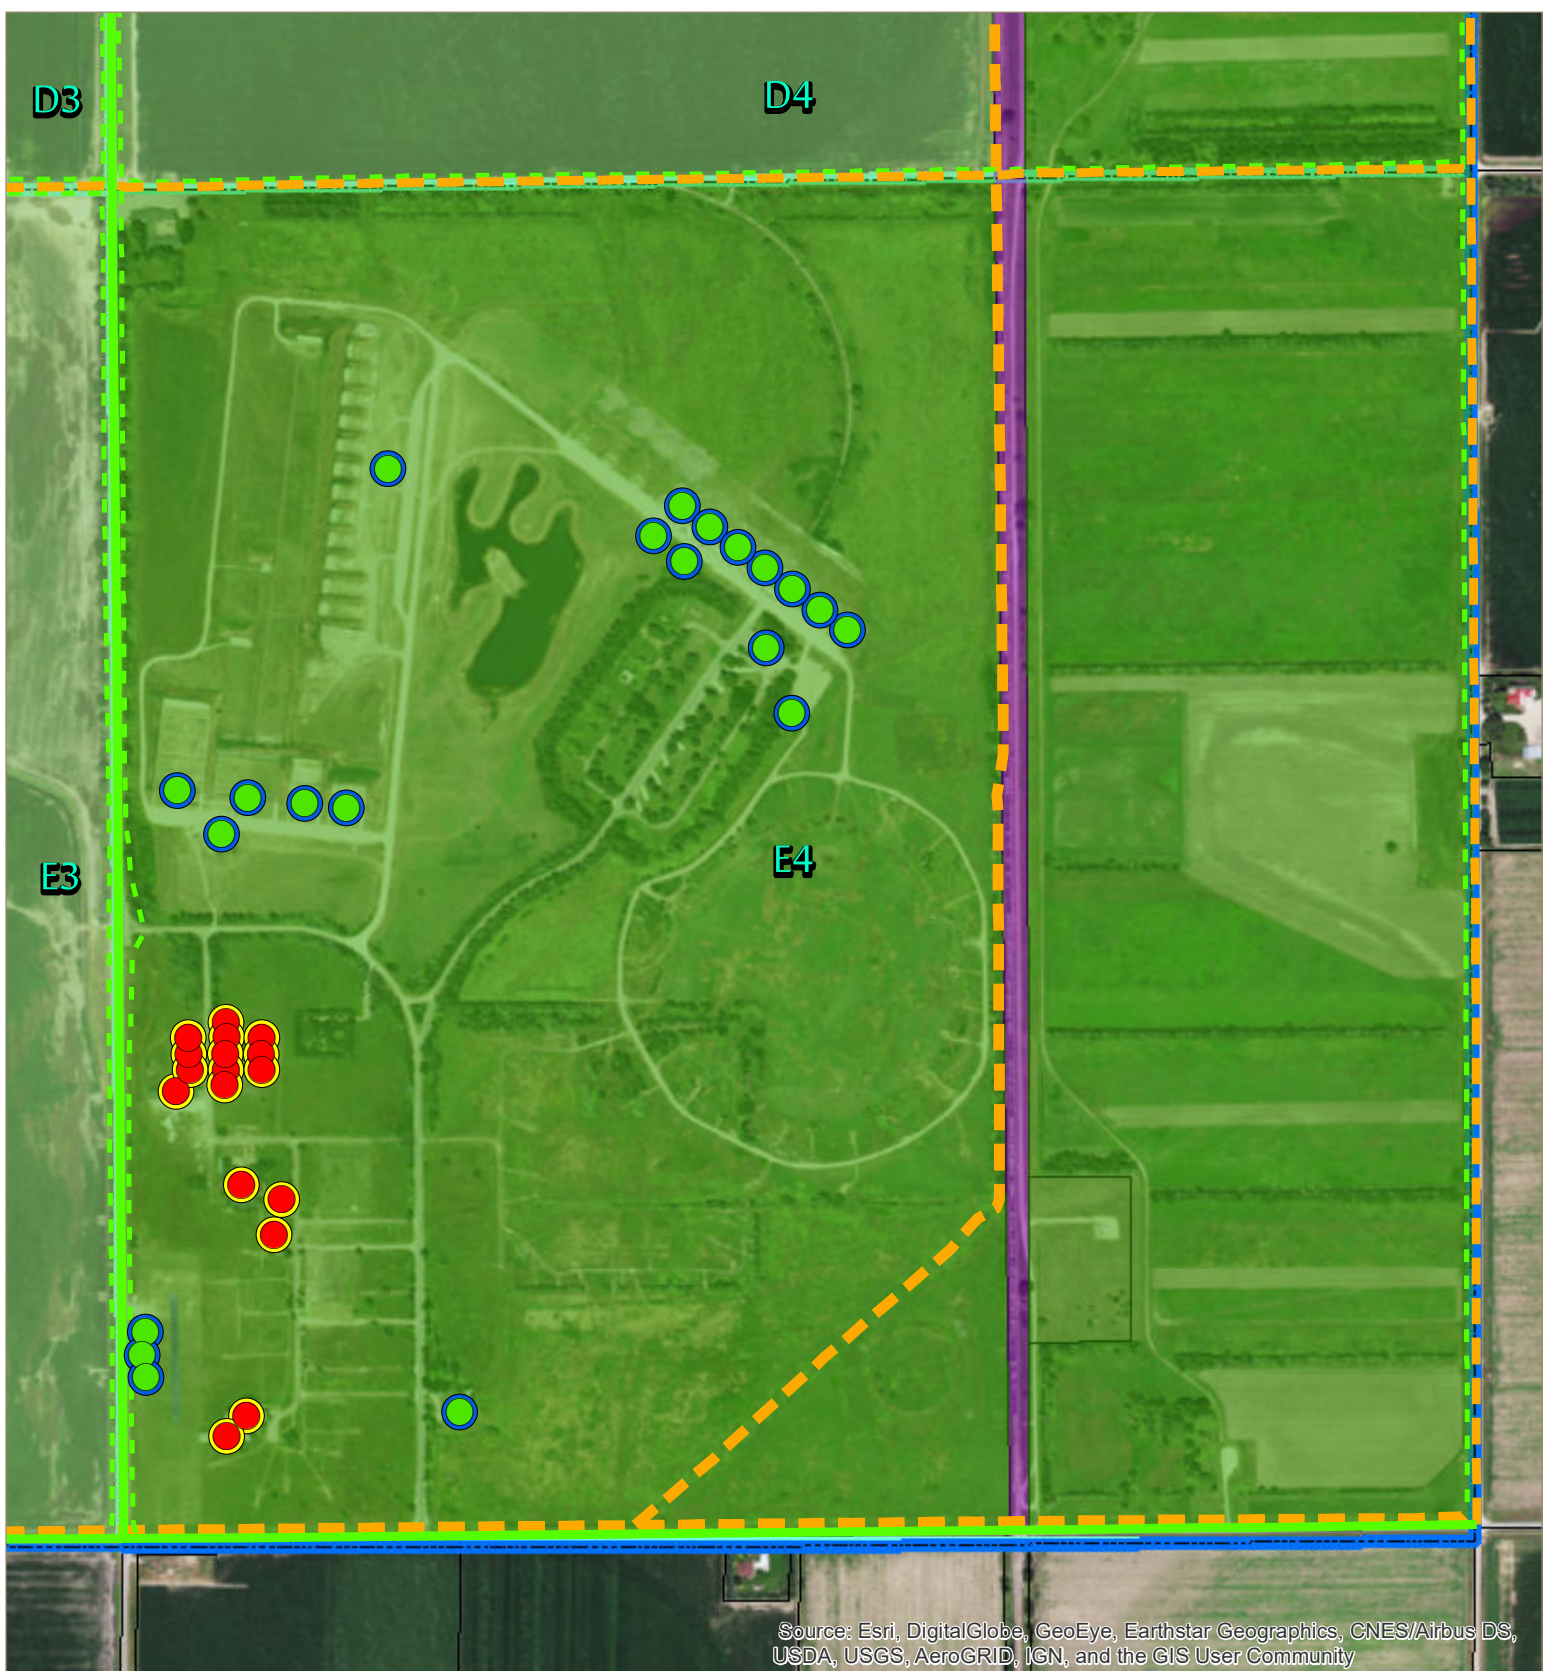
CAAP - SECTION E4

<ul style="list-style-type: none"> Previously Studied Areas CAAP Blight Study Limits CAAP Index Mapping Sections Hall County Parcels 	<ul style="list-style-type: none"> Less Than 40 Years Old - 44 Structures 40+ Years Old - 158 Structures Good - 46 Structures Deteriorated-Dilapidated - 156 Structures 	<p>Existing Land Use</p> <ul style="list-style-type: none"> Agricultural Commercial Industrial Parks & Rec Public 	<p>Road Conditions</p> <ul style="list-style-type: none"> Good (Paved) - 37,111 Linear Feet Fair (Paved) - 34,565 Linear Feet Gravel Road - 164,648 Linear Feet Closed - 23,459 Linear Feet 	<p>Drainage Features</p> <ul style="list-style-type: none"> Drainage Ditch Rural Sections Ditches 	<p>DATA SOURCES: BASE DATA PROVIDED BY HALL COUNTY AERIAL IMAGERY PROVIDED BY ESRI</p>
--	---	---	---	---	--
