City of Grand Island, NE

Blight and Substandard Study

Area #9

March 2012

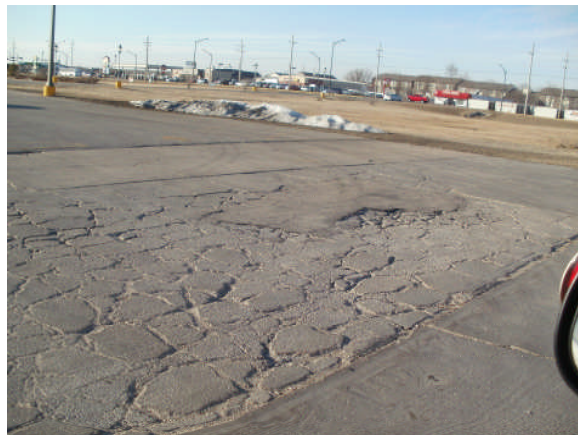
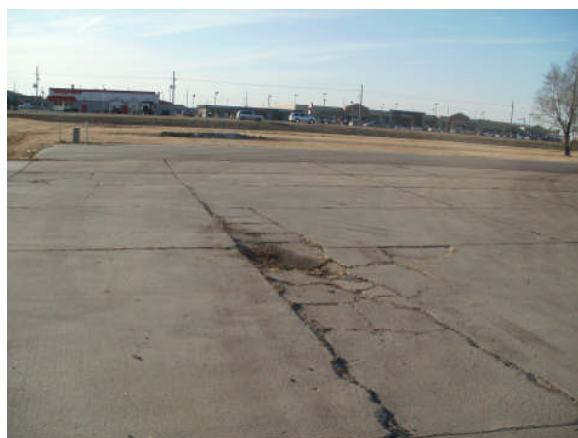
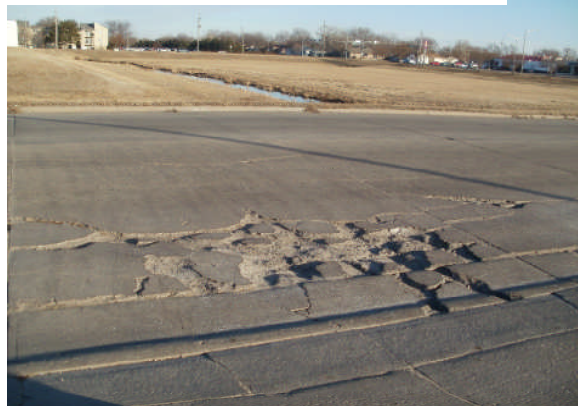
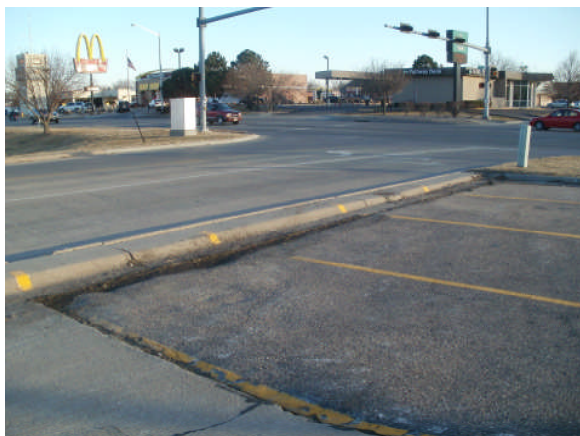
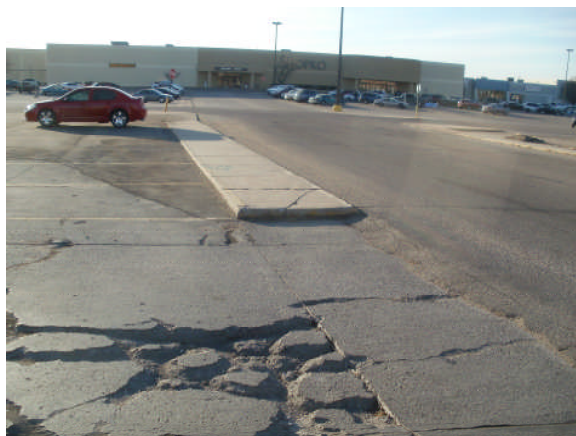
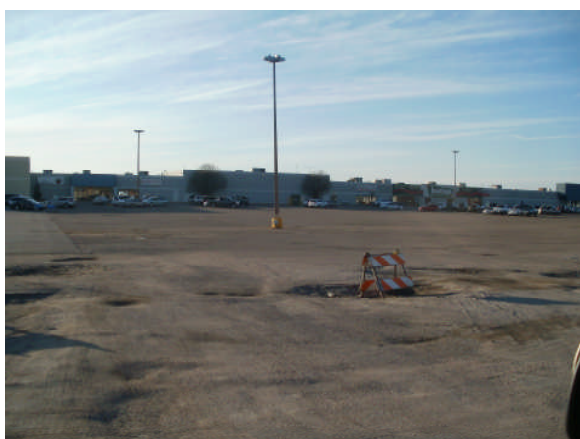
The Study Area contains a major deteriorated condition; the parking areas throughout the area, as well as the demarcated driving areas.

The parking areas throughout the entire Study Area are in a serious state of disrepair. In a number of situations, the deterioration may present a potential hazard to vehicles. The parking surface and driving areas contain major surface break-ups and spawling. These conditions have been likely caused by several circumstances over the years, including:

- Lack of maintenance
- Sub-soil conditions
- Heavier than expected traffic
- Flooding in recent years
- Freeze/thaw cycles

Photos 1 through 7 indicate examples of different deteriorated conditions within the parking and driving areas across the entire site.

A number of these items can be prevented through proper design, enforcement and maintenance, with maintenance being a key.

Due to the large amount of broken pavement in the Study Area, the parking areas are considered to be deteriorated or in a state of deteriorating; therefore, they are a direct contributing factor to the conditions of blight.

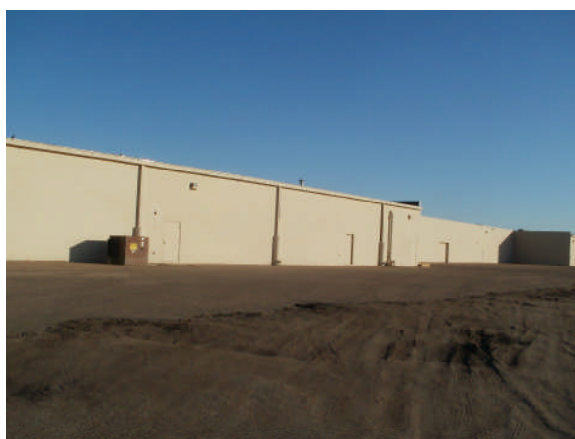
Photo 7

In addition to broken pavement in the Study Area, there are some areas where the actual driving areas have reverted to dirt and mud as seen in Photo 7.

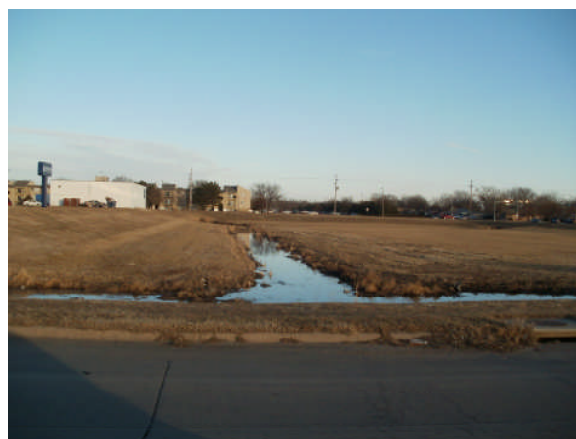
Photo 8

The photographs of the Study Area indicate standing water within key drainage ways on the site, see Photo 8.

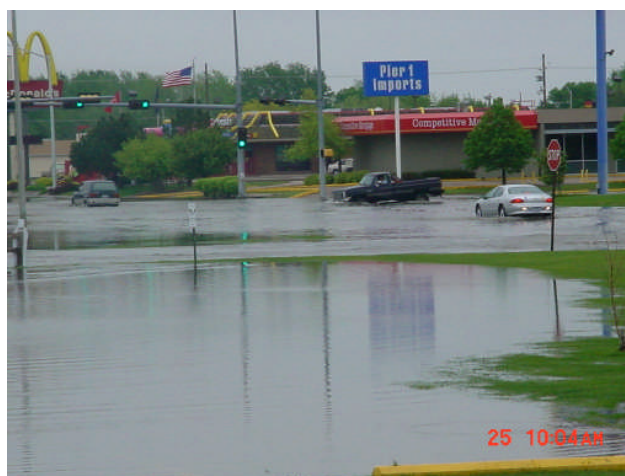
In addition to Photos 8 and 9, Photo 10 is a picture that was taken on May 11, 2005 after the city of Grand Island had been inundated by a spring storm that dropped nearly 8 inches of rain on the community. Photo 10 is from the southwest corner of the study area looking easterly.

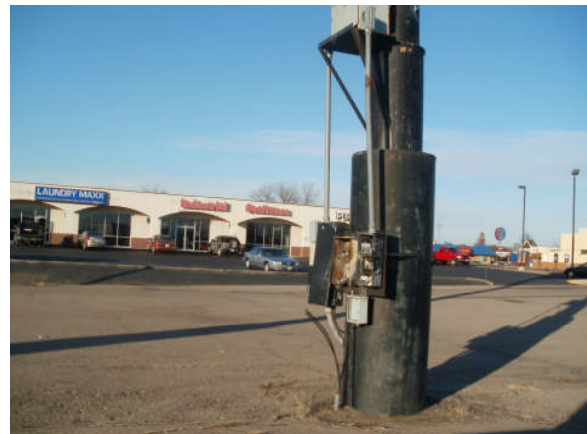
Photo 11

One final contributing factor is the existing location of the Grand Island Mall pole sign on the Webb Road side of the Study Area. Currently the sign poses a safety risk due to its location. The pole sign is located in the middle of the parking lot and is paved right up to the poles. In addition, there are no barriers in place to minimize the potential for vehicles to hit the sign. If a driver is not paying attention and/or is unfamiliar with the parking lot configuration the potential is good for a collision. Photo shows the location of one of two poles supporting the sign.

- **Dangerous conditions to life or property due to fire or other causes**
 - The primary signage (pole sign) on the Webb Road side of the area has two large steel poles that have no separation from the vehicular movements of the site.
