**Grand Island, Nebraska
Blight and Substandard Study - Area 18
Completed on behalf of: Middleton Electric**

PURPOSE OF THE BLIGHT AND SUBSTANDARD STUDY

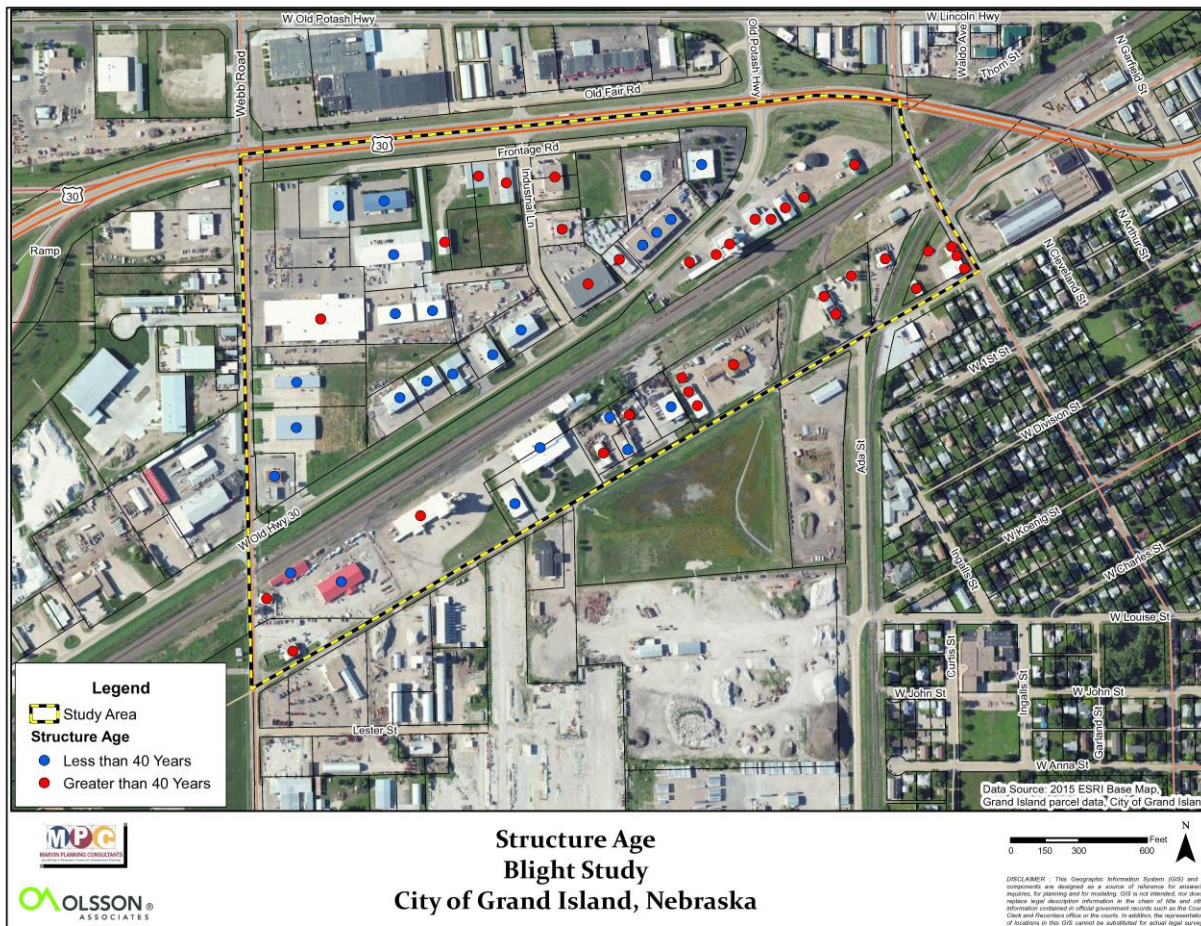
Figure 3
Unit Age Map

Age of structures can be a contributing factor to the blighted and substandard conditions in an area. Statutes allow for a predominance of structures 40 years of age or older to be a contributing factor regardless of their condition. The following paragraphs document the structural age of the structures within the Study Area. Note the age of structure was determined from the Appraisal data within the Hall County Assessor's website data.

The age of the structures would be a direct contributing factor.

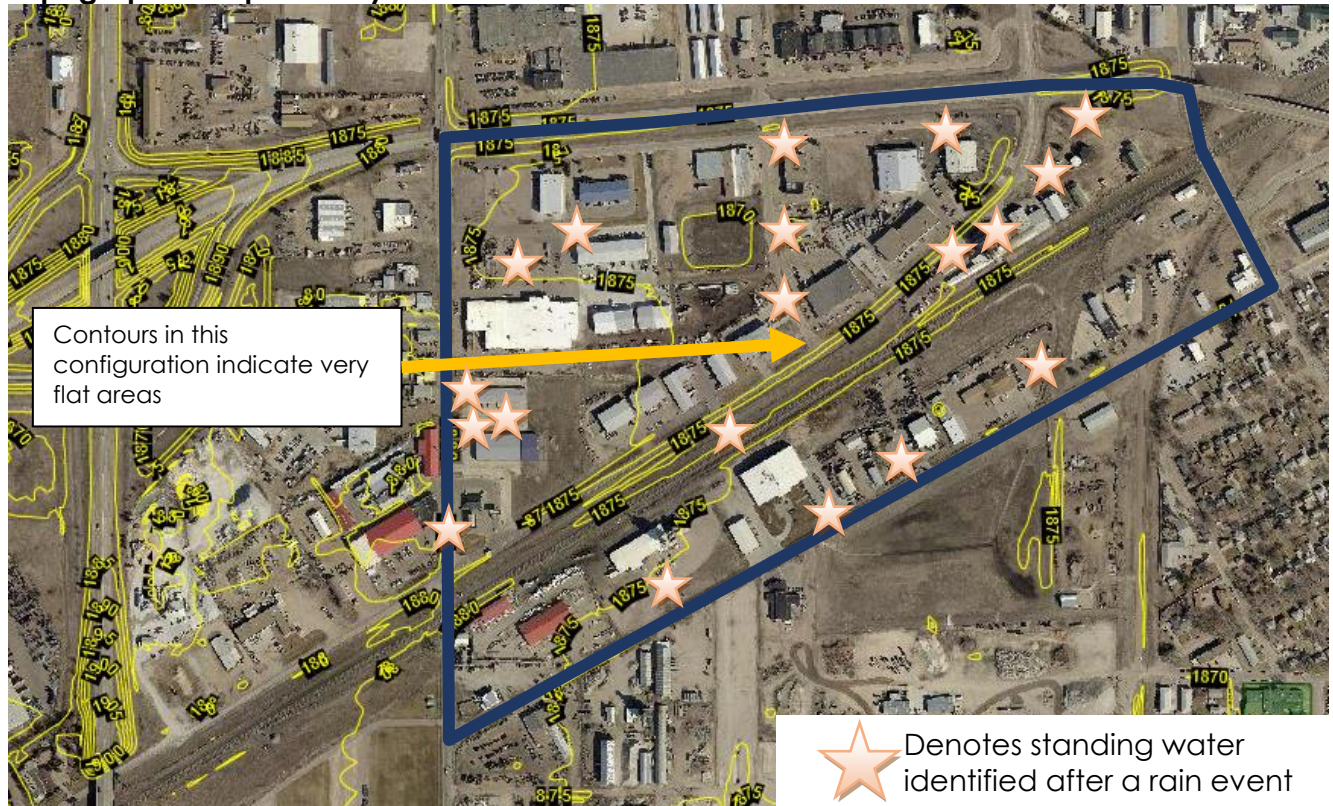
Figure 7 is an existing topographic map from the City of Grand Island's website. The map confirms the flatness of the area between US Highway 30 on the north and 2nd Street on the south. The most common contour identified on the map is the 1875 contour. There are actually only two other contours in this study area, one is 1880 along the centerline of S. Webb Road and the 1870 contour at the bottom of the small stormwater catchment.

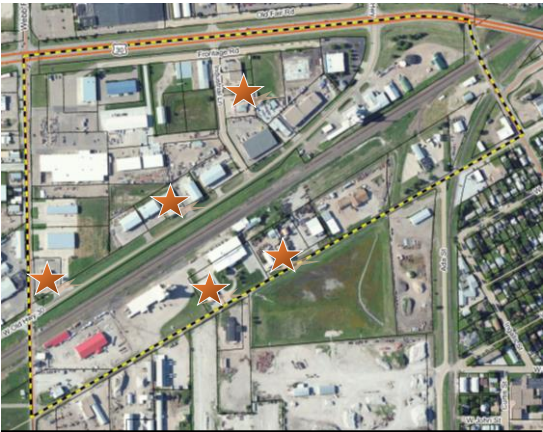
Figure 9: Small Lot Sizes
Source: Marvin Planning Consultants

Figure 9 to the right identifies the lots in the study area deemed to be either too narrow, too shallow, or both (resulting in an overall small lot). Considering the current land use plan and zoning for this area, these lots have the potential to be undesirable or overcrowded with building in the future; in some cases these lots are already overcrowded.

Based upon the discussion regarding lot size and shape above, the lots in Figure 9 are not adequate for the type of land use and zoning designated for this area. Parking and deliveries opportunities are somewhat limited on these lots.

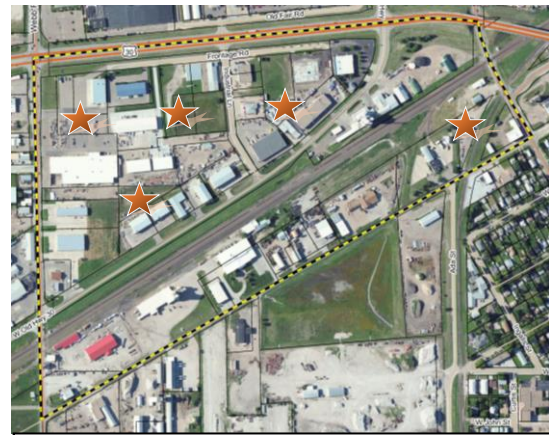
Figure 10: Accessibility
Source: Marvin Planning Consultants

Several of the lots are currently tied to a business with direct access to major thoroughfares. However, if these lots were ever sold off, it would create a condition of land locked lots. Figure 10 above indicates those landlocked lots.

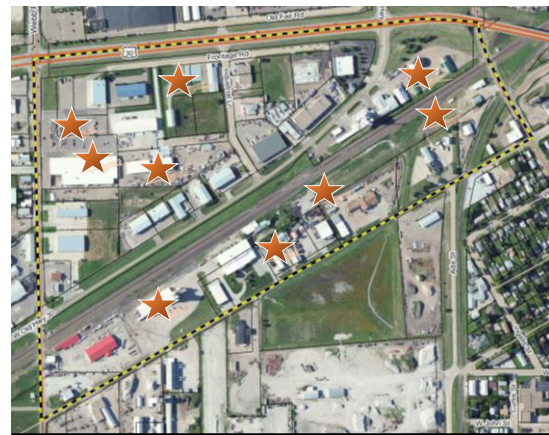
Figure 11: Improper Subdivision
Source: Marvin Planning Consultants

Improper subdivision or obsolete platting is another blighting condition found in the study area. Figure 11 identifies a number of irregularly shaped lots throughout the area. If this area were to be platted under the current process, it is likely these lot configurations would not occur or be approved.

In addition, Figure 11 indicates an area along the south side of the Union Pacific Railroad corridor. This area is one large lot with multiple uses leasing ground from the railroad. Each of these uses should be contained on their own individual lots. Finally, this same condition occurs along the northside of the corridor where the Aurora COOP facility is located.
