BOILER INSPECTION AND REPAIR SPRING 2022 OUTAGE

C131306

Platte Generating Station

OUTAGE INSPECTION REPORT 2015

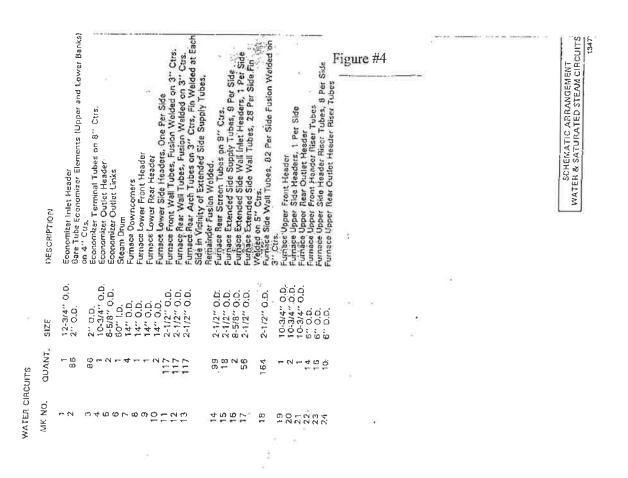
Figure #4

All of the pressure parts were visually inspected during the outage in 2015. Most of the inspections were performed in the convection pass area. Unless otherwise noted, all assemblies and tubes are numbered and referenced from left (East) to right (West) and front (North) to back (South). **Figure #4** (following page) shows the water and saturated steam circuits.

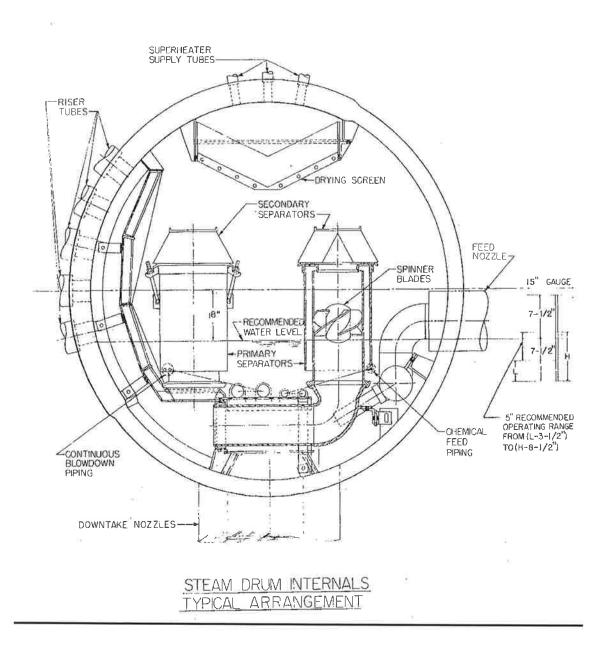
Figure #5 below shows a cut away section of the steam drum for this unit.

Perform periodic inspections in the steam drum of the penetration welds for signs of stress corrosion and crack indications.

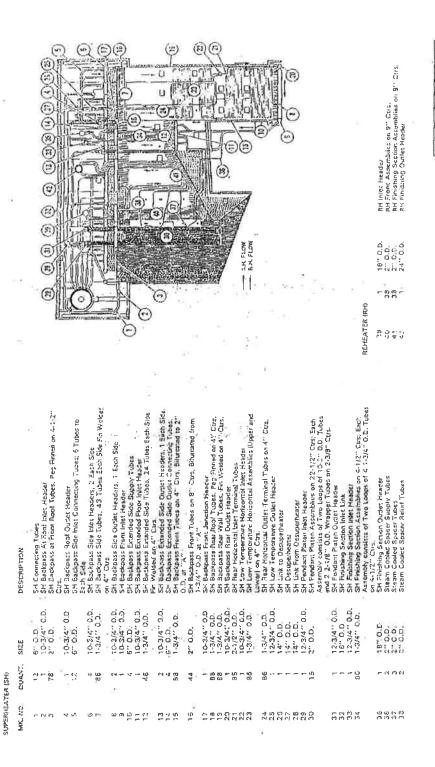
Figure #6

The superheat and reheat circuits were inspected during this outage. The superheat and reheat section of the report is broken down according to the steam flow path through these circuits. A schematic arrangement diagram of the superheat and reheat circuits is shown in **Figure #6** (following page). The components of these circuits are listed in order according to the steam flow path.
