City of Grand Island, NE
Blight and Substandard Study
Area #32
May 2021

PURPOSE OF THE BLIGHT AND SUBSTANDARD STUDY

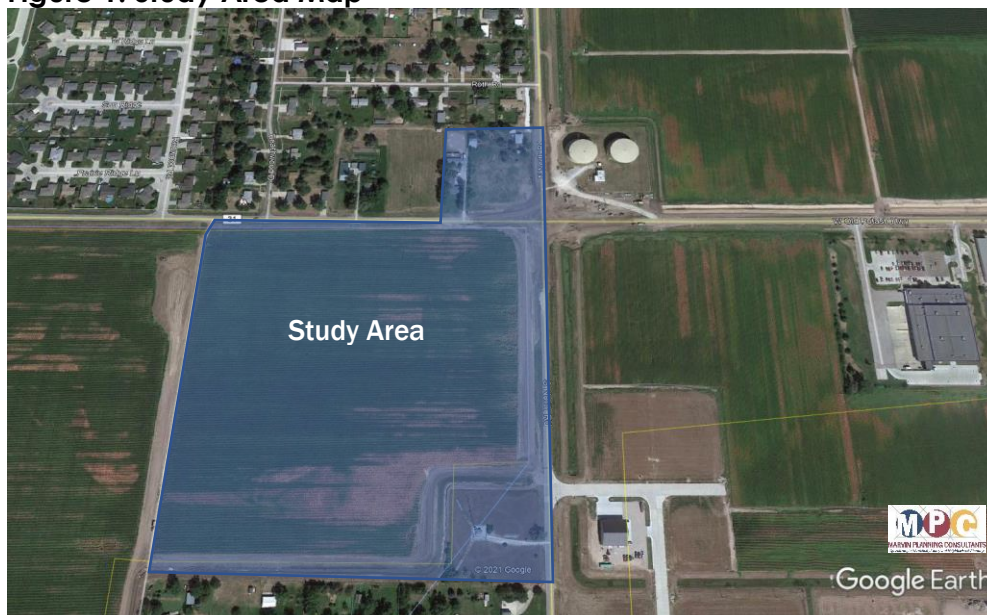
Figure 1: Study Area Map

The following is the description of the designated area within the City of Grand Island. Point of beginning is the intersection of the centerlines of Old Potash Road and North Road; thence, northerly along the centerline of North Road to the extended north property line of a tract referred to as Miscellaneous Tracts 14-11-10 PT SE 1/4 SE 1/4 2.72 AC (124 North Road North; thence, westerly along the said north property line and continuing along the north property of a tract referred to as Pontious Sub Part Lot 1 100' X 185.47' & All of Lot 2, at the northwest corner of said lot, thence boundary turns south along the west property line of said lot and continuing to the intersection with the centerline of Old Potash Street; thence westerly along the centerline of Old Potash Road to the intersection with the extended west line of the NE 1/4 of the NE1/4 of 23-11-10; thence, southerly along said west line of the NE 1/4 of the NE1/4 of 23-11-10 to the southwest corner of a tract referred to as Misc tract to the City of Grand Island S 1/2 NE 1/4 NE 1/4 23-11-10; thence, easterly along said south property line and continuing onto the south property line of a tract referred to as Misc Tracts 23-11-10 Pt NE 1/4 NE 1/4 2.29 AC and continuing to the intersection with the centerline of North Road; thence, Northerly along said centerline to the POB. A total of 43.29+/- acres

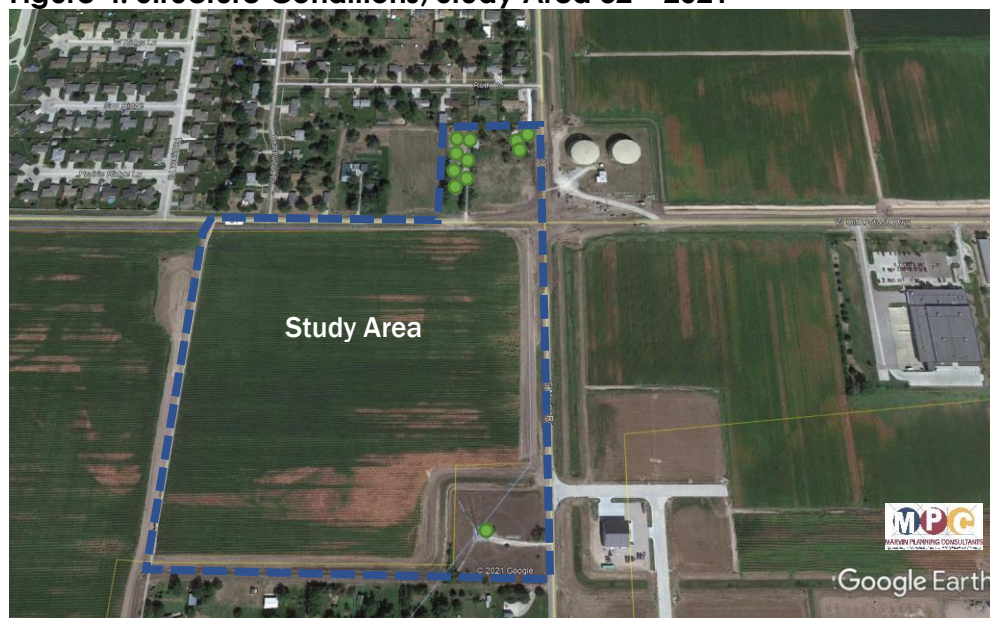
Figure 4: Structure Conditions, Study Area 32 – 2021

Structural conditions were evaluated, structures were either rated as: Excellent, Very Good, Above Normal, Normal, Below Normal, Poor or Very Poor. The data and rating system come from the Hall County Assessor's database and is the same database used to value properties in the area. According to the data there are 10 structures in the study area.

- **0 (0.00%) structures rated as Excellent**
- **0 (0.00%) structure rated as Very Good**
- **0 (0.00%) structures rated as Above Normal**
- **10 (100.00%) structures rated Normal**
- **0 (0.00%) structures rated Below Normal**
- **0 (0.00%) structures rated Poor**
- **0 (0.00%) structure rated as Very Poor**

Based upon these data, an assumption has been made that normal conditions in combination with the age of structures or a condition less than normal may constitute the possibility of some or considerable deterioration. It is common for older structures to need more maintenance and upkeep in order to maintain a good or higher condition. Even a structure rated as normal will show some signs of deteriorating which in turn can become a dilapidated structure in the future if it is not addressed over time. Overall, 100.00% of the structures in this study area are considered as a normal condition.

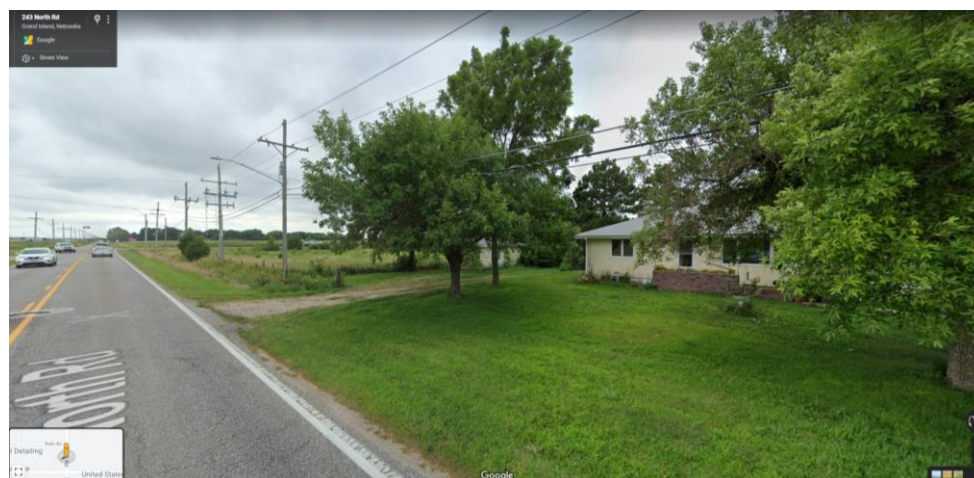
The study area does not contain any sidewalks either along Old Potash Road or North Road. Sidewalk is critical to the overall pedestrian movement of an area, long-term. Even sidewalk constructed which at present goes nowhere will eventually connect to several portions of the community.

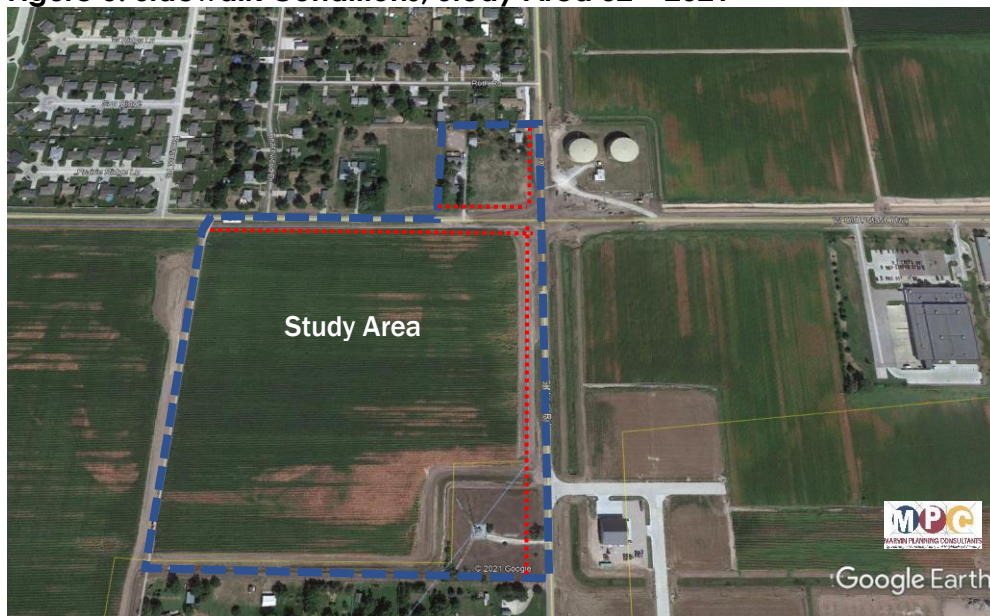
Figure 5: Sidewalk Conditions, Study Area 32 – 2021

- **0 (0.00%) lineal feet of Excellent sidewalk**
- **0 (0.00%) lineal feet of Good sidewalk**
- **0 (0.00%) lineal feet of Average sidewalk**
- **0 (0.00%) lineal feet of Fair sidewalk**
- **3,000 (100.00%) lineal feet of Poor or Missing sidewalk**

Due to the lack of sidewalk, sidewalks are considered a direct contributing factor.

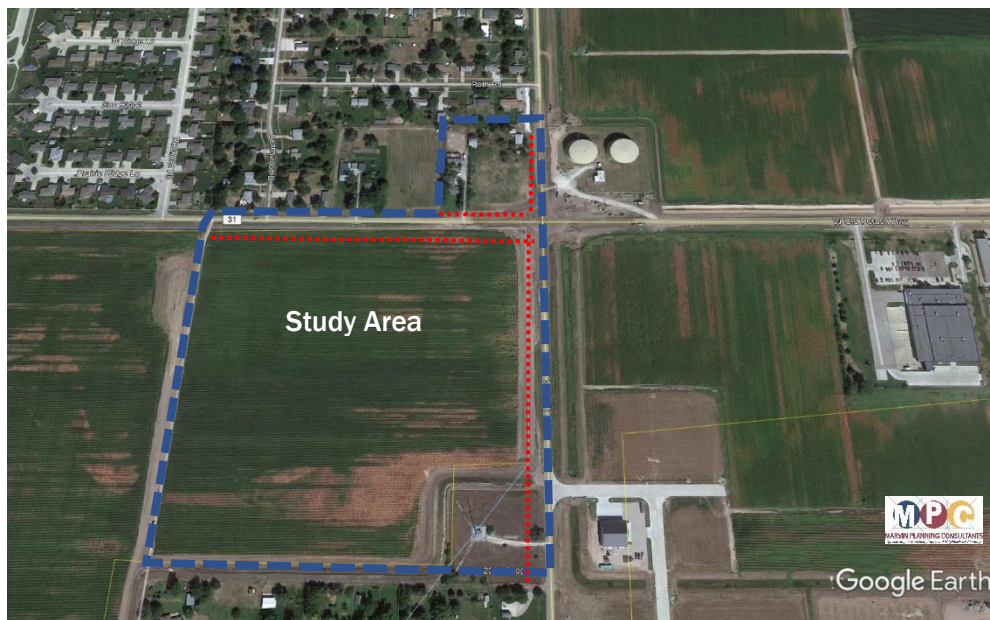
Figure 6: Curb and Gutter Conditions

Curb and gutter for the Study Area were examined similarly to sidewalks. The curb and gutter were graded as either Excellent, Good, Average, Fair, Poor and Missing. There is no curb and gutter within the study area. And is considered rural section drainage.

- **0 (0.0%) lineal feet of Excellent curb and gutter**
- **0 (0.00%) lineal feet of Good curb and gutter**
- **0 (0.00%) lineal feet of Average curb and gutter**
- **0 (0.00%) lineal feet of Fair curb and gutter**
- **3,000 (100.00%) lineal feet of Poor or Missing curb and gutter**

Due to the large amount of deteriorating and missing curb and gutter, the curb and gutter conditions would be a direct contributing factor.

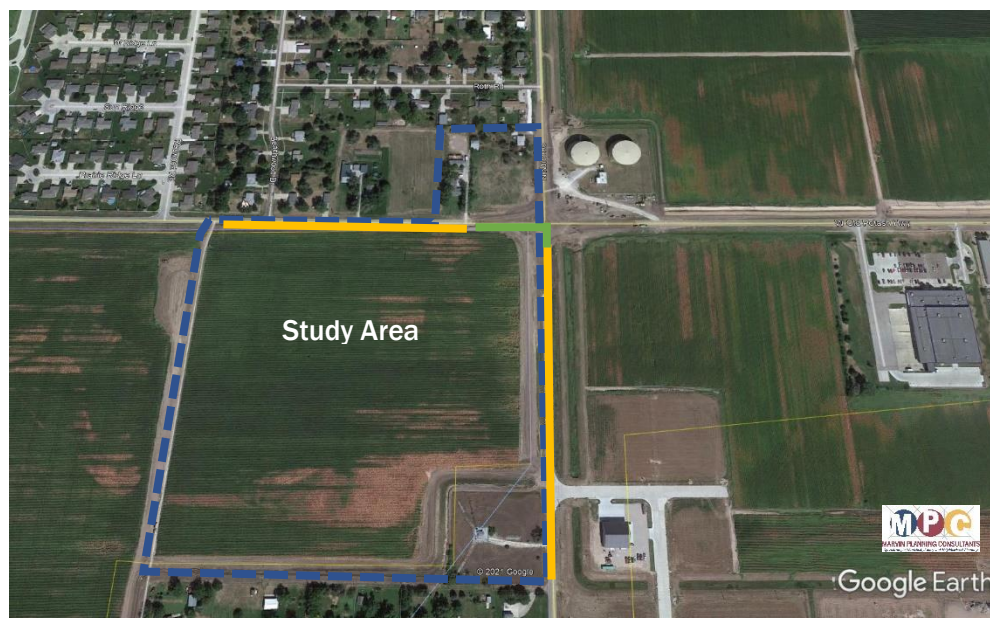
Figure 7: Street Conditions

- **425 (16.2%) lineal feet of Excellent street**
- **0 (0.0%) lineal feet of Good street**
- **2,205 (83.8%) lineal feet of Average street**
- **0 (0.0%) lineal feet of Fair street**
- **0 (0.0%) lineal feet of Poor street**

The streets within the Study Area are in either excellent condition or average condition. Overall, 83.8% are considered to be in average condition; thus, making streets a contributing factor. Similar to sidewalks and curb and gutter, a rating of average is considered the beginning of deterioration and may continue to decline over the next few years.

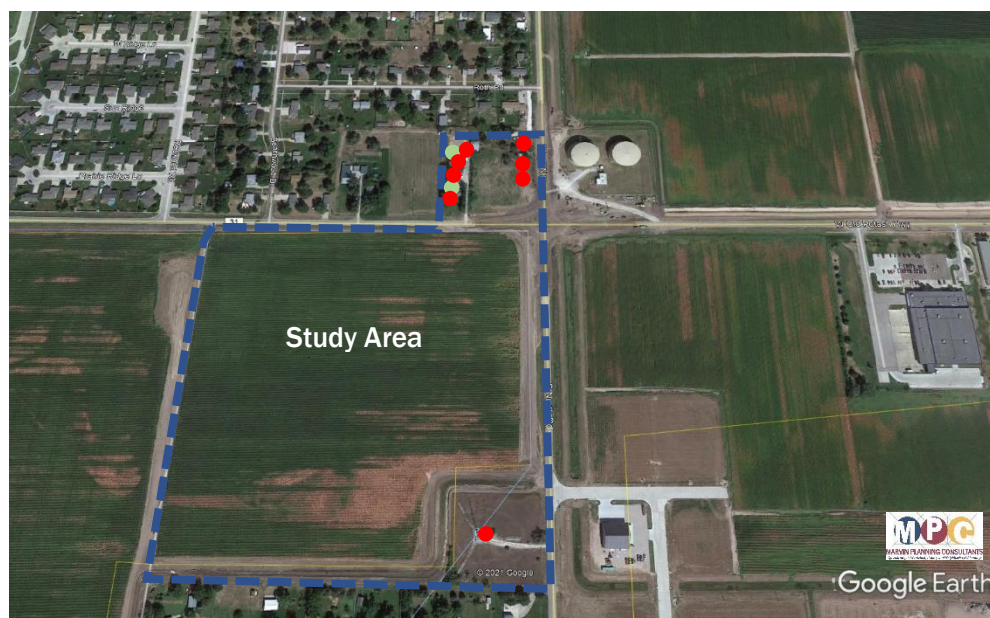
Figure 8: Age of Structures

- 8 (80.0%) unit was determined to be 40 years of age or older.
- 2 (20.0%) unit was determined to be less than 40 years of age.

However, when examining the age based upon a cumulative approach, as in Table 1 the average age of the primary structures is equal to 41.8 years; thus, meeting the requirements of the statutes.

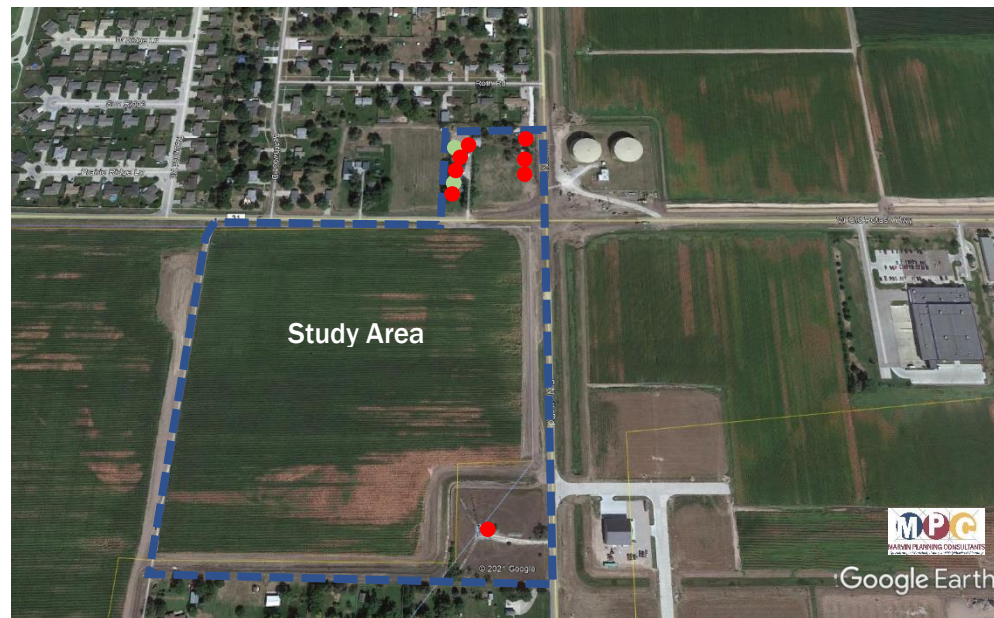
Figure 8: Age of Structures

- 8 (80.0%) units were determined to be 40 years of age or older.
- 2 (20.0%) units were determined to be less than 40 years of age.

However, when examining the age based upon a cumulative approach, as in Table 2 the average age of the units is equal to 41.8 years; thus, meeting the requirements of the statutes.
